Rondout Creek Management Unit 2

Stream Feature Statistics

Management Unit 2
Between Station 4700 and Station 1100

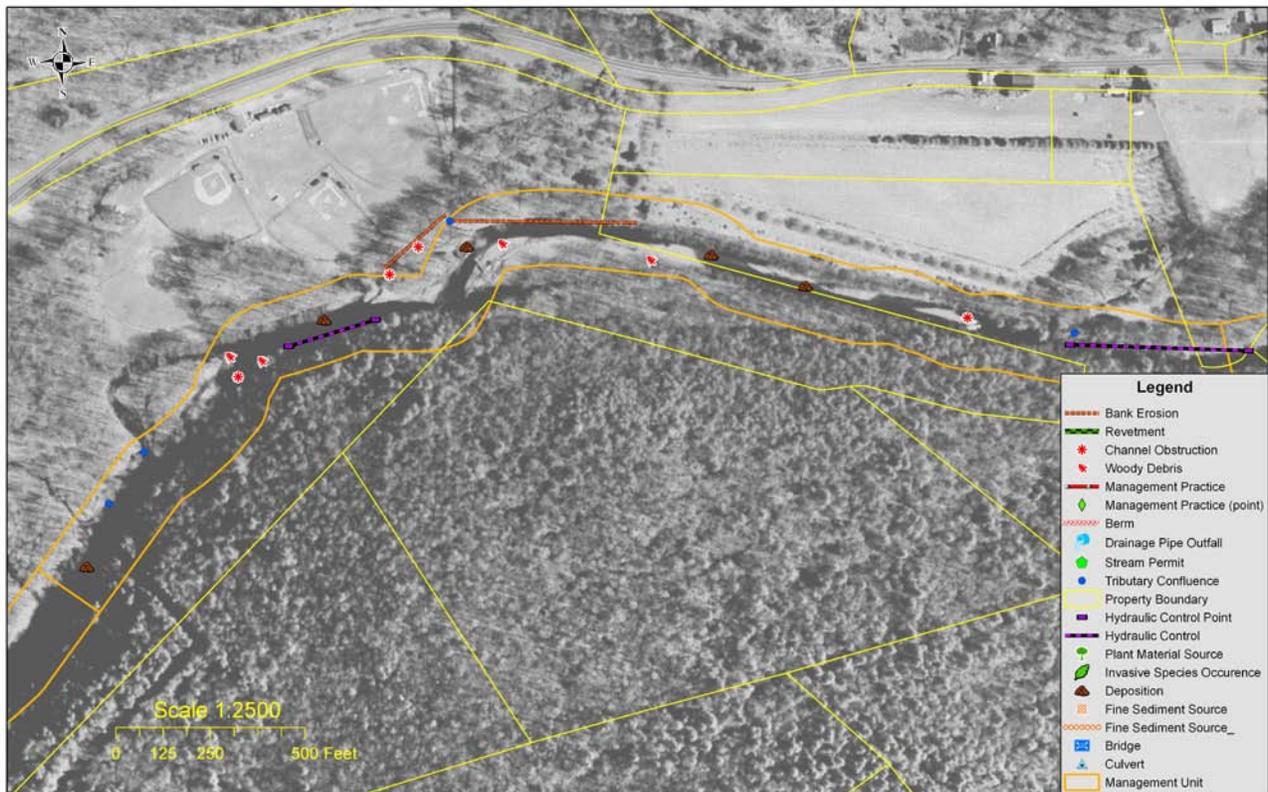
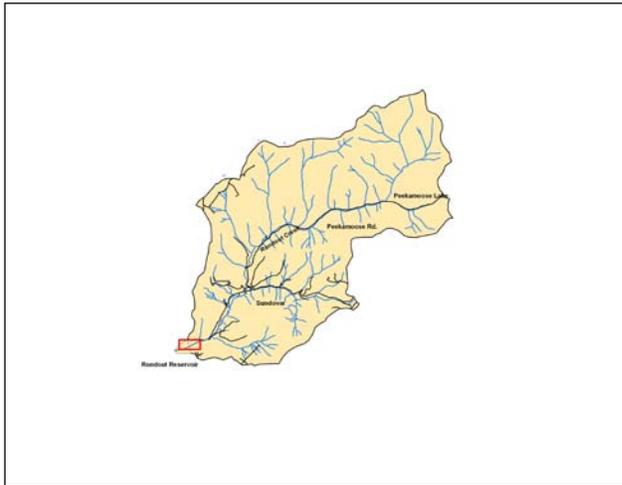
Figure 1 Management Unit 2 Stream feature inventory

The 2009 stream feature inventory revealed that 10% (703 ft.) of the stream length exhibited signs of active erosion along 3,595 ft. of total channel length (Fig. 1). Revetments have not been installed in this management unit. No berms were identified in this management unit at the time of the stream feature inventory.

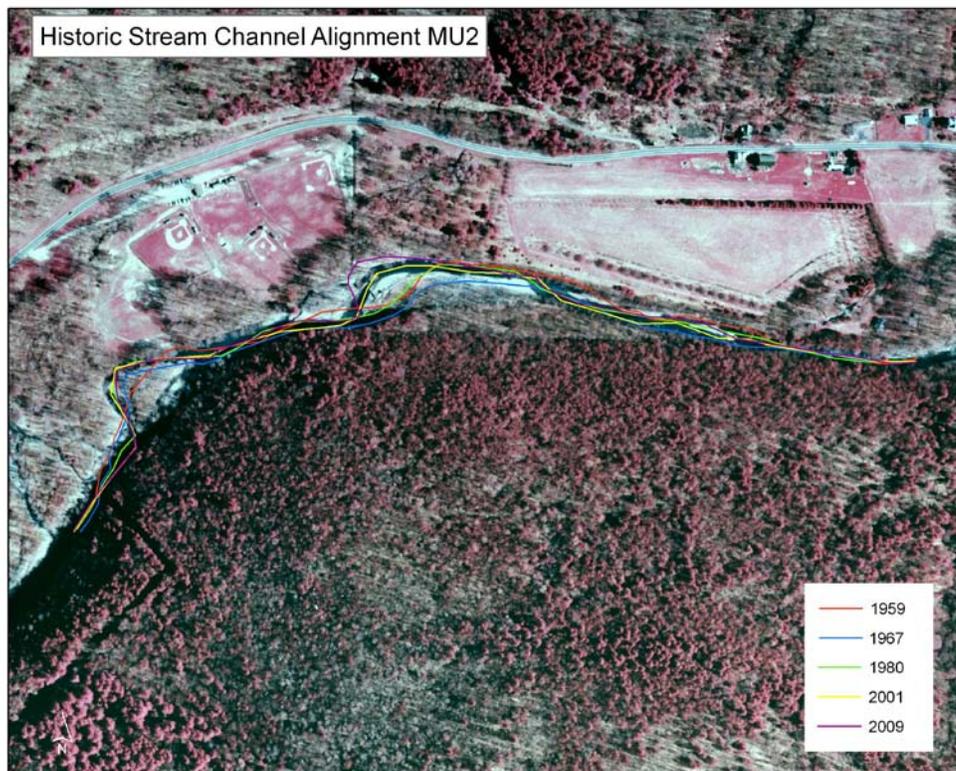
Figure 2 Historical channel alignments in MU2

valley floor floodplain numerous times. An analysis of historic aerial photography shows that, just since 1959, there has been significant channel shifting in this management unit (Fig. 2). There have been numerous Article 15 stream disturbance permits issued for work in this management unit (Fig. 1).

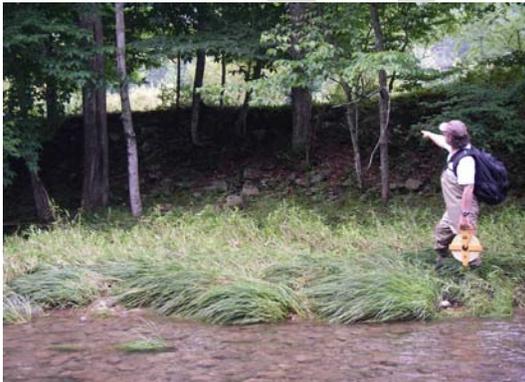
Figure 4 Right bank, lateral bar, moderate entrenchment, Stn 3500

about 1000 ft. to approximately Station 3300, with evidence of historical incision to bedrock, and subsequent aggradation across the bed, and in lateral bars on the right, possibly due to historical channel management resulting in an over-widened channel. This reach, however, has mature vegetation on both banks, and appears to be quite stable owing to the bedrock control of left bank and bed.

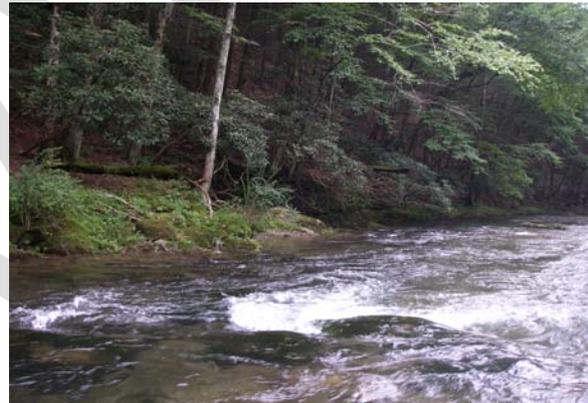
Beginning at Station 4700, the Rondout runs along the left valley wall for about 450 ft. (Fig 3), to the confluence of an unnamed tributary on the right. Bedrock ledge outcroppings control the channel on the left and in the bed for much of this reach, with bedrock protrusions in the bed occasionally obstructing flows.

Figure 3 Bedrock ledge in channel bottom and left bank

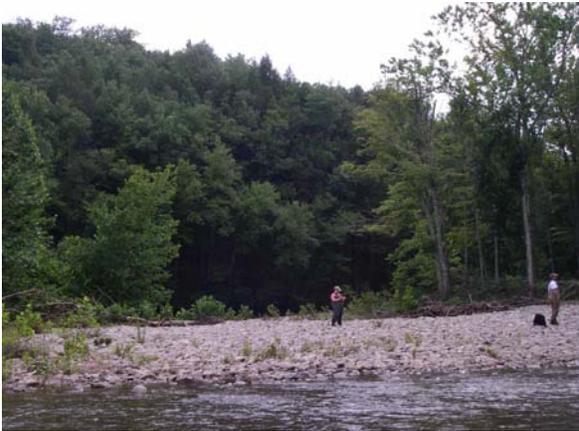
Station 2700. The point bar has collected significant woody debris; it also has a small backchannel against the left valley wall. Across the channel on the right, at the outside of the meander, erosion is occurring from Station 2300 to Station 3050, adjacent to the Jerry Scanna Memorial Little League Field (Figs. 5-10). The alluvial soils in the right bank have a significant fraction of fine material. A Small, unnamed tributary confluences with the Rondout through the eroding bank. The bankfull channel width increases to 150 ft. in some parts of this reach; the equilibrium width is around 95 ft.

Figure 5 Point bar

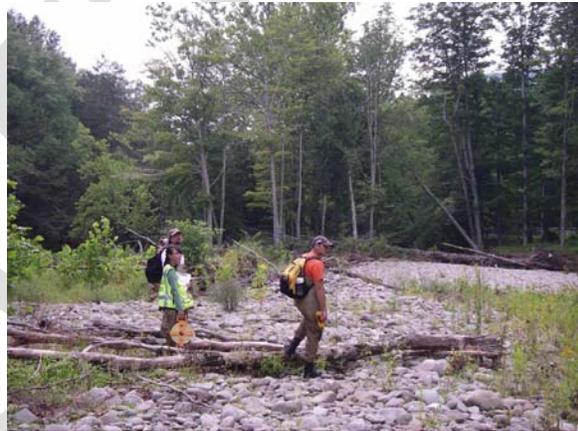
Figure 6 Large woody debris on the left floodplain

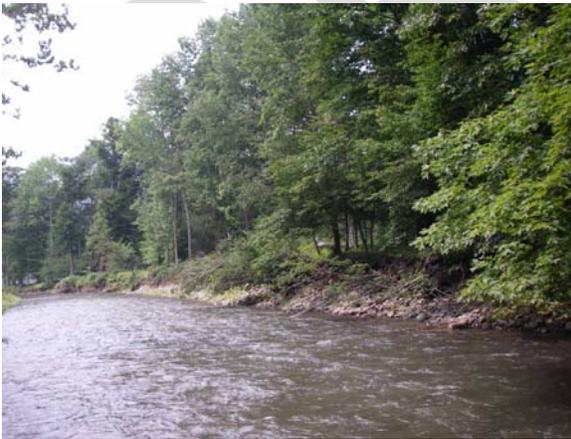
Figure 7 Erosion on right bank, Stns 2300 - 3050

Recommendations for this entire aggradational area include extensive soil bioengineering treatments to stabilize the right bank through the reach, and to narrow the floodplain on the left with plantings. Woody debris causing an obstruction to bankfull and larger flows (Fig. 9) should be removed or repositioned to increase floodplain stability.

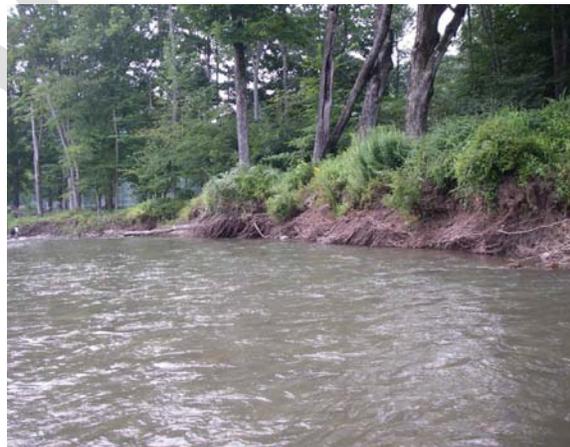
Figure 8 Bank erosion along the baseball field

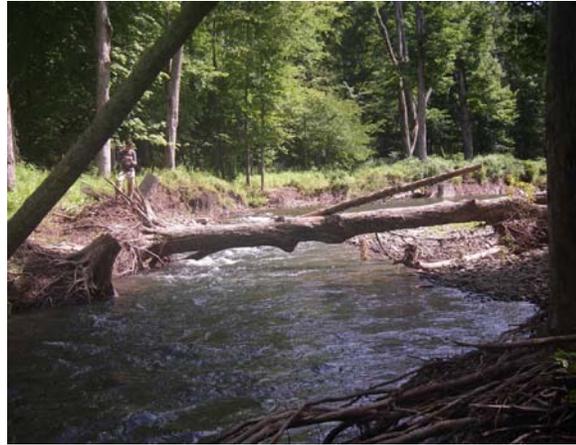
Figure 9 Woody debris, an obstruction at higher flows

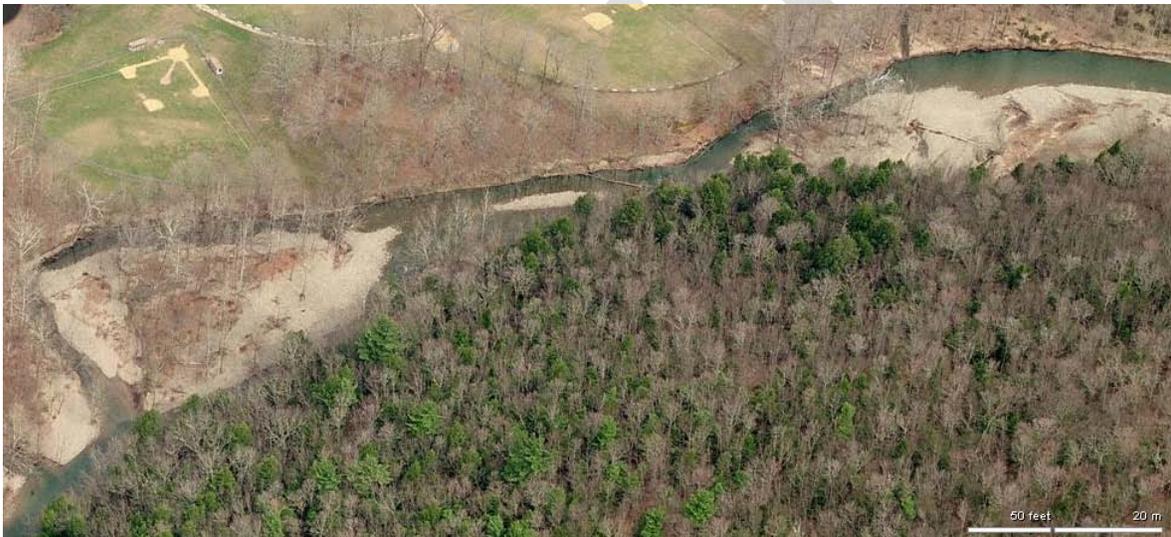
Because this location, just upstream of the confluence of Sugarloaf Brook and the Rondout Reservoir, experiences backwatering from waterbodies downstream, redimensioning the channel is unlikely to significantly improve sediment transport, and it is likely to remain an aggradational reach.

Figure 10 Aggradational areas adjacent to ball field

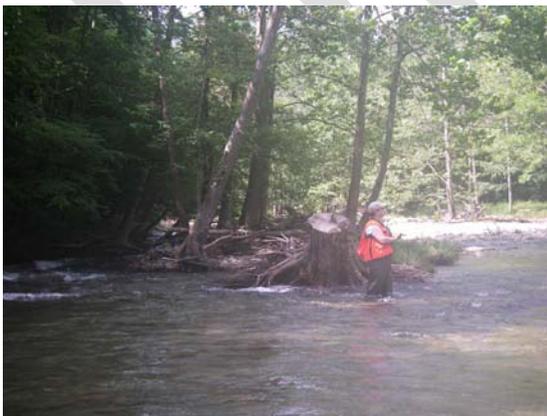
The channel narrows and moves back against the left valley wall, controlled by ledge again, around Station 2400 for approximately 300 ft., before again encountering severe aggradation, multiple woody debris obstructions, and a headcut, which often occurs at the downstream end of an aggrading reach, at the point where the channel diverges into two threads (Figs 11-12).

Figure 11 Main channel divergence

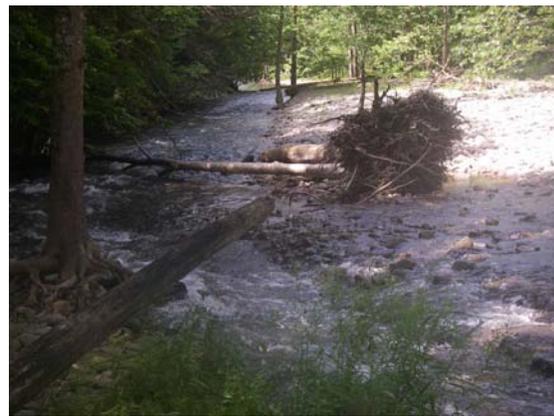
Figure 12 Headcut, both threads near convergence

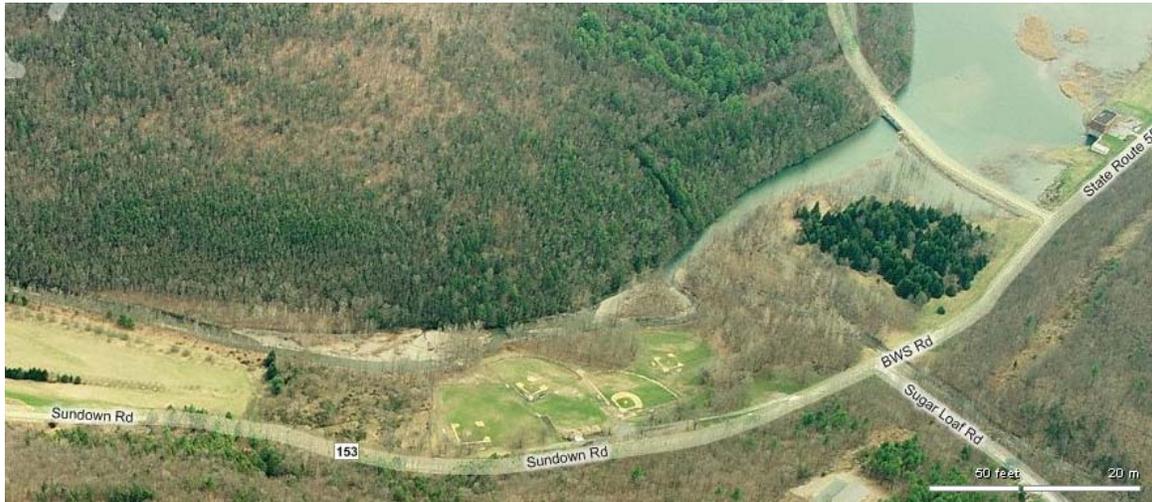
Figure 13 Sediment transport in Management Unit 2, controlled by downstream water bodies

For a number of reasons, Management Unit 2 is incompetent in terms of sediment transport for much of its length. Varying conditions of entrenchment, reaches with overly wide bankfull dimensions, bed and bank hydraulic control by bedrock setting the low gradient, and backwatering from the reservoir and tributary confluence just downstream combine to result in moderate channel aggradation in much of the unit. In some places, this discontinuity of sediment transport appears to be the result of historic channel management; in these locations, channel narrowing with appropriate bioengineering treatments and floodplain plantings, combined with woody debris management to reduce resistance to flow within the channel might increase velocities and improve sediment competence. These treatments have merit based on property protection and water quality objectives.
