# Rondout Creek Management Unit 4

Management Unit 4  
Between Station 7900 and Station 7100

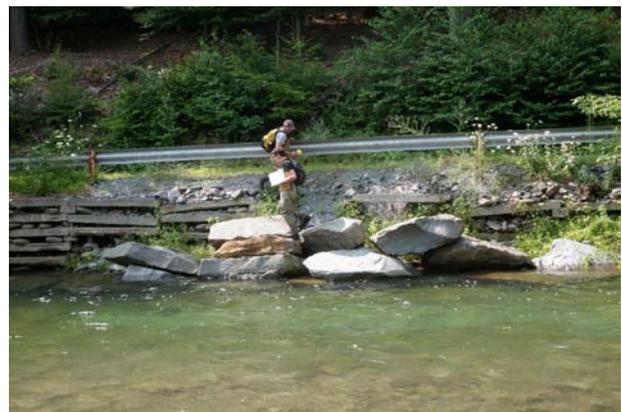
Just opposite the confluence, on the right, the concrete crib-wall revetment protecting Sullivan County Rte 153/Sundown Road has been battered by the flows coming out of the tributary, and large rock has been dumped to protect the embankment for a length of approximately 100 ft. where the cribbing is failing. Cribbing begins to be functional, although still in poor condition, around Station 7700, and continues to Station 7400.

*Figure 5 Stn 7700, functional crib wall begins again*

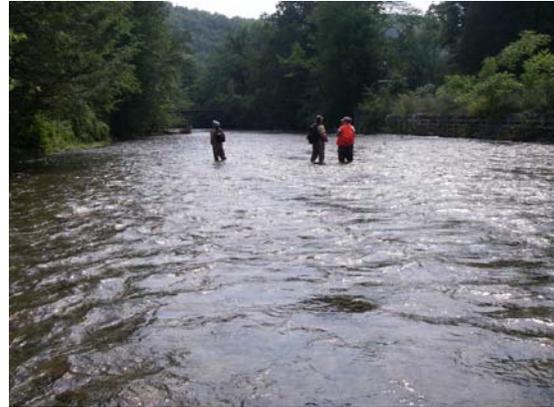
Deposition evident in the bed here indicates a possible sediment transport problem, likely created in part by two pairs of bridge abutments downstream that encroach on larger flows, causing the Rondout to backwater and lose its ability to effectively convey sediment through the reach (Fig. 6). Road drainage is received on the right at Station 7500 via a piped outfall (Fig. 7).

Figure 6 Bed aggradation, Stn 7500

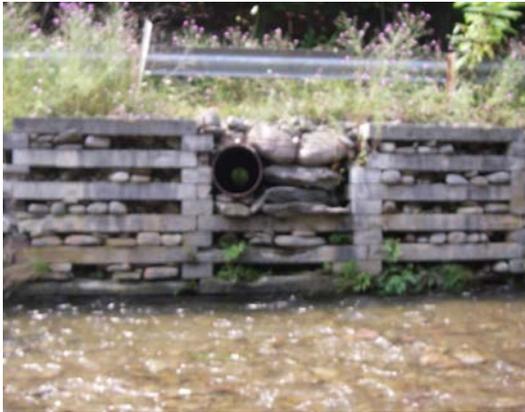
Figure 7 Steel pipe outfall, right bank

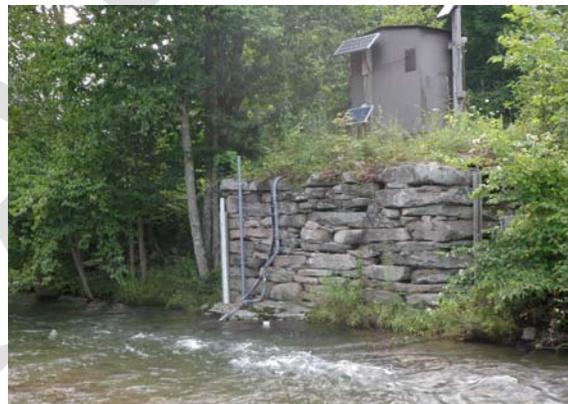
The first set of abutments is the historical stacked rock foundations for the covered bridge crossing at Station 7400 (Fig 8). A USGS gage is located adjacent to the right abutment.

Figure 8 USGS stream gaging station located atop an old bridge abutment on the right bank

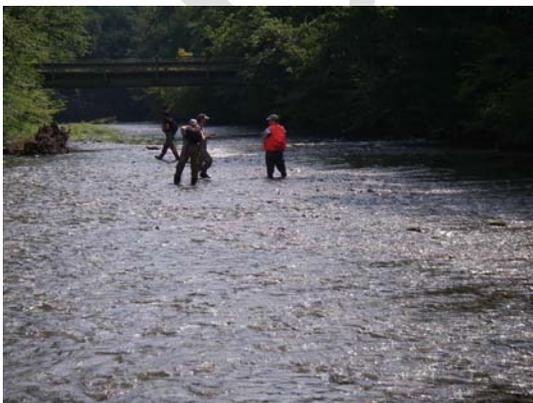
Narrow vegetated strips emerge on both banks downstream of these abutments. Approaching the East Mountain Road abutments, a transverse bar crosses from right to left, ending in a lateral bar on the left, downstream of a large rootball snagged on the bed and bank. On the opposite bank, at the right approach to the crossing, a large stand of the invasive plant, Japanese knotweed was observed.

Figure 9 Transverse bar, transitioning to lateral bar

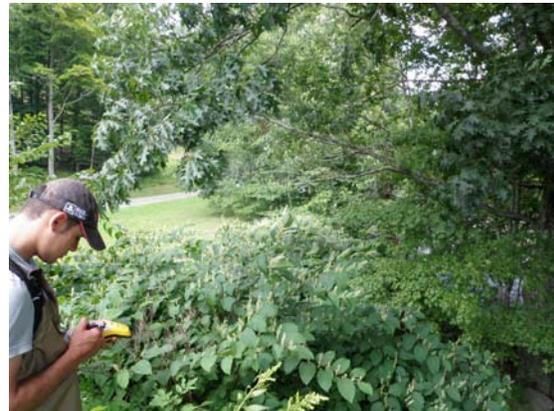
Figure 10 Japanese knotweed stand

observed in Management Unit 4, likely carried in road fill used in constructing the bridge approach on the right.
