Rondout Creek Management Unit 5

Management Unit 5
Between Station 9600 and Station 7900

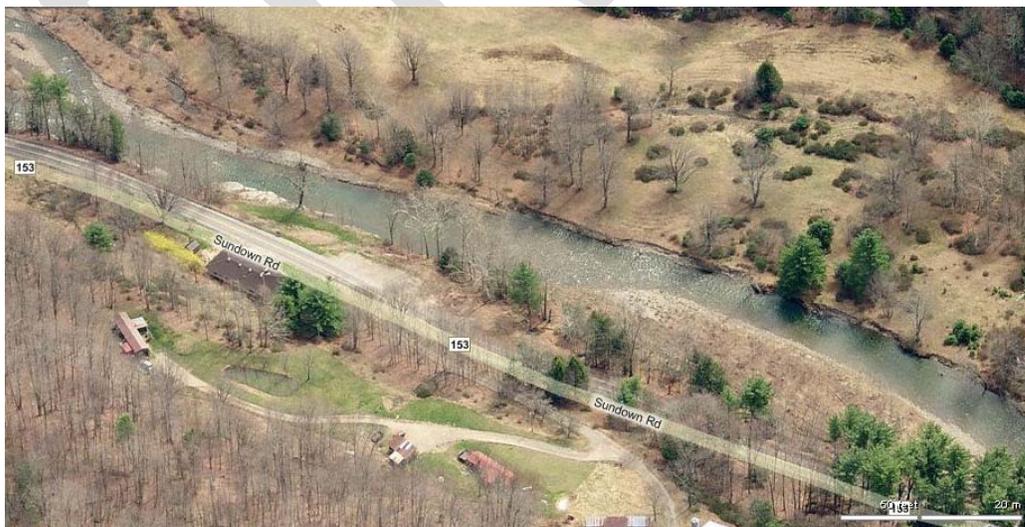
With the convergence of the last of the braided channel threads in MU6, the Rondout begins MU5 as a single channel thread at the right side of the valley floor (Fig. 4), running along the embankment of County Rt. 153/Sundown Road. The right bank is controlled by bedrock ledge for approximately 370 ft. (Fig 5), ending at Station 9230.

Figure 4 Upstream end of MU5

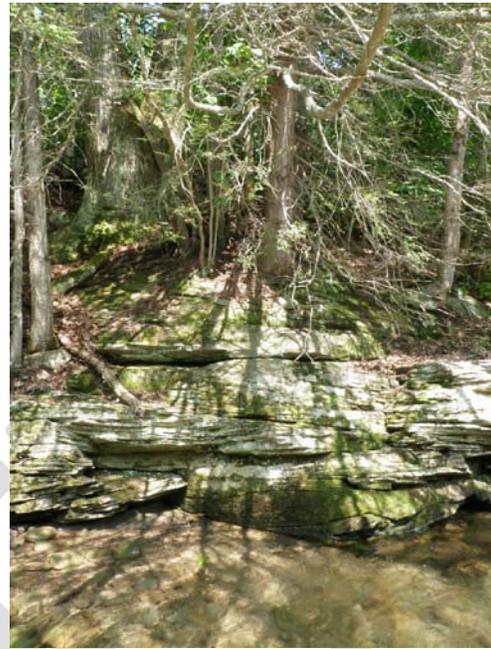
Figure 5 Bedrock ledge, right bank

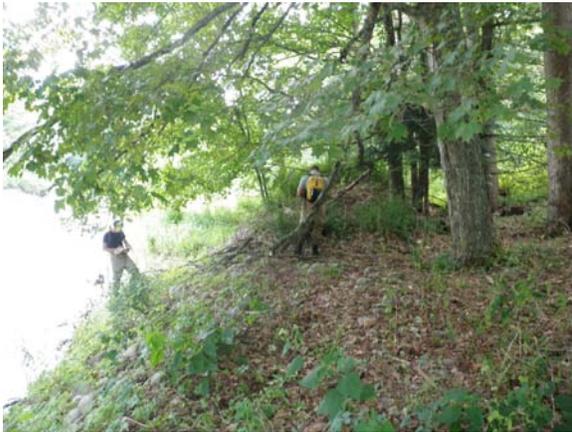
A small spring enters from the floodplain on the left. Remnants of a *sidecast berm* were observed on the right at Station 9000 (Fig. 6), and a piped outfall carrying road drainage, with only fair outfall protection at Station 8900 (Fig. 7).

Figure 6 Berm on the right bank, Stn 9000

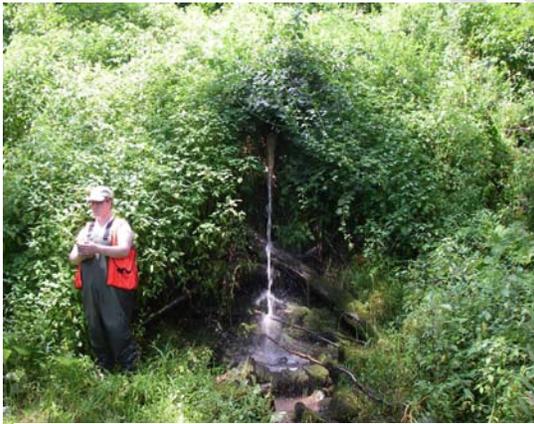
Figure 7 Piped outfall carrying road drainage

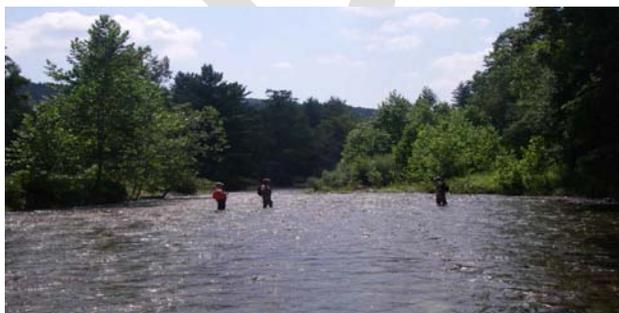
Continuing downstream, the bankfull channel widens, and a lateral bar has formed on the right side of the channel. Aggradation, associated with backwatering from the confluence of East Mountain Brook downstream, is evident from here through the remainder of Management Unit 5 (Fig. 8). The lateral bar has vegetated with extensive stands of willow and sedge (Fig 9), which could be harvested for use in bioengineered bank stabilization projects.

Figure 8 Over-widened and aggrading channel

Aggradation was observed in this management unit, and a sediment transport analysis is recommended to determine if the channel, in its current dimensions, effectively conveys sediment.

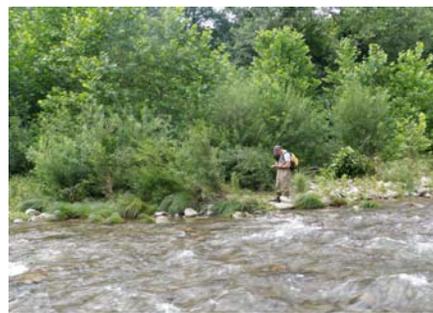
Figure 9 Willow stand on lateral bar

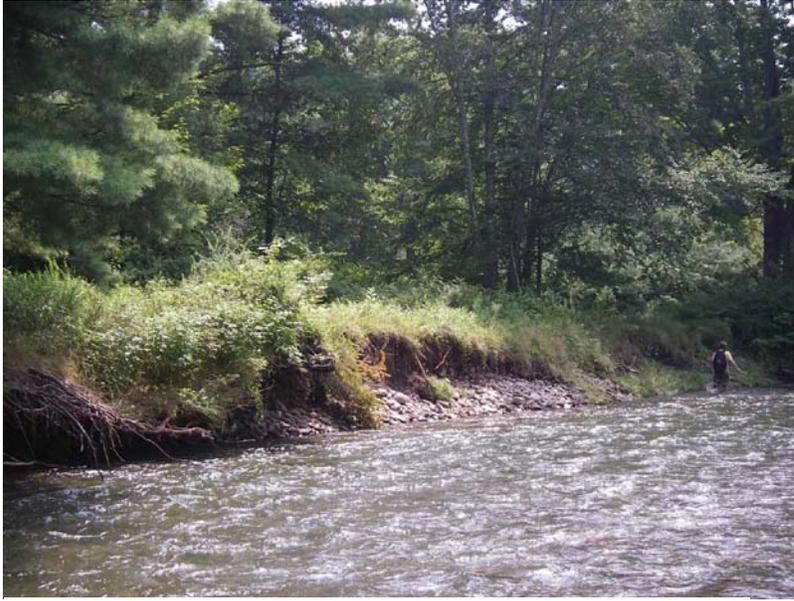
Figure 10 Bank erosion adjacent to a mowed field along the left bank

Opposite the lateral bar, the left bank is exhibiting moderate erosion (Fig. 10, note technician for scale) for approximately 400 ft. between Stations 9000 and 8600. Some of the adjacent pasture has been mowed. Downstream of the erosion, another lateral bar is forming on the left bank, beginning around Station 8500. A utility line crosses the stream here, with a pole on the left bank at this station.

The formation of these two bars indicates that the stream may be trying to reestablish sinuosity through this management unit. This occurs where the erosive power of the stream is greater than the strength of the material in the bank; under these conditions, banks erode, usually in an alternating left-right sequence, until the lengthening of the stream reduces channel slope sufficiently, and the shear stresses acting on the bank equal its resistive strength. The lateral bars then evolve into point bars on the inside of meanders. Alternatively, equilibrium can be established through increasing the cohesiveness of bank materials with the tensile strength provided by the dense root masses of certain trees, shrubs and sedges.

It is recommended that *bioengineering practices* be installed on this eroding bank, using materials harvested from the opposite bank. Prior to installation of practices, sediment conveyance capacity of the channel should be evaluated to ensure that no channel restoration is necessary.

It is recommended that a buffer on the floodplain on the left, adjacent to the eroding bank, be planted with woody vegetation to reduce the risk of further erosion, and that bioengineering treatments be installed on the eroding bank and the revetted road embankment, as appropriate. See Section 2.6, *Riparian Vegetation*, for resources available to landowners for revegetating riparian areas of their property.

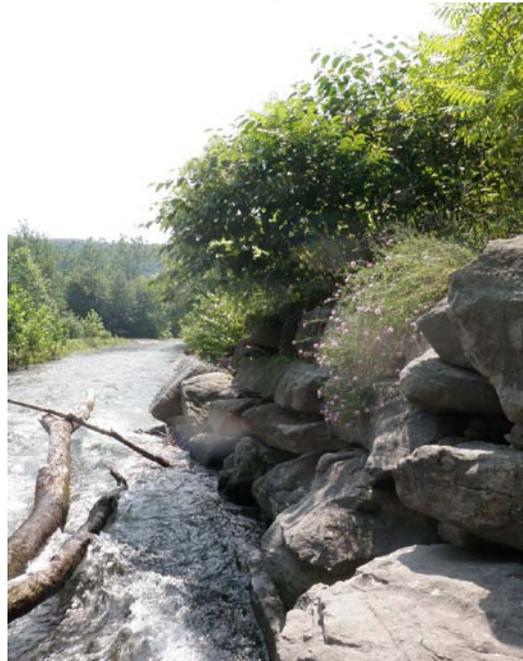
Opposite the lateral bar on the left, beginning at Station 8400, the channel runs immediately adjacent to the road on the right, with little vegetative buffer through the end of the management unit, and is revetted in two places. The first section, from Station 8300 to 8200, is stacked rock wall (Fig. 11). A stand of the invasive plant, Japanese knotweed, was observed at the downstream end of this rock wall.

Figure 11 Invasive Japanese knotweed at the downstream end stacked rock wall, right bank

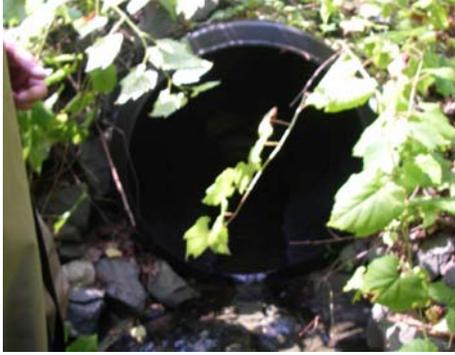
At Station 8000, a corrugated plastic piped outfall on the right bank carries road drainage, outfalling on a stone slab (Fig. 12). The right bank is intermittently controlled through the remainder of Management Unit 5 by exposed bedrock ledge (Fig. 13), and a mix of dumped rock and concrete crib wall revetment (Fig. 14).

Figure 12 Plastic piped outfall, right
The revetment is in poor functional condition; at points where it is failing, large rock has also been dumped to provide protection for the embankment.

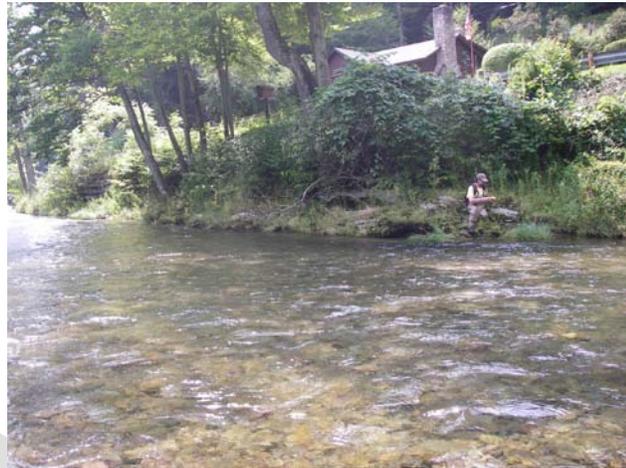
Figure 13 Bedrock ledge at Stn 7900

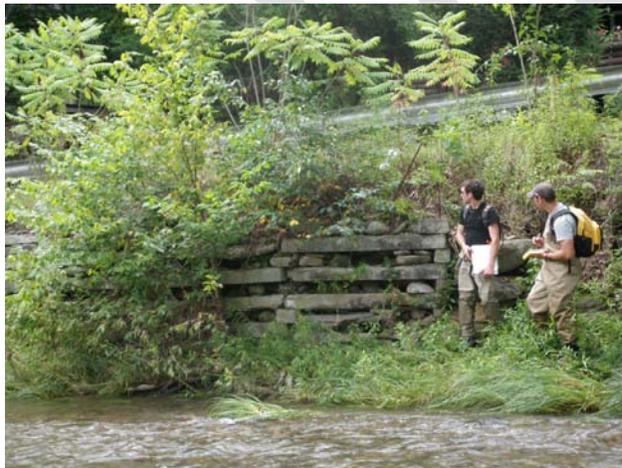
Figure 14 Concrete cribbing revetment, Stn 7870

Recommendations for this reach include replacement of the cribbing with stacked rock wall, interplanted where possible with bioengineering treatments. Turbidity has been observed during low flows in East Mountain Brook, and a full stream feature inventory is recommended to identify possible sources of fine sediment and other management concerns.

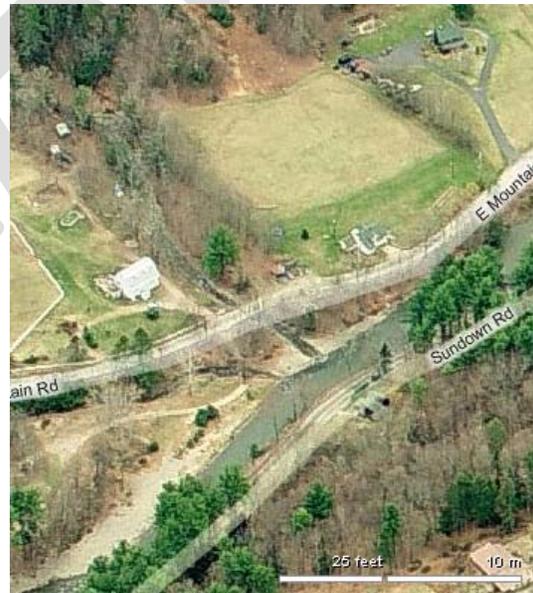
The floodplain narrows on the left as East Mountain Road angles toward the channel, constricting overbank flows. A small tributary enters on the left from the floodplain at Station 7850, and East Mountain Brook, conflues with the Rondout at Station 7800, the end of Management Unit 5.

Figure 15 Confluence of East Mountain Brook, end of MU5

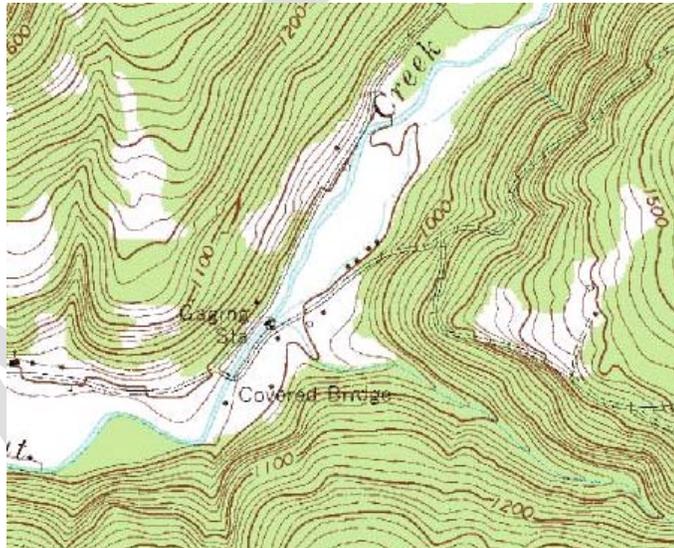
A major tributary, East Mountain Brook, joins the Rondout Creek at the bottom of Management Unit 5 from the left. Such confluences often produce backwater effects upstream, causing aggradation, and over geologic time, build an alluvial fan, as is seen here (Fig. 16).

Channel gradients are often flattened upstream of confluences, and that also is seen here. Evidence of historical channel management was observed at this site, in the form of a sidecast berm, overly wide channel and revetment.

Figure 16 Alluvial fan at confluence of East Mountain Brook
