Rondout Creek Management Unit 9

Management Unit 9
Between Station 22,300 and Station 25,300

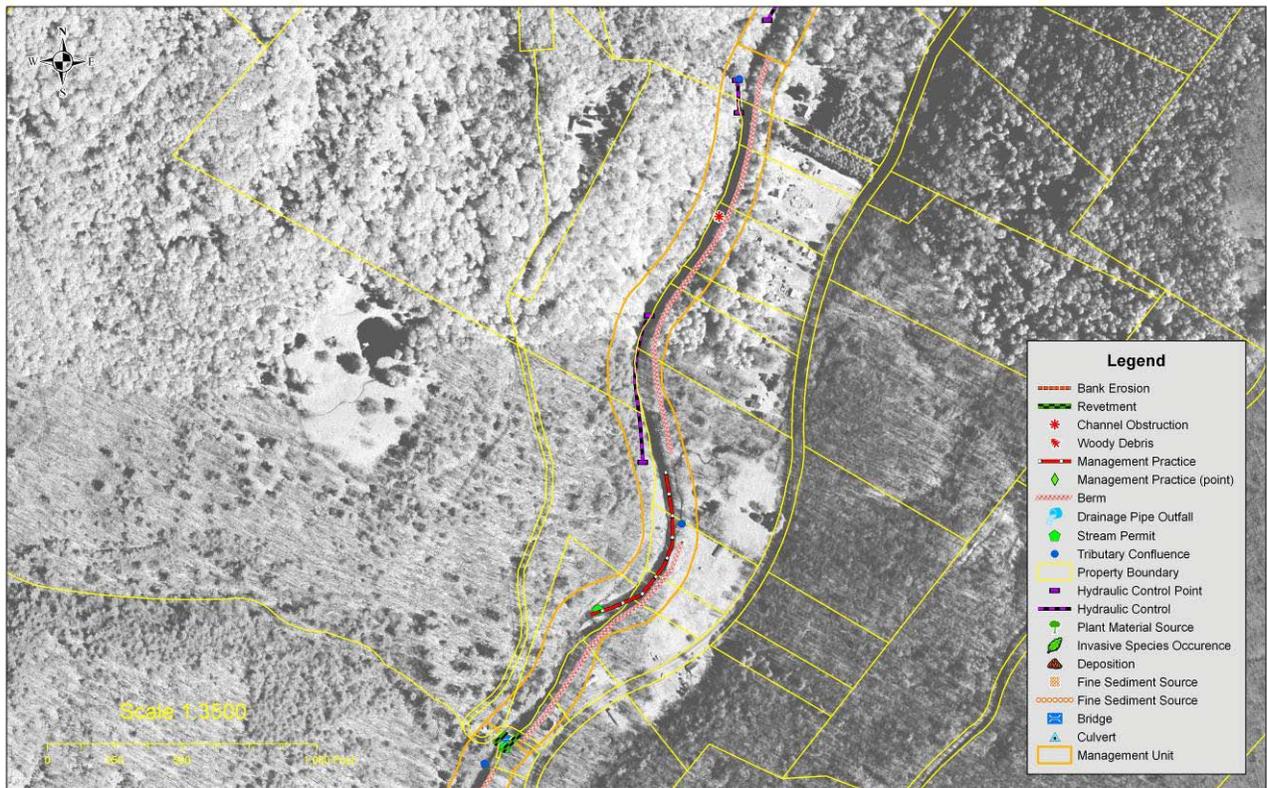
Figure 1 Management Unit 9 Stream feature inventory

The 2009 stream feature inventory revealed little sign of active erosion along 2,943 ft. of total channel length (Fig.1). Revetment has been installed on 0.88% (52 ft.) of the stream length. Flow deflector and grade control vanes were installed in 2009 on approximately 20% of the stream length. Berms, in various states of repair are evident along 95% of the stream length.

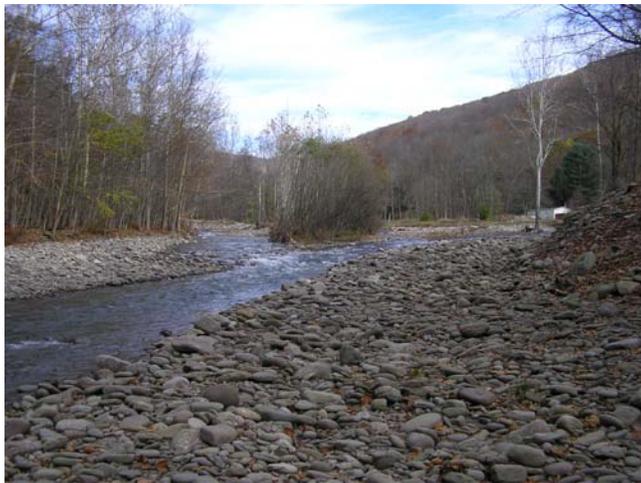
Figure 4 Historic aggradation, channel shifting upstream of Ballace Road Bridge, MU9

Throughout much of this unit, moderately entrenched conditions are created by ledge and bedrock along right valley wall and in the streambed, and by berm remnants of varying elevation and functional integrity along the left bank. The channel generally runs along the right valley wall, receiving waterfalls from contributing tributaries, including one recently formed at Station 24160 when a pond upslope breached its embankments; current conditions at this pond should be evaluated as part of future assessments. Several smaller channels bring tributary flow from the left valley wall across the floodplain through the numerous private properties between the channel and the road. While historic channel management disconnected much of the floodplain on the left except during larger flows, the berms –installed after the flooding of the mid-1950s-- have been breached in numerous locations. The channel is largely stable here due to the hydraulic controls provided by the bedrock in the channel bottom and right bank, and mature woody vegetation in the riparian corridor on the left through much of the unit, and it is recommended that the upstream section be surveyed and monitored to evaluate its appropriateness for providing reference morphology for future channel work. The section upstream of the Balace Road bridge, however, between Station 22800 and 23500, has been the site of instability in recent decades, with an inadequate bridge span at Balace Road producing backwatering at bankfull flows, and resulting in aggradation and channel shifting upstream (Fig 4).

In recent years the site had been mowed to the edge of stream on the left, compromising the strength of the bank, resulting in migration of the meander there into the field, and setting up conditions for the stream to jump the bank and flow downvalley into Peekamoose Road (UC Rte 42), threatening the cottage at the corner of Balace Road and damaging the county road.

Following repeated failure of berms, gabion baskets and rip-rap placements installed to keep the channel in place, the bridge was replaced with a longer span and greater capacity between the abutments, and in 2009 a FEMA-financed project (“the Balace Road project”) installed rock vanes to check the channel migration, and rebuilt the berm. Vegetation was installed in the floodplain. It is recommended that this project be monitored for its structural and functional performance following major flow events. The bridge approach on channel left still represents an obstruction to flows in the floodplain.
