Rondout Creek Management Unit 17

Management Unit 17
Between Station 51,100 and Station 52,300

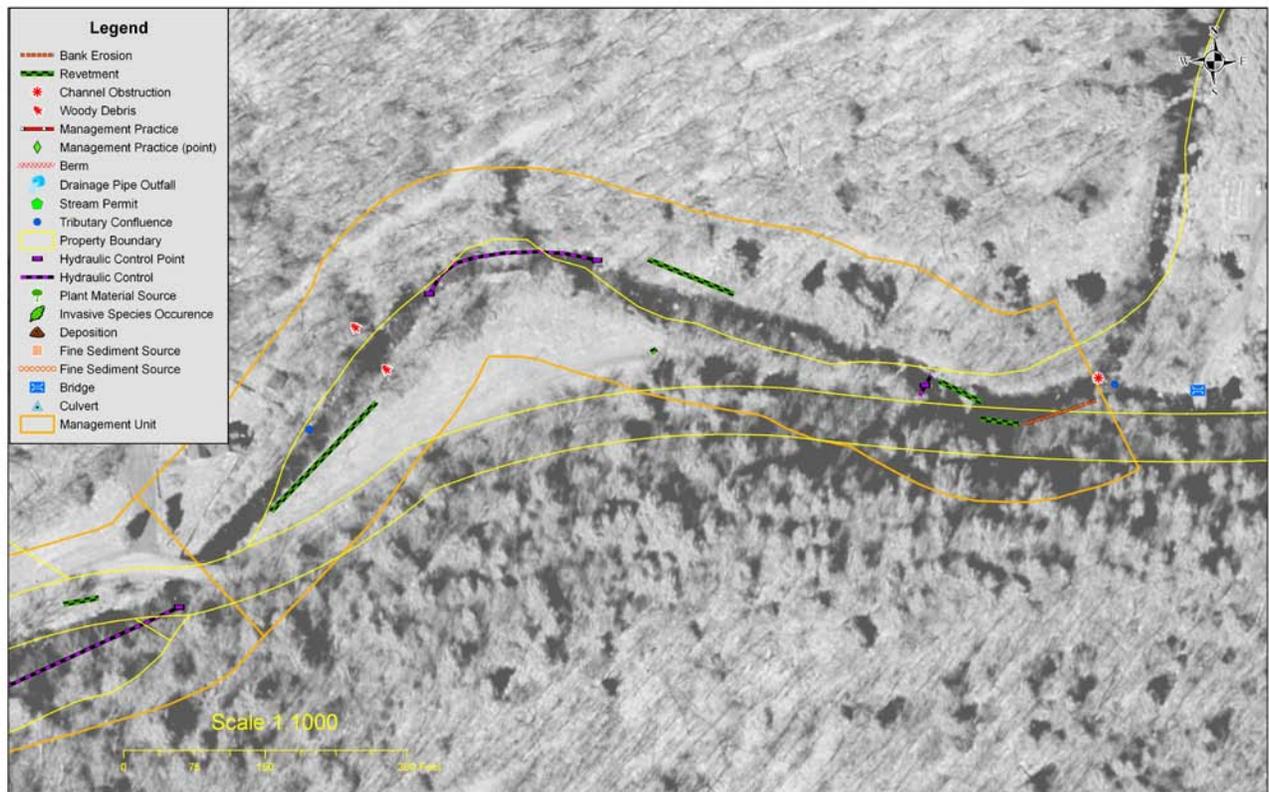
Figure 1 Stream feature inventory MUI7

The 2009 stream feature inventory revealed that 4 % (81 ft.) of the stream length exhibited signs of active erosion along 1,134 ft. of total channel length (Fig. 1). Revetment has been installed on 15.77% (358 ft.) of the stream length. No berms were identified in this management unit at the time of the stream feature inventory.

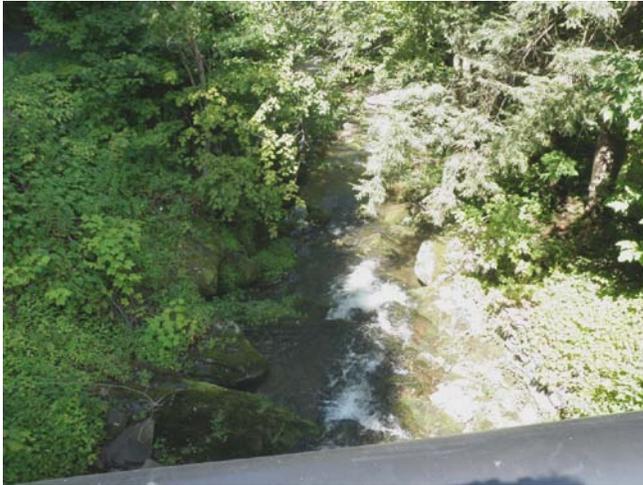
Figure 3 Looking downstream from private bridge, start of MU17

Looking downstream from the newly renovated private bridge at the outlet of Peekamoose Lake (Fig. 3), the Peekamoose Gulf creek flows for about 100 ft. adjacent to Ulster County Route 42, the embankment of which forms the left bank of the creek, before it joins the larger flow of the headwaters of the Rondout Creek. The headwaters drainage comprises 6.7 mi.², and likely contributes significant bed sediment loading during higher flows; it is recommended that a stream feature inventory be conducted in these headwaters.

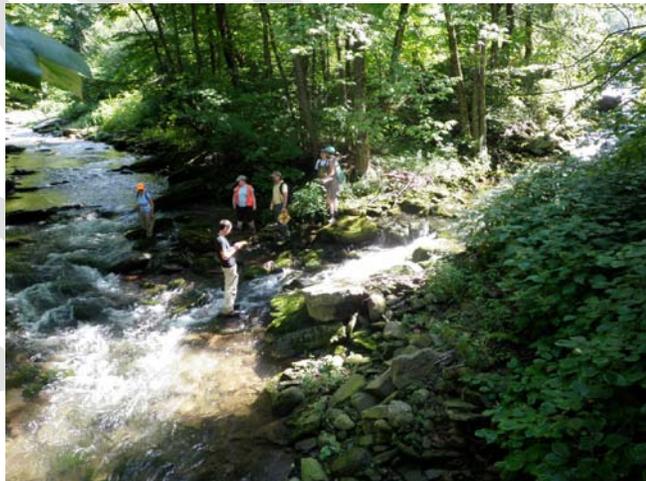
The headwaters flow enters from the right, turning hard to the right as they hit the Peekamoose Road embankment (Fig. 4). This area has received extensive historical management; dry-stacked rock walls control the low terrace on the inside of this turn, stream right (Fig. 5). The road embankment directly opposite the confluence receives the force of the flow of the Rondout

Figure 4 Looking upstream into the Rondout Creek headwaters, left, with the creek gorge entering, right

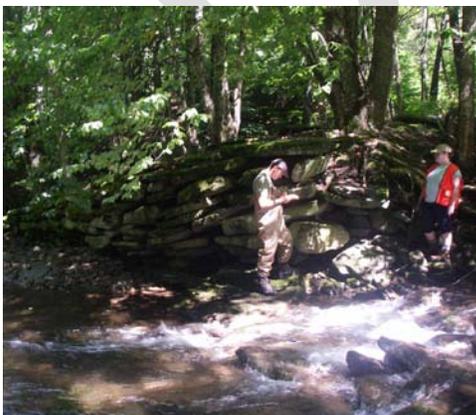
Figure 5 Stacked rock revetment

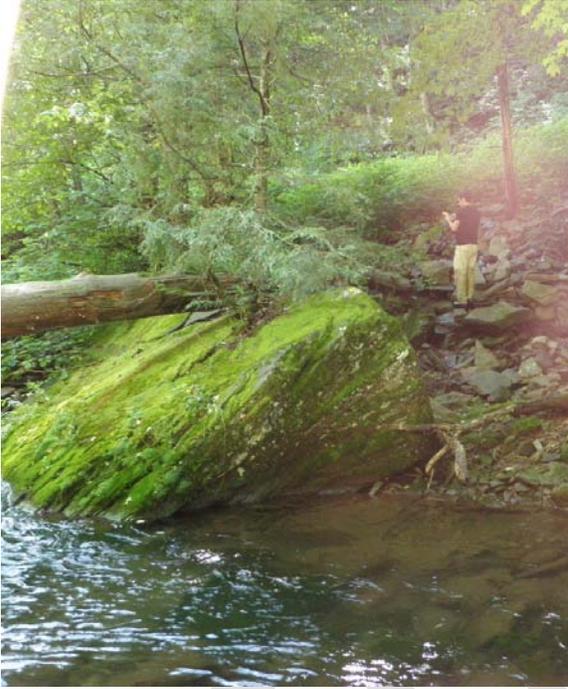
headwaters, and some minor erosion is evident here. The erosion is significantly mitigated by the protection offered by large boulders in the bed and left bank, but the finer soils at the top of the bank are eroded by stormwater runoff from the road; gabion baskets have been installed, but the soils below the baskets are eroding. As a result these baskets are losing some functional integrity;

Figure 6 Looking upstream, erosion left embankment, boulder toe protection

while not a high priority, the recommendation here is that the site be considered for an upgrade of the revetment and road shoulder, and installation of bioengineering treatments. Minor adjustments to some of the large boulders in the stream would improve protection of the toe of the embankment and reduce erosion hazard risks associated with larger flows.

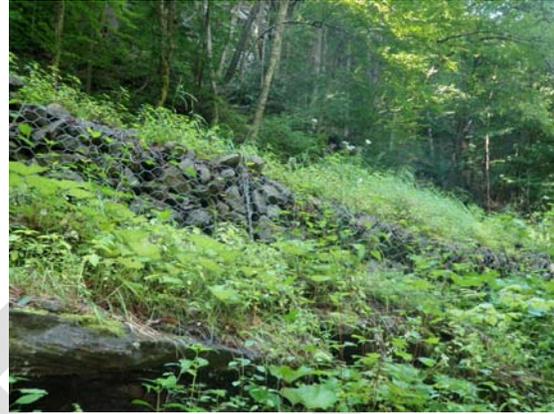
Figure 7 Compromised gabion basket revetment

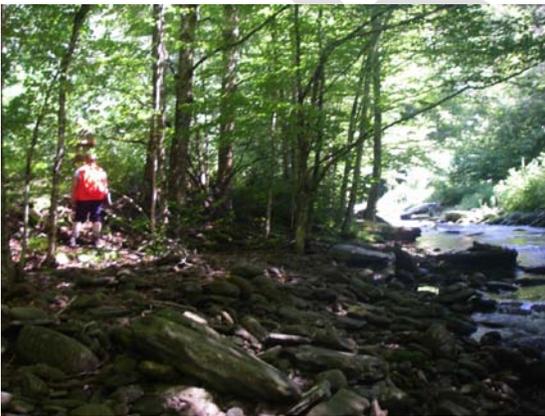
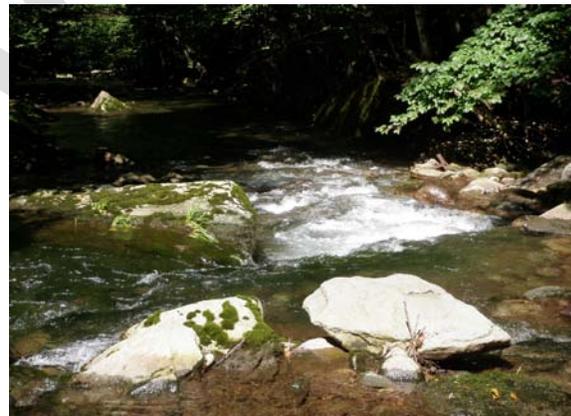
Continuing downstream and for the rest of Management Unit 17, the channel appears to be very stable, with a well-vegetated, well-connected floodplain bench developing on one or both sides of the channel, large boulder and bedrock control of the bed in most places and effective

Figure 8 Stable reach with well-vegetated floodplain, left, and bedrock-controlled bed features, right

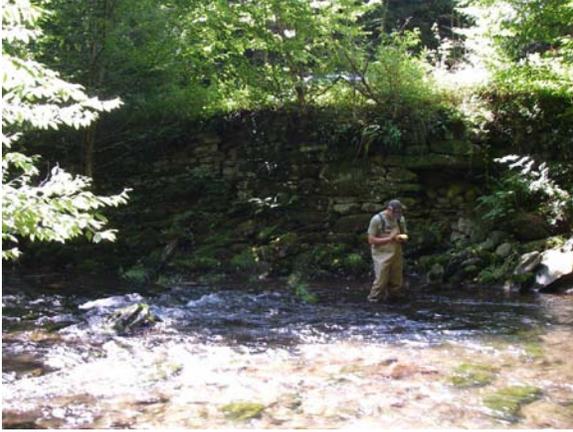
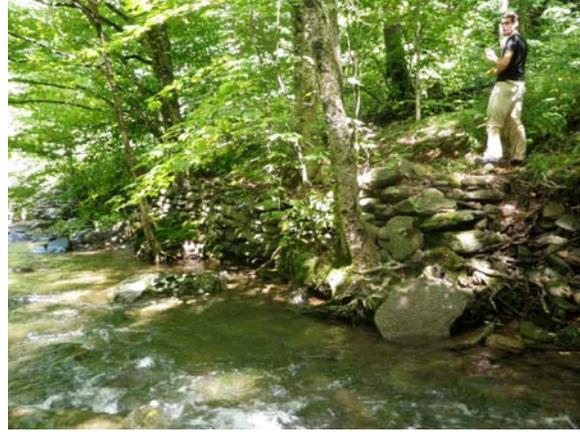
sediment conveyance capacity (Fig. 8). Between Stations 51650 and 51800, however, entrenchment increases where dry-stacked rock wall revetment stabilizes higher terraces (Fig. 9). The floodplain elevation increases relative to the streambed around Station 51800, but then drops again approaching the bridge crossing at the close of the Management Unit.

Figure 9 Stacked rock wall, both left and right banks, creating entrenched conditions

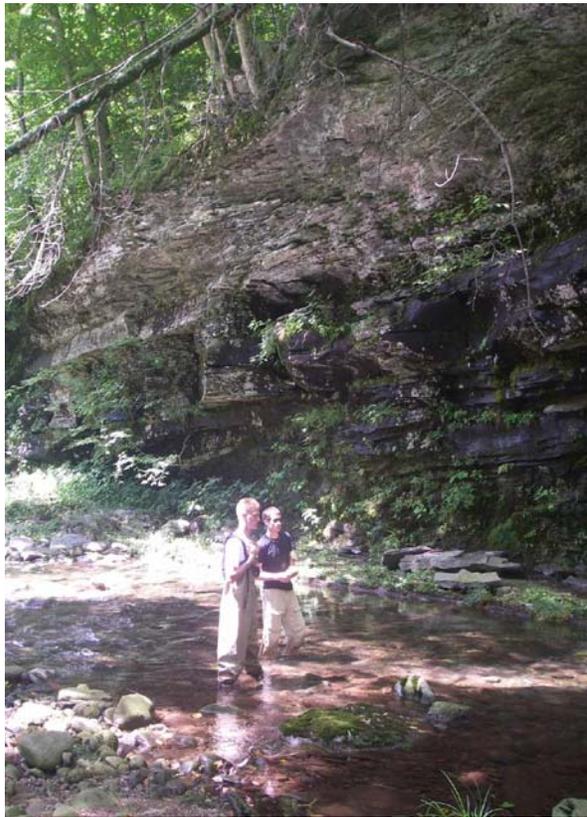
Figure 10 Bedrock ledge providing control in the bed and right bank

As the channel bends to the left between Stations 51500 and 51700, the right bank and streambed are controlled by a high bedrock ledge (Fig. 10), opposite a mowed field on the left. Approaching the bridge crossing at Station 51100, woody debris was accumulating on both floodplains and at the channel margins. A small unnamed tributary enters from the right flowing through a residential area, and stacked rock revetment begins again on the left bank adjacent to the hayfield around Station 51370, continuing to the left upstream wingwall to the bridge abutment (Fig. 11).

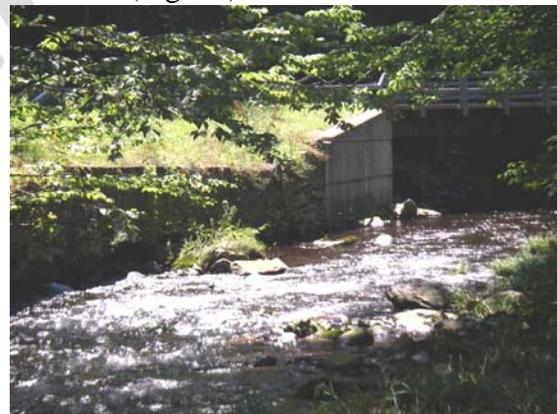
Figure 11 Stacked rock revetment, left bank
