PROJECT REPORT

Bank Stabilization East Branch Rondout Creek Demonstration Project Ulster County Highway Garage

Report produced by John G. Perrella, Construction Supervisor

Fall/Winter 2011

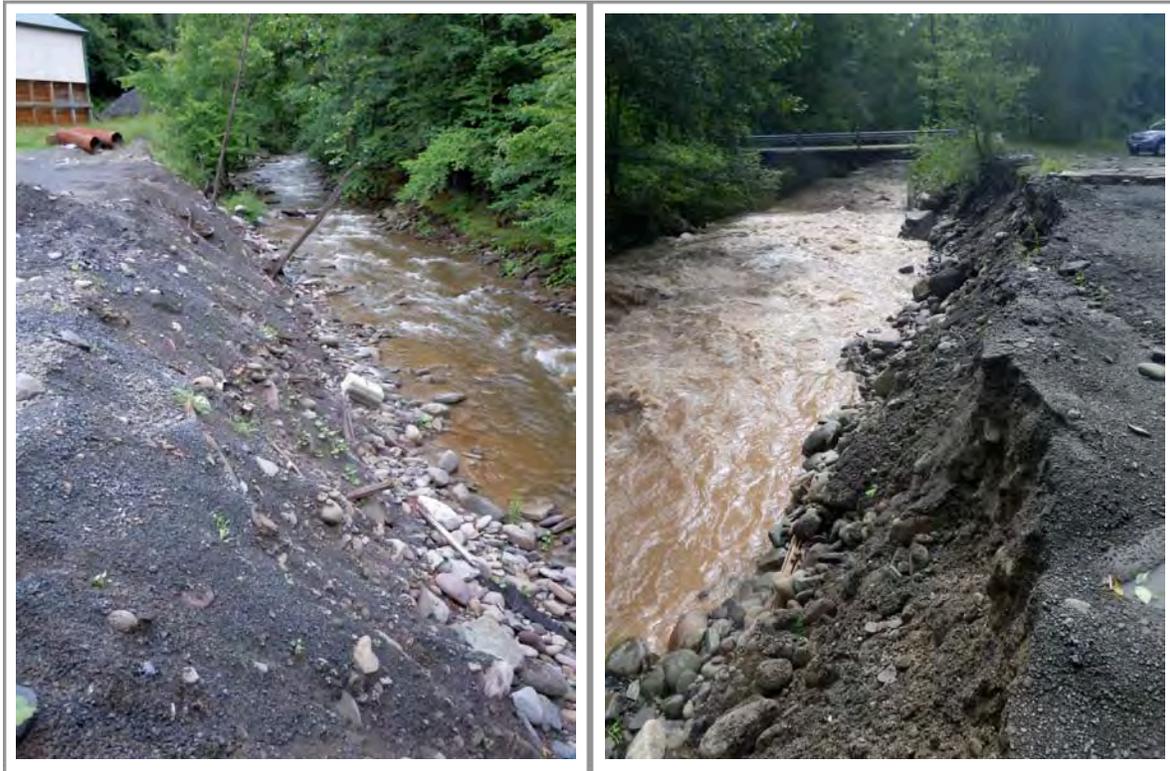
On July 28, 2011 Tropical Storm Irene swept through the Catskills and inflicted major damage to much of the area. This storm affected the demonstration site by scouring a substantial amount of material from the stream bank of the demonstration site. The photo above left shows existing conditions just upstream of the demonstration site before storm event. On the right hand photo above it can clearly be seen that a large amount of material was removed from the bank resulting in a change order to the contract (Appendix I).

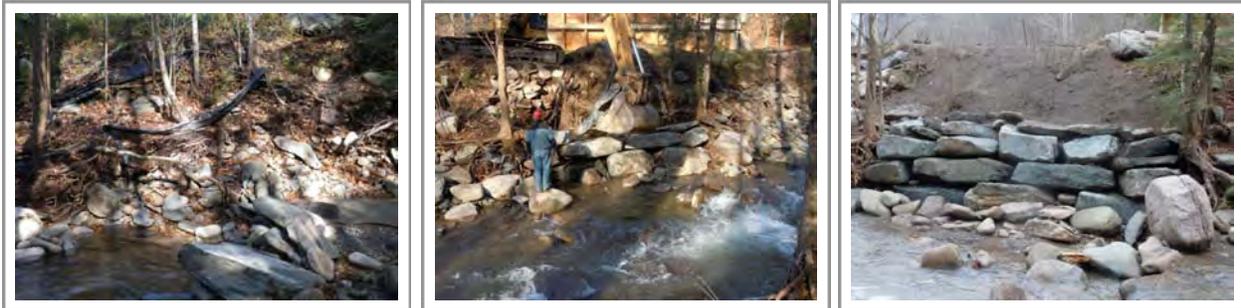
The advent of Tropical Storm Irene in late August 2011 produced three areas of scouring just upstream of the cribwall in the demonstration project. These three areas were designated A, B and C and were treated with a combination of large stone, root wads and plantings. A series of photos depicting the three areas before treatment, during the construction process and the final result of the corrective measures which were taken follow.

Section A utilizes large stones to stabilize the bank at the base. Willow clumps or local origin are planted among the stones.

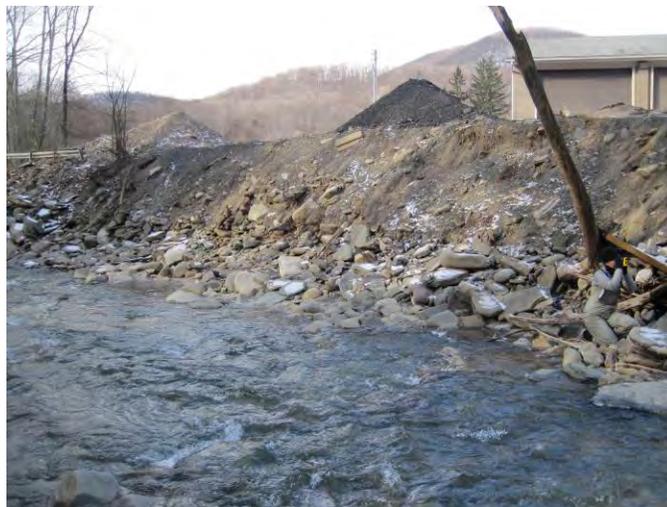
The study reach is characterized as being confined by high ground, straight alignment, and having a rocky rapids bed. The mean bed slope is 2.6%. The right bank downstream of the private drive bridge has a 2:1 slope with a sparse woody buffer extending from the bankfull height to the top of the bank. Near station 14+00, the woody buffer is replaced with fine gravel and sand deposited by surficial runoff from the eastern edge of the DPW garage staging area. From the Sheely Road Bridge to station 13+25, the right bank has a combination of stone retaining wall and placed riprap on the lower slope and gravel cover on the upper slope at the DPW garage. About 175 linear feet of the right bank has had a slope failure between station 11+50 and station 13+25 (Photo 1).

Photo 1: Bank Failure site on right bank upstream of Sheely Road Bridge.

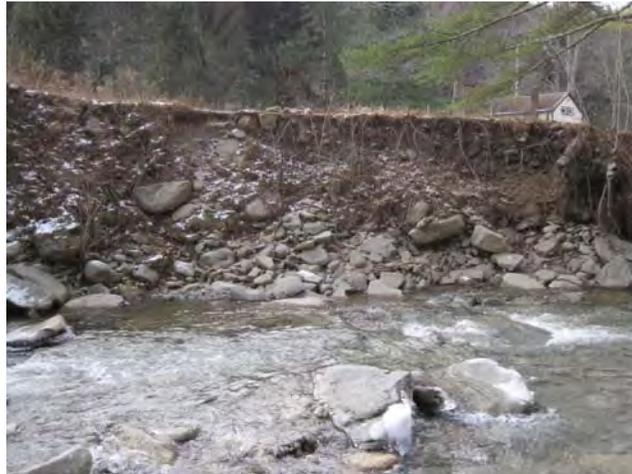
The left bank is also steep with a 2:1 slope with dense hardwood forest cover. Downstream of the unnamed private drive bridge, there are approximately 50 feet of scour exposing unsorted glacial till (Photo 2) followed by approximately 25 linear feet of undercut bank exposing roots of the 30-inch diameter at breast height (DBH) white pines overhead and glacial till. The bank is undercut by up to three feet in some locations.

Photo 2: Bank scour on left bank downstream of unnamed private drive bridge.

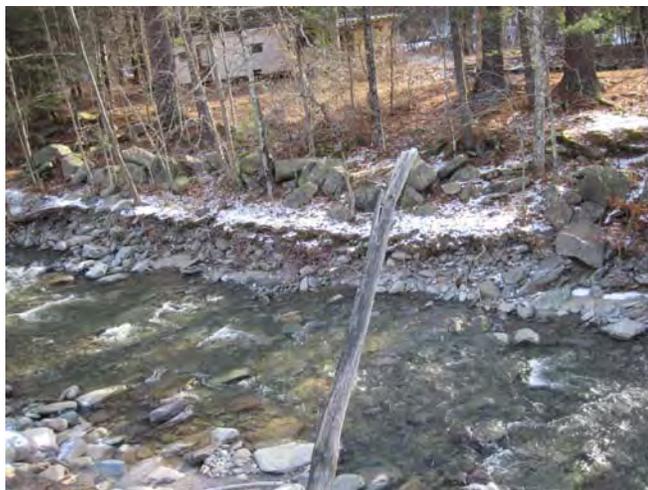
Beginning at station 15+75 through station 11+00, there is a dense forested buffer at least 20 feet thick. Near station 14+75, a terrace has formed at bankfull height that continues to station 12+25 (Photo 3).

Photo 3: Bankfull bench on left bank.

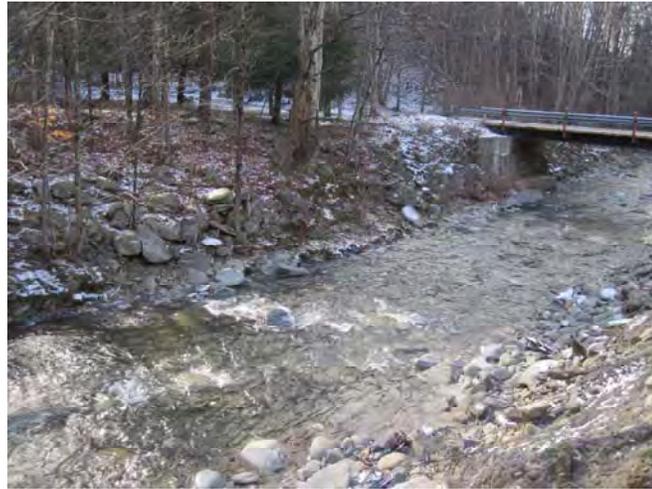
The channel perimeter below the bankfull height is composed of three distinct materials: a dense cover of static boulders that armor the bed and lower banks, a semistatic armor of cobbles and small boulders, and mobile gravel and rounded small cobbles (Photo 4). The latter material is in limited quantity, found in pockets and small bars. The bank and bed roughness is high (estimated Manning's $N=0.06$).

Photo 4: Rapids bed form and channel roughness of study reach.

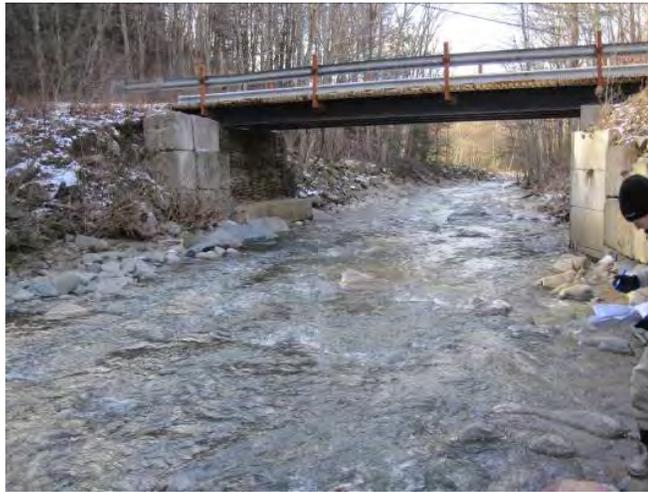
The Sheely Road Bridge over East Branch Rondout Creek is approximately 28 feet long by 12 feet wide. The bridge consists of a concrete deck slab on concrete abutments. The abutments are composed of stacked concrete blocks that extend upstream and downstream of the bridge approximately two feet on the right bank (Photo 5). The footings are not visible, and the abutment base elevation is unknown. There is no visible bedrock. The downstream right and left abutments appear to be subject to scour and erosion.

Photo 5: Looking downstream at Sheely Road Bridge.

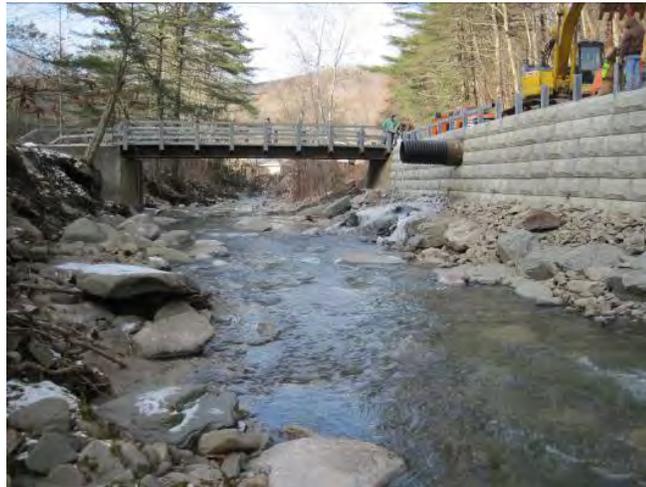
The unnamed private drive bridge over East Branch Rondout Creek is approximately 46 feet long and 18 feet wide. The bridge consists of a concrete deck slab on concrete abutments. The parapets are approximately 25 feet long, 42 inches high, and two feet wide. The upstream right bank consists of a modular concrete unit wall approximately 10 feet in height that extends approximately 100 feet upstream of the bridge crossing (Photo 6). The stone wall is nearly flush with the right bank abutment. Downstream of the crossing, the concrete abutment transitions to a stacked stone wall that extends downstream approximately 20 feet. The left concrete abutment extends approximately six feet into the channel and is limited to the width of the bridge crossing. There are no wingwalls upstream or downstream of the left abutment. The left bank bridge abutment shows signs of scour damage on the downstream side, and the upstream side is not armored. The channel bed in front of the structure is accumulating coarse bed material and is aggrading. Some material is being pushed into the structure.

Photo 6: Looking downstream at unnamed private drive bridge.
