Schoharie Creek Management Unit 2

Town of Hunter – Dale Lane (Station 151439) to Bunny Lane (Station 148641)

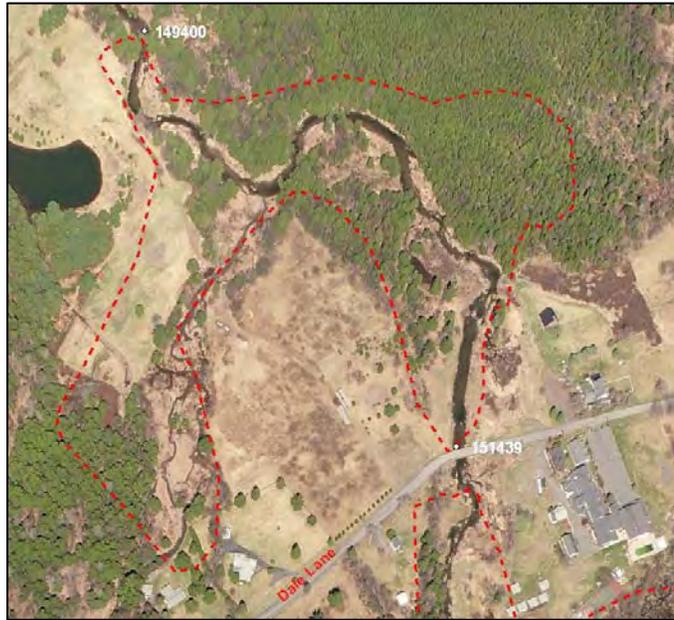
The upstream half of this management unit was dominated by a large wetland (Station 151439-149400). Wetlands are important features in the landscape that provide numerous beneficial functions including protecting and improving water quality, providing fish and wildlife habitats, storing floodwaters, and maintaining surface water flow during dry periods. This wetland is approximately 17 acres in size, including some areas of open water (see Section 2.6 for detailed wetland type descriptions). There were four beaver dams within this wetland area.

*Wetland located at beginning of MU (Station 151439-149400)
Approximate wetland boundary delineated by NYSDEC*

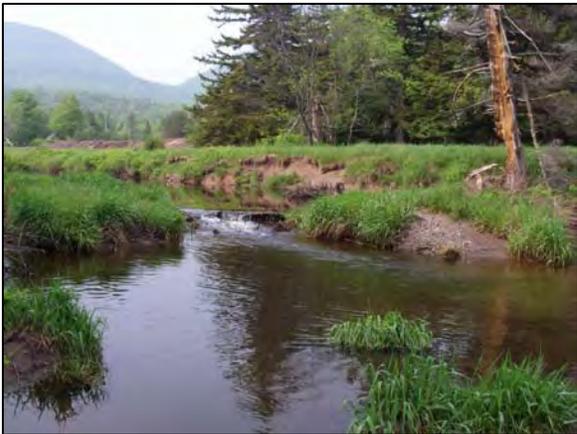
*Bank erosion and beaver dam at Station 151100
looking upstream*

The stream channel was well defined throughout this wetland. The first 400ft of stream in this management unit was fairly straight with three minor erosion occurrences located on the left streambank totaling 1,045 ft² in eroded area (Station 151100). To prevent future erosion, vegetation plantings are recommended for these streambanks, including vegetative protection of the toe. Reshaping these streambanks by grading may be necessary prior to planting.

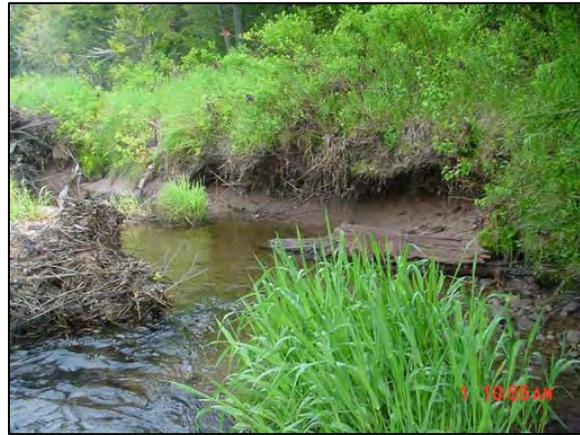
Further downstream, along the right bank, the stream undercut the bank exposing a 90ft² area of glacial lake silt/clay (Station 150740). Fine sediment inputs into a stream can be a serious water quality concern because they increase *turbidity*, degrade fish habitat, and can act as a transport mechanism for other pollutants and *pathogens*. Immediately downstream was a second 20ft² glacial lake silt/clay exposure (Station 150500).

Clay exposure at Station 150740

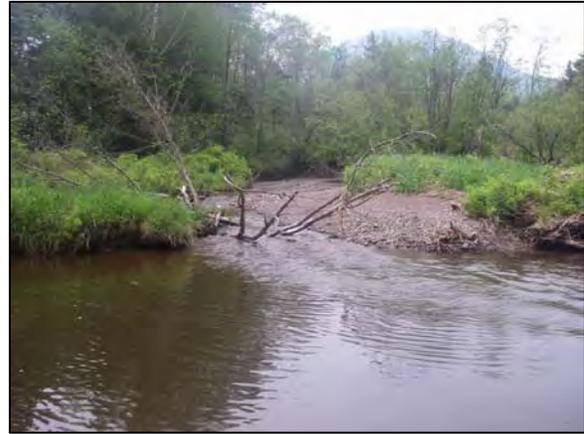
Tributary at Station 150035 - looking upstream

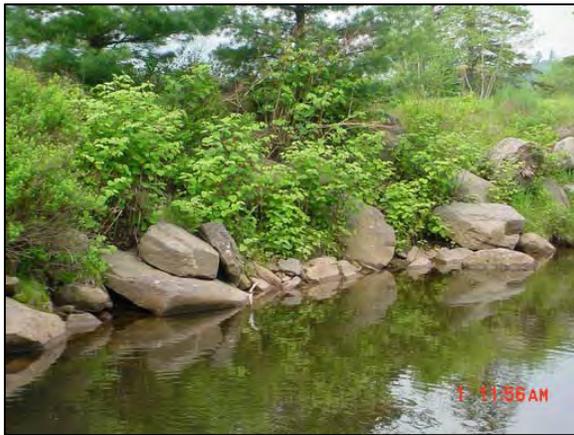
Japanese knotweed on rip-rap at Station 149530

As the land use on the left streambank changed from forested to residential, the buffer thinned and rip-rap was installed to protect the bank (Station 149530, Inset B). This old rip-rap was approximately 184ft in length, and while only in fair condition still provided some protection of the streambank toe. Japanese knotweed (*Fallopia japonica*) has colonized the disturbed area above the rip-rap. This was the first occurrence of Japanese knotweed on the Schoharie Creek mainstem. Knotweed is an invasive non-native species.

Removal of Japanese knotweed is recommended at this site because it does not provide adequate erosion protection due to its very shallow rooting system, and it grows rapidly to crowd out more beneficial streamside vegetation (See Section 2.7 Riparian Vegetation). It is also recommended to interplant native shrub and sedge species through the rip-rap and along the toe of this streambank. This planting will help to strengthen the revetment, while enhancing aquatic habitat.

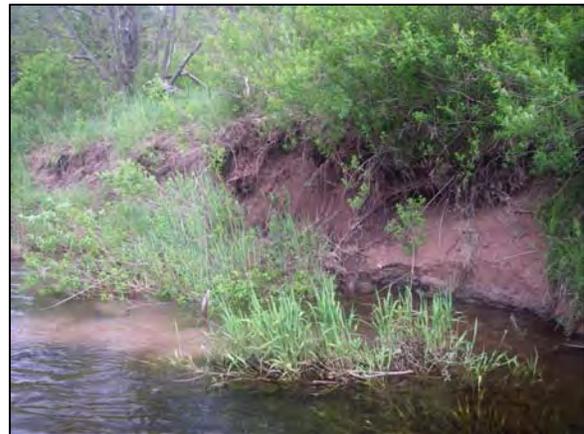
The stream channel widened as it approached the bridge at Bunny Lane. On the right streambank and bed there was a 100 ft² area of exposed clay (Station 148740). This clay exposure was composed of a mixture of both *lacustrine* clay beds and glacial till deposits with a high clay component.

Clay exposure at Station 148740

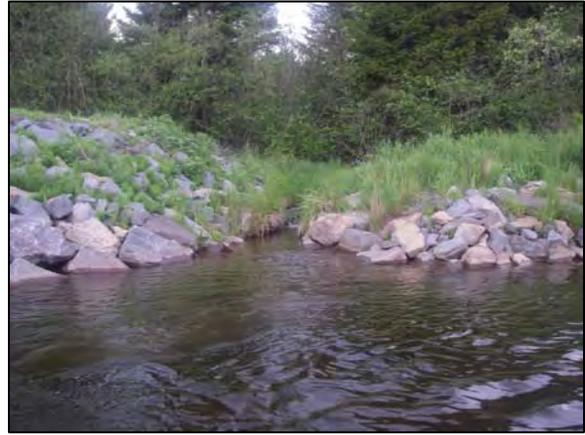
Through the middle of the right bank rip-rap, a small unnamed tributary entered the Schoharie Creek (Station 148690). Originating across Platte Clove Road, this stream drains the lower slopes of Roundtop Mountain. As the stream crossed under the road, the slope flattened and the stream passed through a large forested wetland before entering the Schoharie Creek in a small, slightly entrenched channel. This tributary is classified as C by the NYS DEC, indicating that the best uses for this stream are supporting fisheries and other non-contact activities (NYSDEC, 1994).

Tributary at Station 148690 - looking upstream

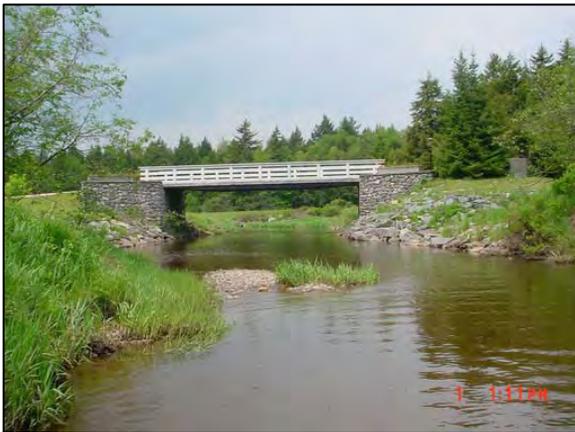
Bridge at Bunny Lane

At the downstream end of this management unit the stream passed under the private bridge at Bunny Lane. This bridge may constrict the floodplain at very high flows, but passes most flows effectively. The bridge had concrete wing walls and rip-rap to protect the abutments from scour.

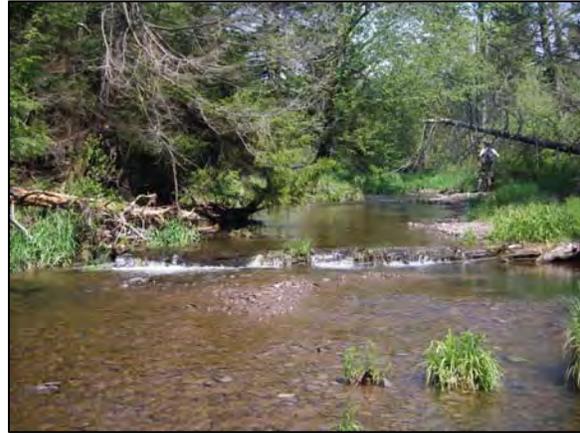
Habitat structure

There were six fish habitat structures in this management unit. Habitat structures were historically installed throughout the Schoharie Creek by the New York State Department of Environmental Conservation (NYSDEC), often in an effort to create scour pools. Scour pools offer deeper holding habitat, and the spillways raise the amount of dissolved oxygen in the water. The structures, most often in the form of a flat log weir perpendicular to the channel, also provided temporary grade control. In

general, due to the horizontal, channel spanning design, they cause water to back up on the upstream side of the structure which can increase sediment deposition. Because most of these structures do not include an area for concentrated flow that provides for sediment transport, sediment deposition often occurs downstream from an initial scour area under the structure. This can cause widening of the channel, which further decreases sediment transport. In some settings, this can promote lateral channel migration, increase stream channel width-to-depth ratios and result in bank erosion up- or downstream. In wild streams, these functions – both positive and negative – are performed to a large extent by large woody debris. It is recommended that an aquatic habitat study be conducted on the Schoharie Creek with particular attention paid to springs, tributaries and other potential thermal refuge for cold water fish, particularly trout. Once identified, efforts should be made to protect these thermal refugia locations in order to sustain a cold water fishery throughout the summer.
