Schoharie Creek Management Unit 3

Town of Hunter – Bunny Lane (Station 148641) to Station 138610

Schoharie Creek Management Unit 3 Stream Feature Inventory

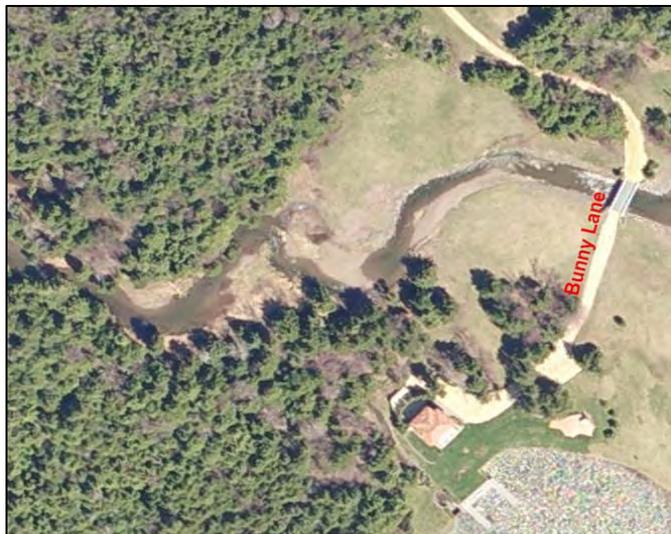
The riparian buffer beyond the rip-rap was comprised of mown grass to the edge of the bank (Station 148641- 148300). The risk to bank stability can be minimized by maintaining mature trees along the critical 100 foot buffer zone. Buffer width should be increased by the greatest amount agreeable to the landowners, but increasing the forested buffer width by at least

Riparian planting site downstream from Bunny Lane
(Station 148641- 148300)

100 feet will increase buffer functionality, such as filtering nutrients and pollutants, if any, from the adjacent lawn.

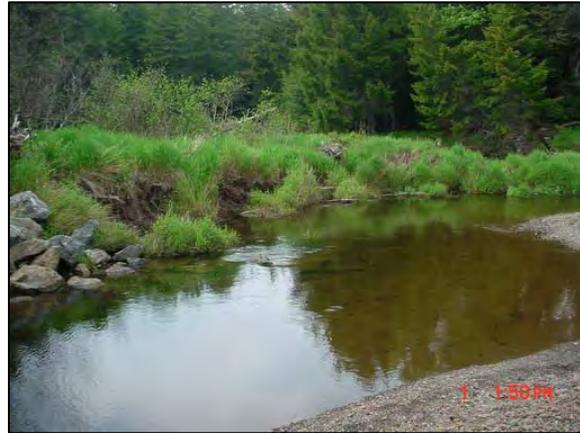
As the rip-rap on the left streambank ended, erosion began (Station 148200).

This erosion was 48 ft in length, exposing an area of 194 ft², including a 30ft² area of *lacustrine* clay. Fine sediment inputs into a stream can be a serious water quality concern because they increase *turbidity*, degrade fish habitat, and can act as a transport mechanism for other pollutants and *pathogens*. To prevent future erosion,

Bank erosion and clay exposure at Station 148200

riparian plantings including native willow and sedge species along the streambank toe are recommended. Reshaping these streambanks by grading may be necessary prior to planting. This work should be preceded by a more detailed site assessment.

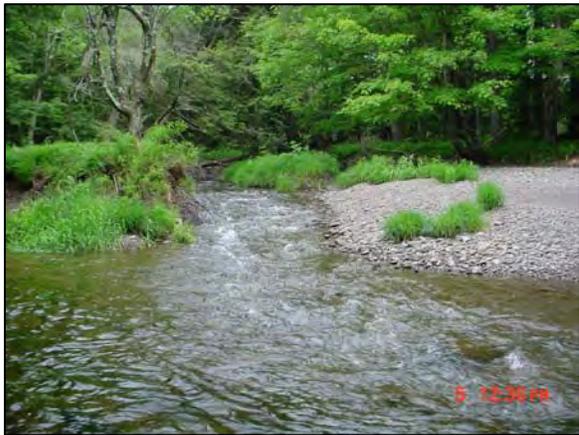
Roaring Brook at Station 147040 - looking upstream

Downstream, Roaring Brook entered from the left streambank (Station 147040). This *tributary* was moderately sloped running along the valley between Sugarloaf and Spruce Top Mountains before entering the Schoharie Creek. The New York State Department of Environmental Conservation classifies streams and rivers based on their “best use” (NYSDEC, 1994). This tributary was classified as C(t), indicating that the best

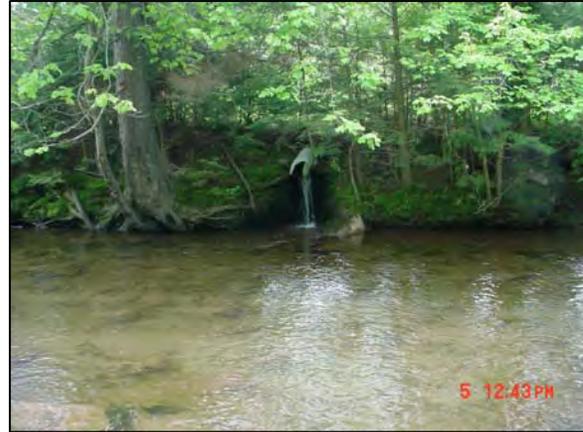
Just downstream, on the right streambank was a piped outfall which flowed intermittently and conveyed excess water from a pond in the adjacent field (Station 146830). This outfall was presumably installed flush with the streambank which has since been eroded by the pipe's discharge. Rock outfall protection is usually recommended in these instances to prevent bank erosion.

Piped outfall at Station 146830

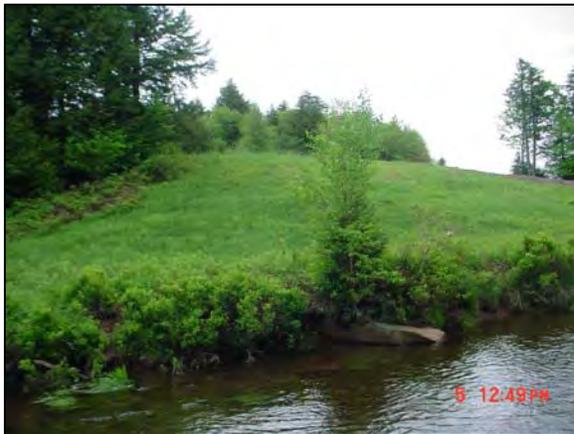
The adjacent riparian buffer has been mowed to the top of the streambank (Station 146750). Areas of *herbaceous* vegetation, such as this, present opportunities to improve the streamside buffer with tree plantings, in order to promote a more mature vegetative community along the streambank and in the floodplain. The deep and complex root systems of trees may also act to filter nutrients and pollutants found in stormwater runoff.

Riparian planting site at Station 146750

Another solution is to simply stop mowing this area and allow for natural regrowth.

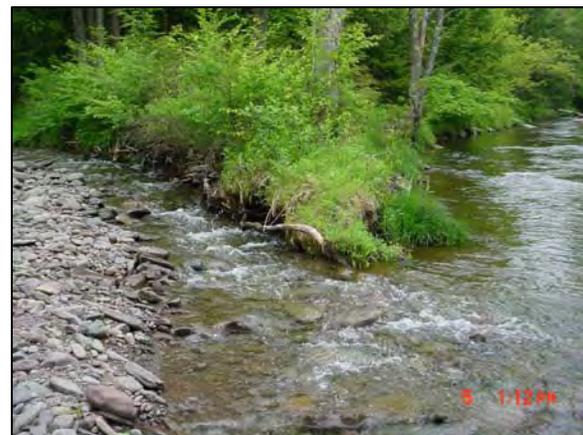
An unnamed tributary entered the stream at Station 146100. Originating on steep mountainous slopes, this stream drained parts of Roundtop Mountain before crossing under Platte Clove Road where the topography flattened before it entered the Schoharie Creek. As a result of this topography change, the tributary lost its ability to transport sediment gathered from the mountain slopes, and began to deposit

Tributary at Station 146100 - looking upstream

sediment at its mouth and into the more gently sloped Schoharie Creek. This is a common feature of confluence areas, which often contain extensive sediment bars, function as important sediment storage areas and are typically among the most dynamic and changeable areas in the stream system. This tributary is classified by the NYSDEC as C(t).

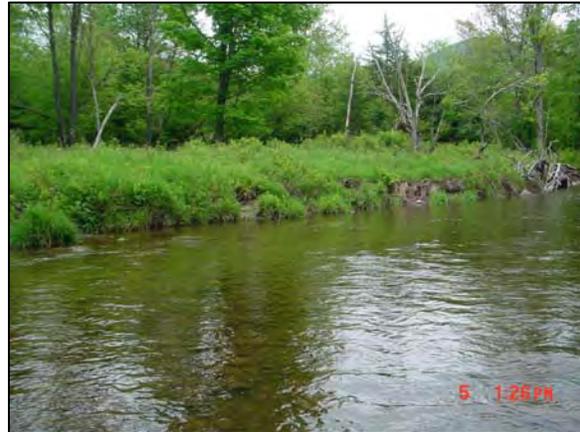
At Station 145900, the right streambank buffer was dominated by small herbaceous plants. This riparian area would benefit from native tree plantings.

Riparian planting site at Station 145900

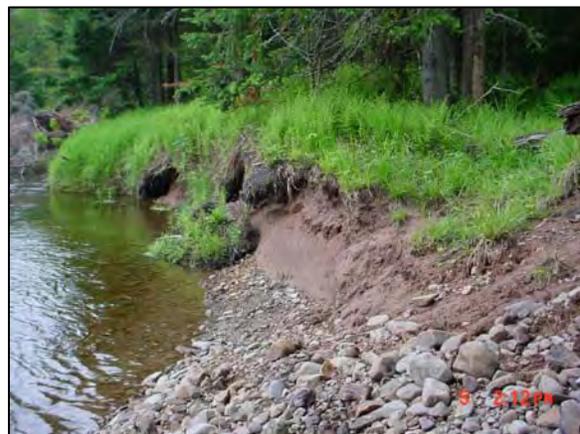
At the next meander bend there was another 120 ft² clay exposure on the right stream bank (Station 144700). This bank scour may have been exacerbated by upstream and downstream woody debris. While woody debris is valued for its many habitat features, it can also present problems when it diverts stream flows. Removal of some woody debris is recommended at this site to reduce potential clay inputs into the stream.

Clay exposure at Station 144700

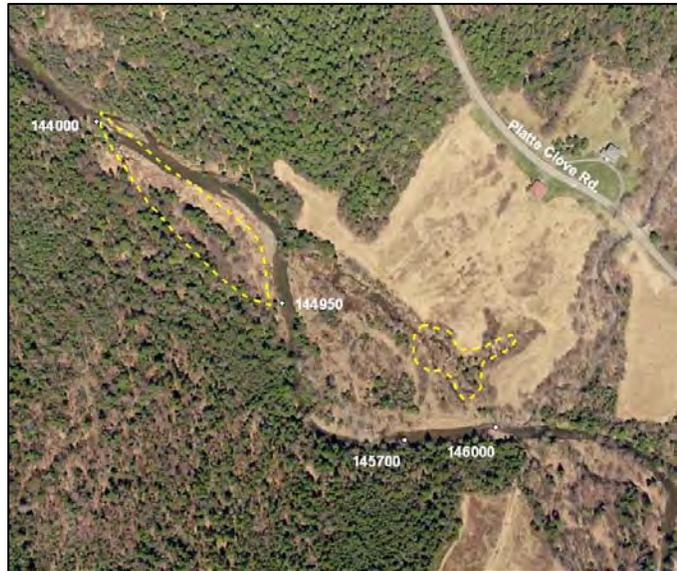
There were two significant wetlands in this area (Station 146000 & 144950). Wetlands are important features in the landscape that provide numerous beneficial functions including protecting and improving water quality, providing fish and wildlife habitats, storing floodwaters, and maintaining surface water flow during dry periods. The wetland at Station 146000 was 0.8 acres in size, and was classified as Palustrine, Scrub-Shrub, Broad-Leaved Deciduous, Temporarily Flooded (PSS1A). The wetland at Station 144950 was 2.3 acres in size, and was classified as Palustrine, Forested, Broad-Leaved Deciduous, Temporarily Flooded (PFO1A) (see Section 2.6 for detailed wetland type descriptions).

*Wetland (Station 146000-145700 and 144950-144000)
Approximate wetland boundary delineated by NWI*

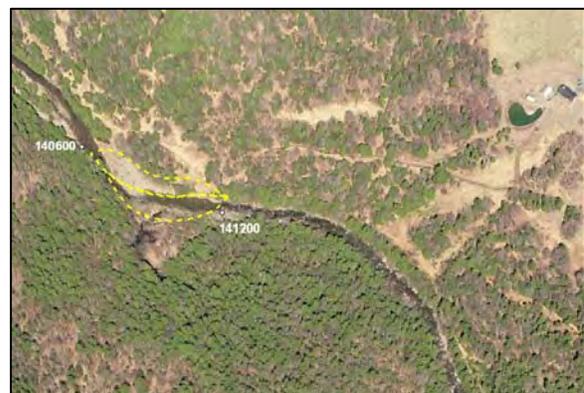
Downstream, at Station 141200 there were two wetlands, which were differentiated by their physical and vegetative characteristics. The wetland along the right streambank was 0.7 acres in size, and was classified as Riverine, Upper Perennial, Unconsolidated Shore, Seasonally Flooded (R3USC). The wetland along the left streambank was also 0.7 acres is size and was

*Wetland located at Station 141200-140600
Approximate wetland boundary delineated by NWI*

classified as Palustrine, Forested, Broad-Leaved Deciduous, Temporarily Flooded (PFO1A).

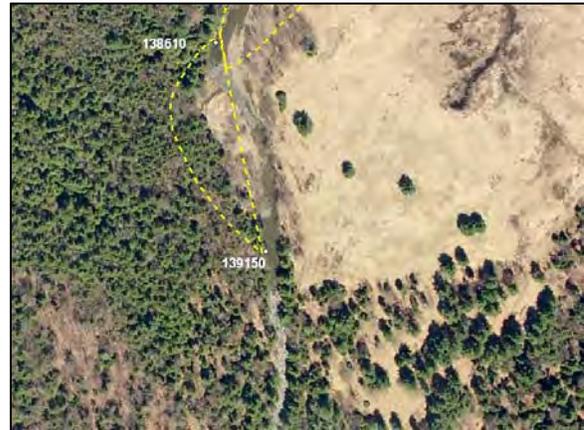
At the end of the management unit there was a large 1.3 acre wetland, classified as Palustrine, Scrub-Shrub, Broad-Leaved Deciduous, Temporarily Flooded (PSS1A) on the left bank (Station 139150). Across the stream, bank stability was suffering from scour, and the riparian buffer was inadequate (Station 138900, Inset A). To improve the buffer native trees should be planted in the upland area, and willows and sedges planted along the toe to improve bank stability and combat continued scouring.

*Wetland (Station 139150-138610) and planting site
Approximate wetland boundary delineated by NWI*

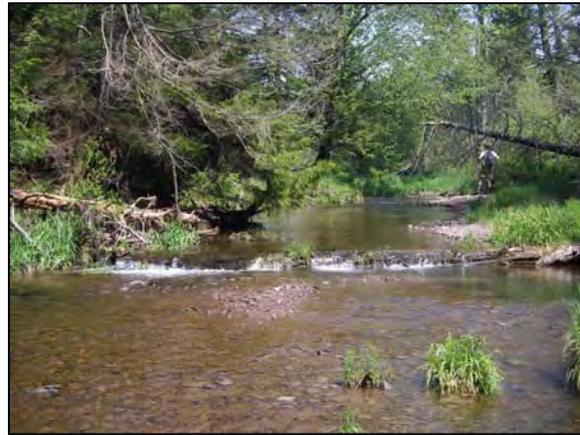
Habitat structure

There were four fish habitat structures in this management unit. Habitat structures were historically installed throughout the Schoharie Creek by the New York State Department of Environmental Conservation (NYSDEC), often in an effort to create scour pools. Scour pools offer deeper holding habitat, and the spillways increase the level of dissolved oxygen in the water. The structures, most often in the form of a flat log weir perpendicular to the channel, also provided temporary grade control. In general due to the horizontal, channel spanning design, they cause water to back

up on the upstream side of the structure which can increase sediment deposition. Because most of these structures do not include an area for concentrated flow that provides for sediment transport, sediment deposition often occurs downstream from an initial scour area under the structure. This can cause widening of the channel, which further decreases sediment transport. In some settings, this can promote lateral channel migration, increase stream channel width-to-depth ratios and result in bank erosion up- or downstream. In wild streams, these functions – both positive and negative – are performed to a large extent by large woody debris. It is recommended that an aquatic habitat study be conducted on the Schoharie Creek with particular attention paid to springs, tributaries and other potential thermal refuge for cold water fish, particularly trout. Once identified, efforts should be made to protect these thermal refugia locations in order to sustain a cold water fishery throughout the summer.
