Schoharie Creek Management Unit 9

Town of Jewett – Carr Road Bridge (Station 83957) to County Route 17 (Station 70652)

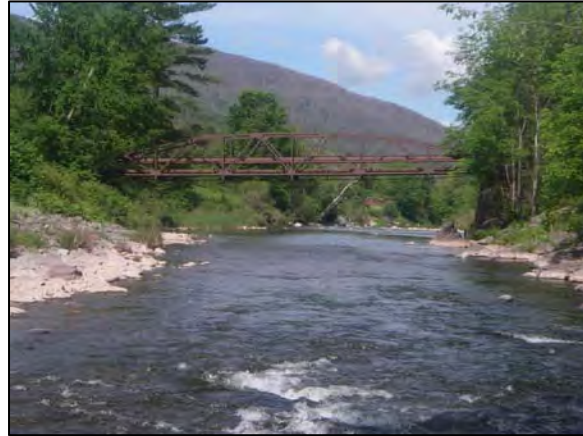
Bridge at Carr Road (Station 83957)

This management unit began as the stream passed under the Carr Road bridge. While *bankfull* flows appeared to flow freely through this bridge, higher flows overtop the bridge and flow over Carr Road rendering the bridge impassable. This bridge is the sole access residents have to cross the Schoharie Creek and during floods residents are cut off from emergency services. Repeated repair of Carr Road after

flood events has also been very costly. Installation of *floodplain drainage*, using culverts set at the floodplain elevation under the bridge approach, would increase hydraulic capacity of the bridge and help mitigate this problem. A hydraulic analysis of Carr Road bridge and upstream floodplain is the first step necessary to begin planning for remediation of flood concerns in this area (see Section 4.8 for recommendations).

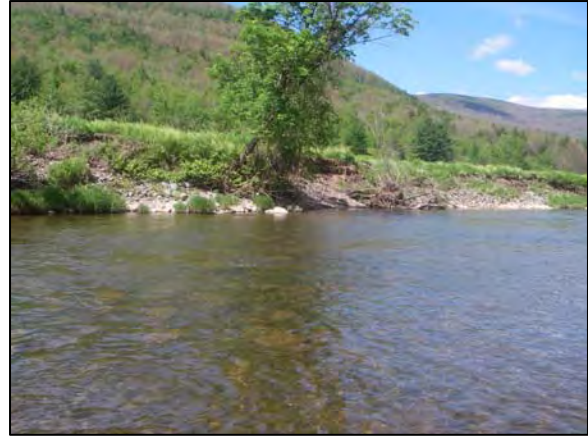
Bank erosion at Station 83400

Downstream, approximately 276ft of the left streambank had suffered minor erosion during high flow events (Station 83400). A piped outfall, which discharged stormwater from Little Timber Road onto this streambank, may exacerbate erosion at this site. The stability of this streambank could be improved with plantings of willow *fascines* and sedges along the toe of the bank coupled with trees and shrubs along the bank. These plantings would also improve the aquatic habitat within this reach. Erosion continued downstream for 331ft of the left streambank (Station 82830). This site was also a good candidate for *bioengineering* stabilization techniques.

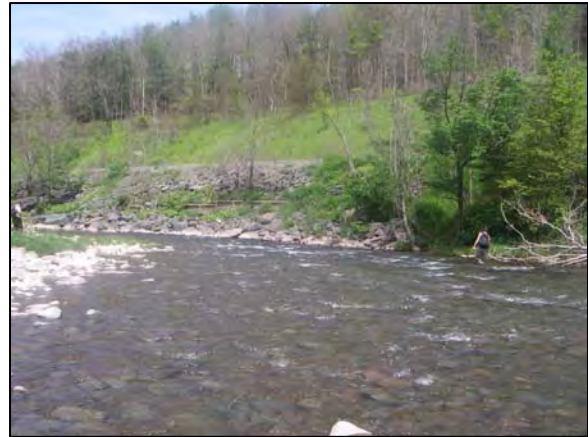
Revetment at Station 82300

As the stream flowed directly towards the County Route 23A embankment, revetment including 767ft of rip-rap and 90ft of T-wall had been installed along the right streambank (Station 82300). Interplanting of the existing rip-rap, by inserting plantings into the soil between the rocks may help to strengthen and increase the longevity of this rip-rap. These plantings will also improve the aquatic habitat by providing shade, resulting in cooler water temperatures.

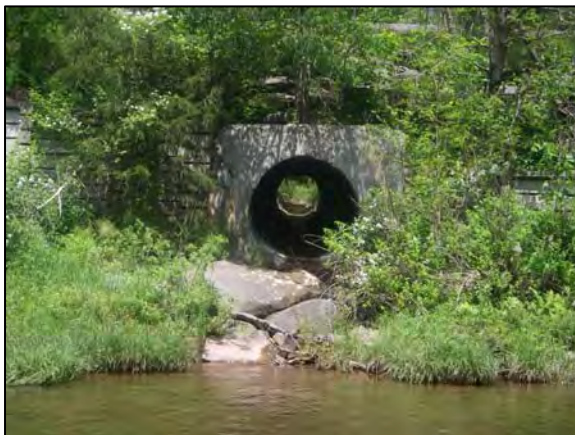
Culvert and Tributary at Station 80800

The downstream County Route 23A embankment had again been stabilized with 414ft of rip-rap and 175ft of T-wall along the right streambank (Inset C, Station 81050). Native vegetation including mature trees and shrubs had grown along this revetment,

providing a good example of interplanted revetment. At the middle of this rip-rap, an unnamed *tributary* entered the Schoharie Creek (Station 80800). This tributary drained the mountain on the opposite side of County Route 23A, before passing under the road and joining the Schoharie Creek through a large concrete culvert. The New York State Department of Environmental Conservation classifies streams and rivers based on their

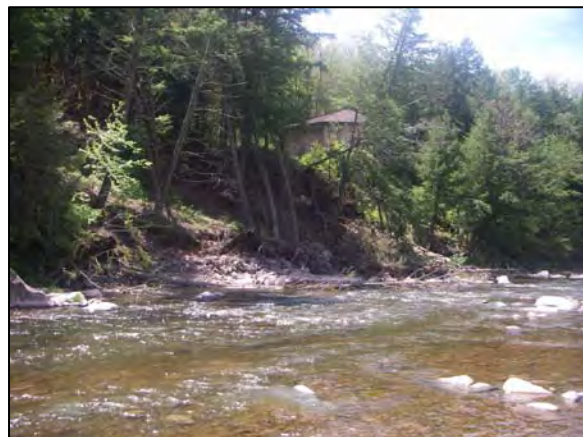
Bank erosion at 78900

Along the outside meander of this bend the *thalweg*, or deepest part of the stream channel, flowed up against the left streambank causing significant bank erosion (Station 78900). Streambank erosion often occurs on the outside of meander bends where the stream velocity is greatest during high flows. A 19,823ft² area of streambank had been left unvegetated, exposing a glacial lake silt/clay deposit. Fine sediment inputs from eroding bank can be a water quality concern because they increase *turbidity* and can act as a transport mechanism for other pollutants and pathogens. Sheet piling had

been installed along 30ft of this bank in efforts to protect a home on the streambank (Station 78760). This home could be threatened in the future if this bank continues to erode.

A bank erosion monitoring site (BEMS) was installed along this bank to study this erosion (Station 78870). A cross-section and long profile survey were conducted to collect baseline *morphology* data. In the future this cross-section can be resurveyed to calculate the bank's erosion rate. If the erosion rate accelerates significantly, full restoration to address property loss and water quality threats should be considered for this site. This would likely involve establishment of a well-vegetated bench on the right bank with rock vanes to direct stream flows away from the bank, regrading and then revegetation of the bank face, and establishment of channel geometry throughout the unit to more effectively convey the *sediment load*.

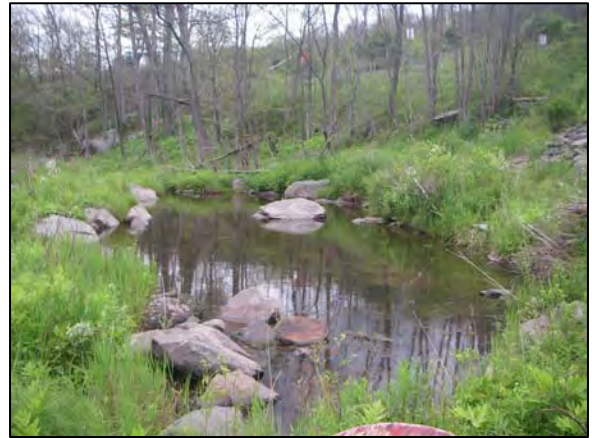
Detention basin at Station 76700

At the next downstream meander bend, the stream was once again pushed against the County Route 23A embankment. Rip-rap had been installed along 312ft of this embankment and was in good structural condition with shrub and herbaceous vegetation growing throughout (Inset B, Station 76900). Several hillside seeps, along with road drainage, entered Schoharie Creek along this bank. A small detention pond designed to retain stormwater runoff, and remove sediment within the stormwater by settling, had been installed on the streambank terrace (Station 76700).

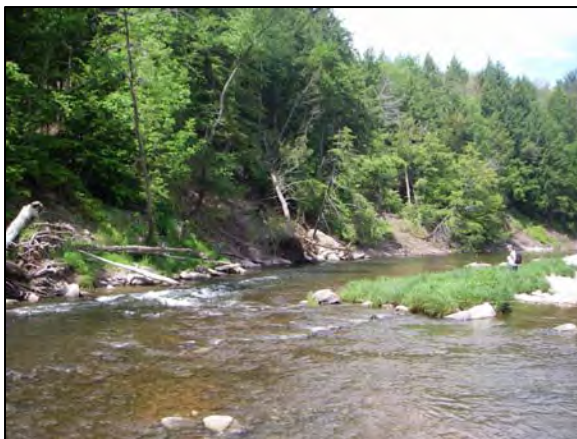
Bank erosion at Station 73100

At the next meander bend downstream, the channel flowed up against the valley wall on the left bank causing a 40,613ft² mass failure (Station 73100). The *thalweg* pushed up against the high hillslope which caused toe erosion that resulted in the loss of the mature forested vegetation, leaving much of the streambank unvegetated. The exposed *mixed till* soils had a high silt and clay content, which likely contributed a significant sediment load during high flows.
