# Schoharie Creek Management Unit 11

Town of Lexington – Bush Road Bridge (Station 63446) to County Route 42 Bridge (Station 55350)

Figure 4.11.1 Management Unit 11 - 2006 aerial photography with stream feature inventory

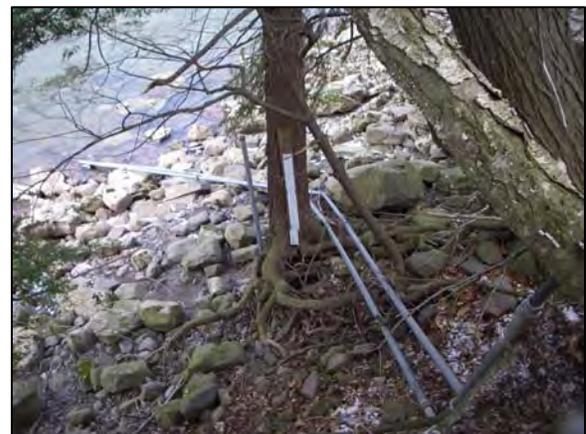
A United State Geologic Survey (USGS) continuously recording stream gage was located on the left streambank approximately 700 ft downstream from the Bush Road bridge (Station 62740). This gage (#01349705) has a drainage area of 96.8mi<sup>2</sup> and has been collecting data from August 1999 to the present. All gage information including real time discharge and gage height

*USGS stream gage #01349705 - Station 62740*

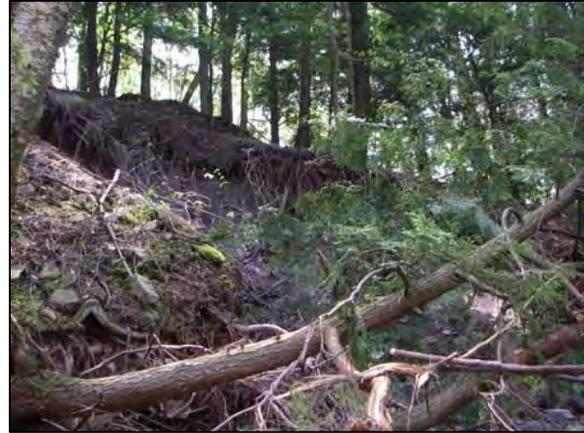
The *thalweg*, or deepest part of the stream channel, flowed up against the left streambank causing the first significant bank erosion in the management unit (Inset D, Station 62100). This *mass failure* had resulted in an erosion area of approximately 11,248 ft<sup>2</sup>, exposing areas of mixed till as well as compromising mature trees at the top of the bank. Streambank erosion often occurs on the outside of meander bends where the stream velocity is greatest during high flows.

*Bank erosion at Station 62100*

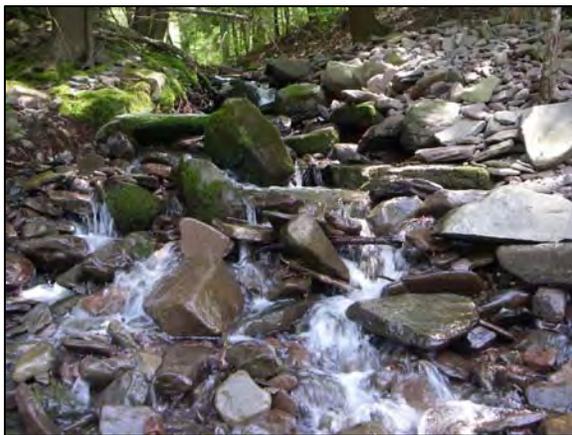
*Tributary at Station 60900*

they entered the Schoharie Creek. As a result of this stream slope change, the tributary lost its ability to transport sediment gathered from the mountain slopes, and began to deposit sediment at its mouth and into the more gently sloped Schoharie Creek. This is a common feature of confluence areas, which often contain extensive sediment bars, function as important sediment storage areas, and are typically among the most dynamic and

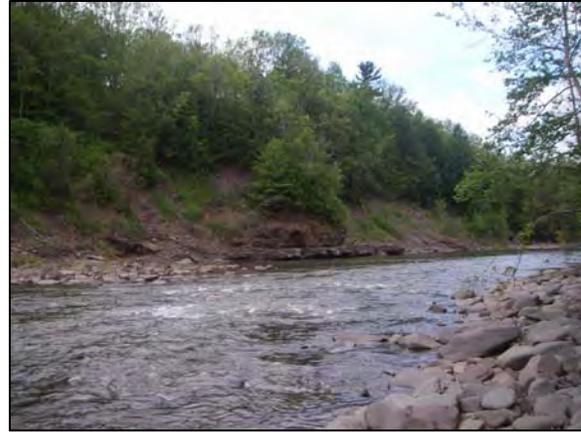
At the next downstream meander bend there was another erosion site (Inset B, Station 59100). The hillslope was undermined by toe erosion, resulting in the mass wasting of a 65,306 ft<sup>2</sup> area along 1,363 ft of the bank. This erosion had left the face of the streambank unvegetated. Throughout the bank *lacustrine clay* deposits were exposed. Clay inputs into a stream are a serious water quality concern because they increase *turbidity*, degrade fish habitat, and can act as a carrier for other pollutants and pathogens. This bank may introduce significant amounts of suspended sediment and woody debris during rainfall events. While woody debris is valued as a feature of good fish habitat, in some instances it can present a threat to infrastructure. This site may stabilize on its own over time. It appeared a low bench may have started to develop at the toe of the eroding bank which may act to reduce flood water velocities near the bank. A bank erosion monitoring site (BEMS) could be installed along this bank to study this bank's erosion rate and document its potential recovery. In-depth survey and design would be necessary to effectively restore this erosion site.

*Bank erosion at Station 59100*

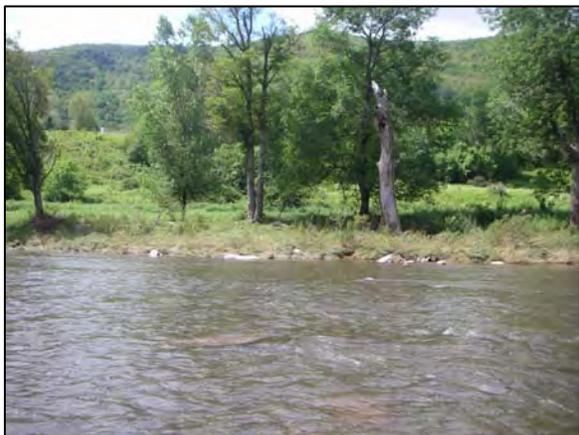
*Planting site at Station 57100*

As the stream gained access to the floodplain on the left streambank the riparian buffer was composed primarily of herbaceous vegetation (Station 57100). A buffer of native trees and shrubs should be planted along the streambank and corridor. Buffer width should be increased by the greatest amount agreeable to the landowner, but increasing the buffer

width by at least 100 feet will increase the buffer functionality, such as slowing the flow of run-off from the floodplain and allowing sediment and its attached pollutants, if any, to settle out before reaching the stream.

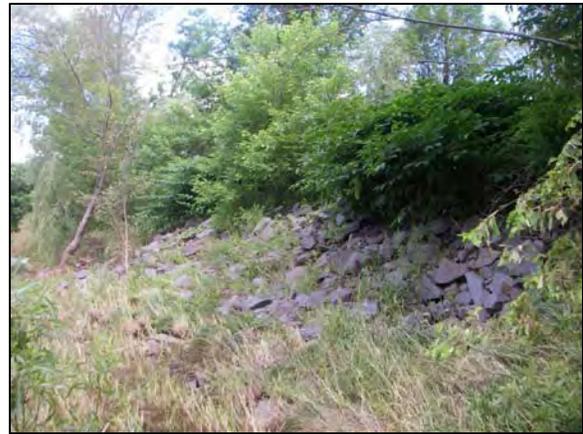
As residential properties started to line the right streambank, revetment including 833 ft of rip-rap (Station 56600) and 165 ft of stacked rock wall (Station 55600) had been installed. The rip-rap appeared to have been dumped between existing streamside vegetation, which may help to stabilize this bank and enhance aquatic habitat.

*Rip-rap at Station 56600*

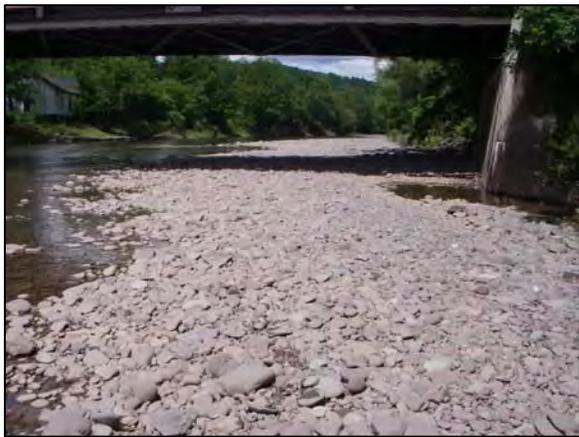
This management unit ended as the stream passed under the bridge at County Route 42 (BIN 1025220) (Inset A, Station 55350). This bridge may constrict the floodplain at very

*Aggradation at County Route 42 bridge  
Station 55350*

high flows, as evidenced by aggradation at the right bridge abutment, but appeared to pass most flows effectively. Higher flows appeared to backwater, resulting in upstream channel widening and aggradation. A large gravel bar had formed along the right streambank indicating inadequate sizing of the bridge opening. An undersized bridge opening causes water to back up upstream of the bridge, reducing stream velocity, which

results in sediment deposition. As bridges are replaced over time, these issues should be evaluated and adjusted if necessary to lessen the probability of flood damage by providing a more effective conveyance channel that promotes water and sediment flow through the bridge opening.

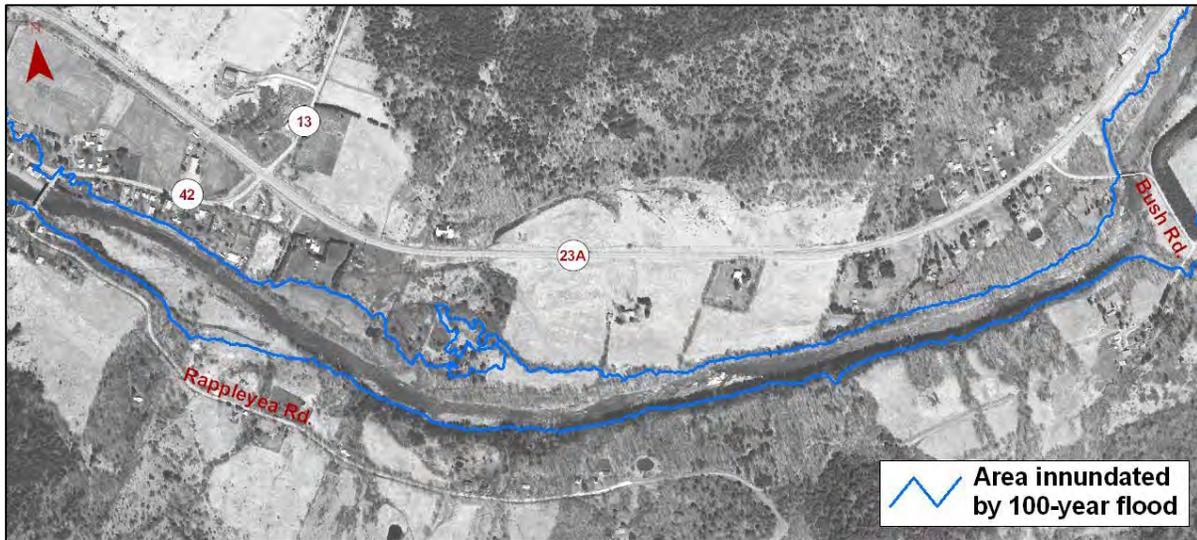
*100-year floodplain boundary map*

According to the current floodplain maps (above), six existing structures in this unit appeared to be situated within the estimated 100-year floodplain. The 100-year floodplain is that area predicted to be inundated by floods of a magnitude that is expected to occur once in any 100-year period, on the basis of a statistical analysis of local flood record. Most communities regulate the type of development that can occur in areas subject to these flood risks.
