Schoharie Creek Management Unit 16

Town of Prattsville – Station 31388 to County Route 23 (Station 19376)

Schoharie Creek Management Unit 16 Stream Feature Inventory

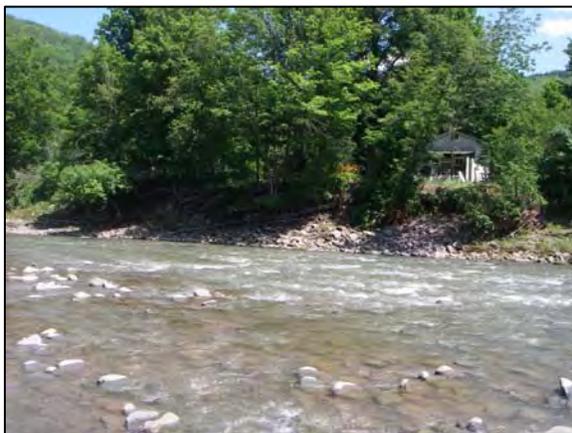
Bank erosion at Station 30600

At the upstream end of this management unit 200 ft of the right streambank had eroded a residential property (Station 30600). To increase bank stability, native shrubs and sedges should be planted along the streambank and toe. On the opposite bank 245 ft (Station 30260) had scoured during high flow events. This type of erosion is common and part of natural stream process. In stable watersheds, the rate of

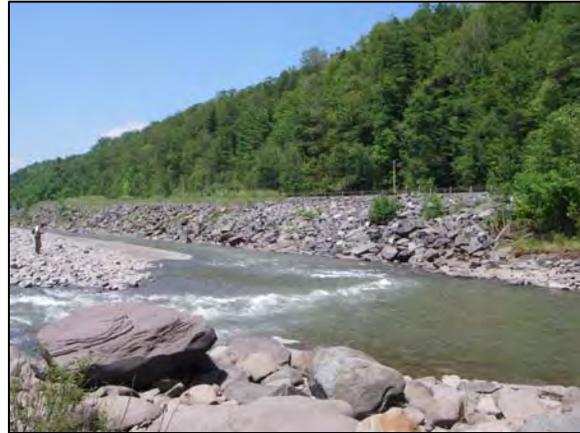
As the stream flowed directly into the County Route 23A embankment, rip-rap had been installed along 2,498 ft of the right streambank (Station 29750) and 1,339 ft along the left streambank (Station 29500). While rip-rap and other hard controls may provide temporary relief from erosion, they are expensive to install, degrade habitat, and require ongoing maintenance or may transfer erosion problems to upstream or downstream areas. Alternate stabilization techniques should be explored for streambanks whenever possible. Interplanting of this rip-rap, by inserting native tree and shrub plantings into the soil between the rocks, would increase its strength and increase its longevity. These plantings would also improve the aquatic habitat by providing shade, resulting in cooler water temperatures.

Rip-rap at Station 29750

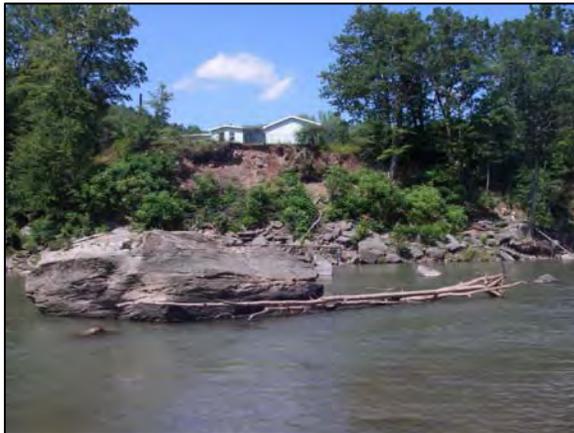
Downstream along this meander bend the *thalweg*, or deepest part of the stream channel, flowed up against the right streambank causing significant bank erosion (Station 28100). Streambank erosion often occurs on the outside of meander bends where the stream velocity is greatest during high flows. The home at the top of this bank could be threatened in the future if this bank continues to erode. Rip-rap had been installed along the toe of the bank.

Bank erosion at Station 28100

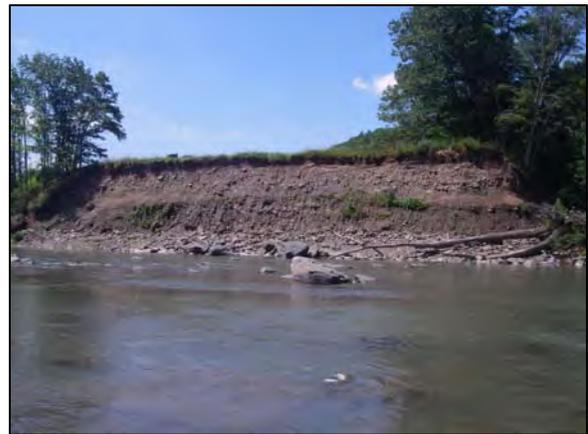
Downstream of the tributary, the erosion continued for an additional 477 ft, leaving a 8,265 ft² area of streambank unvegetated and exposing a large amount of bare soil (Station 27950). A bank erosion monitoring site (BEMS) was installed along this bank to study this erosion (Station 27840). A cross-section and long profile survey were conducted to collect baseline *morphology* data. In the future this cross-section can be resurveyed to calculate the bank’s erosion rate. If the erosion rate accelerates significantly, full restoration to address property loss of the adjacent agricultural fields should be considered for this site. This would possibly involve establishment of a well-vegetated bench at the bank toe with rock vanes to direct stream flows away from the bank, regrading and then revegetation of the bank face, and establishment of channel geometry throughout the unit to more effectively convey the *sediment load*.

Bank erosion at Station 27950

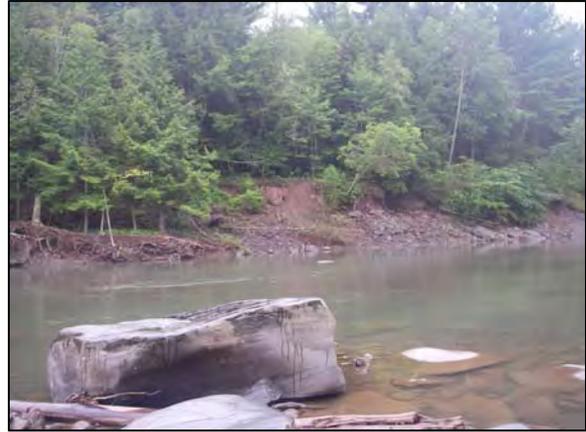
Just downstream, a 37,263 ft² area of eroding streambank had exposed a significant glacial lake silt/clay deposit throughout the entire bank (Station 26260). Fine sediment inputs from eroding banks can be a water quality concern because they increase *turbidity* and can act as a transport mechanism for other pollutants and pathogens. Another bank erosion monitoring site (BEMS) was installed near the

Bank erosion at Station 26260

downstream end of this erosion (Station 25340). If the erosion rate accelerates significantly, full restoration to address water quality threats from clay exposures should be considered.

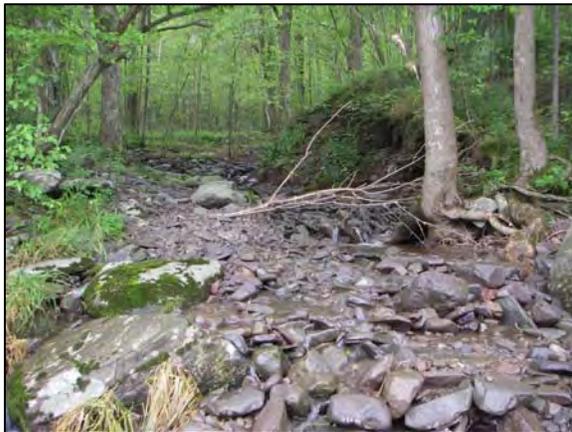
On the left streambank an unnamed tributary entered the Schoharie Creek (Station 23930). This tributary drained Roundtop Mountain, before it reached the flatter topography of the valley floor where it entered the Schoharie Creek. As a result of this stream slope

Tributary at Station 23930 - looking upstream

change, the tributary lost its ability to transport sediment gathered from the mountain slopes, and began to deposit sediment at its mouth and into the more gently sloped Schoharie Creek. This is a common feature of confluence areas, which often contain extensive sediment bars, function as important sediment storage areas, and are typically among the most dynamic and changeable areas in the stream system. This

tributary was classified C by the NYSDEC (NYSDEC, 1994). Possibly due to the increase in runoff and sediment load from the tributary, a 178 ft long *lacustrine* clay deposit had been exposed along the left bank immediately downstream (Station 23800).

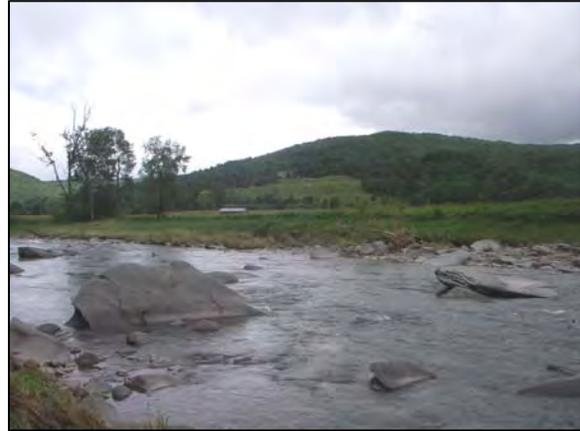
Proceeding downstream, the land use on the right streambank changed from forested to agricultural with fields to the edge of the stream (Station 22900). A riparian buffer of native trees and shrubs should be planted along this streambank and corridor. Buffer width should be increased by the greatest amount agreeable to the landowner, but increasing the buffer width by at least 100 feet will increase the buffer functionality, such as filtering nutrients and pollutants, if any, from the agricultural fields. Buffer enhancement would also increase bank stability and improve aquatic habitat by providing shade, resulting in cooler water temperatures.

Planting site at Station 22900

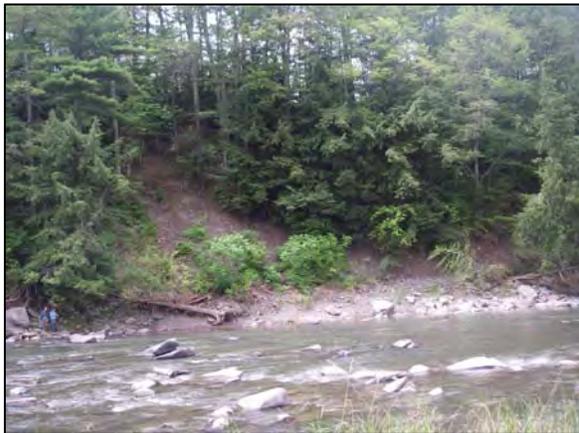
Bank erosion at Station 22800

The hillslope along left streambank had been undermined by toe erosion, resulting in 8,207 ft² bank failure along 205 ft of the bank (Station 22800). Many mature trees had been lost from the bank. However, this site may stabilize on its own over time. It appeared a low bench may have begun to develop at the toe of the eroding bank which may act to reduce flood water velocities near the bank.

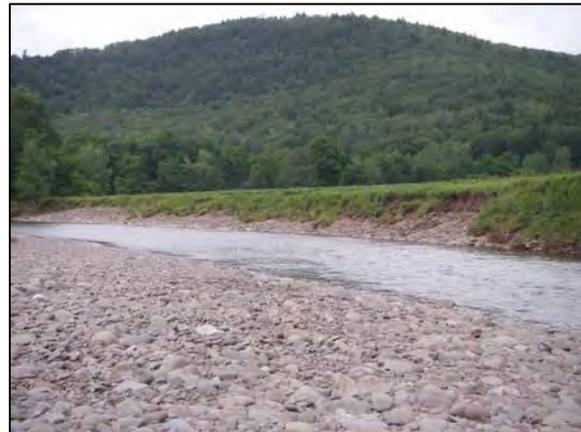
On the right streambank, erosion continued for an additional 741 ft, exposing clay deposits along 75 ft of the bed and bank (Station 20300). A bank erosion monitoring site (BEMS) was installed near the downstream end of this erosion (Station 19770). If the erosion rate accelerates significantly, full restoration to address water quality threats from clay exposures and property loss should be considered for this site. Streambank and buffer plantings are also recommended to slow erosion at this site. This management unit came to an end just upstream of the confluence with Batavia Kill.

Bank erosion at Station 20300
