Schoharie Creek Management Unit 17

Town of Prattsville – Station 19376 to NYS Route 23 Bridge (Station 10486)

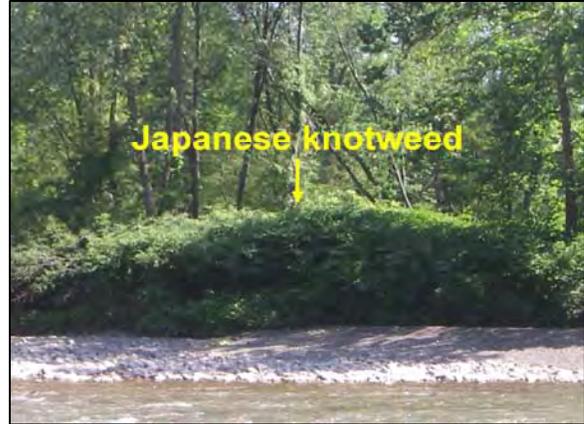
A 356 ft long stand of Japanese knotweed (*Fallopia japonica*) had established along the right streambank downstream from the Batavia Kill confluence. Japanese knotweed is an

invasive non-native species which does not provide adequate erosion protection due to its very shallow rooting system, and also its rapid growth rate crowds out more beneficial streamside vegetation. Large Japanese knotweed stands were documented throughout the management unit with Japanese knotweed present on almost half of the streambanks.

Japanese knotweed at Station 19300

This significant increase in Japanese knotweed is likely due to the introduction of rhizome fragments from the Batavia Kill, which has a high percentage Japanese knotweed on its banks. Once knotweed has established itself in the riparian area, it is able to spread downstream after disturbances caused by beaver activity or by high flows scouring the streambank. Such disturbances often cause stems and rhizomes to break off and float downstream where fragments may establish themselves on streambanks that were previously unaffected by knotweed. Exposed streamside areas such as sediment deposits or disturbed banks with eroded soils lacking vegetation are particularly vulnerable to invasion by knotweed. While it may prove impossible to eradicate Japanese knotweed from all streambanks, it is important to recognize this issue and take action to prevent further spread (See Section 2.7 Riparian Vegetation).

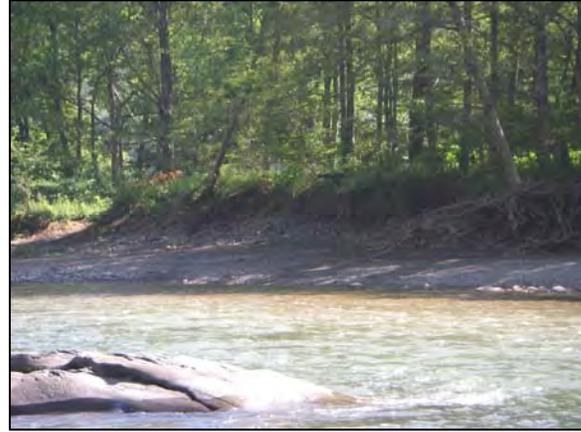
The right streambank had scoured during high flow events along 211 ft (Station 19100). This type of erosion is common and may revegetate on its own with time. To speed up this process and increase bank stability native shrubs and sedges could be planted along the streambank and toe. In stable watersheds, the rate of erosion is slow and a natural healing process usually follows.

Bank erosion at Station 19100

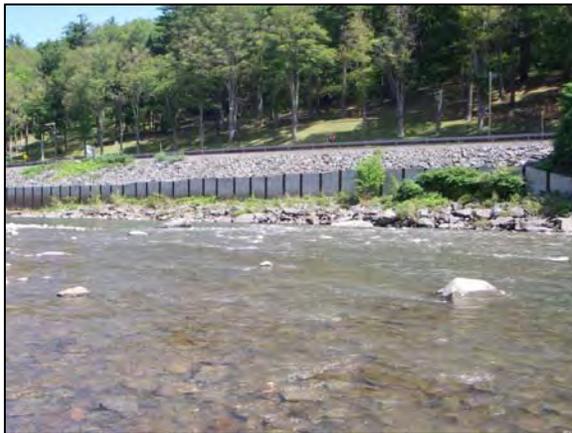
Revetment at Station 16400

As the stream flowed directly into the NYS Route 23 road embankment, rip-rap and a concrete wall and been installed along 577 ft of the right streambank (Station 16400).

Interplanting of this rip-rap, by inserting native tree and shrub plantings into the soil between the rocks, would strengthen and increase its longevity and also improve the aquatic habitat by providing shade, resulting in cooler water temperatures. Plantings of

shrubs and sedges on the lower half bank below the concrete wall would provide additional protection for the streambank toe.

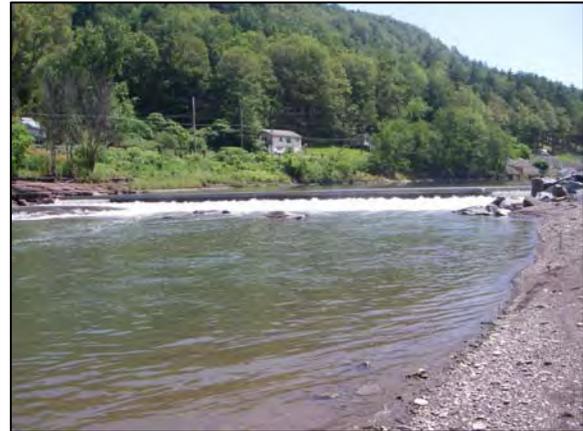
Dam at Station 15280 - looking upstream

smallmouth bass populations over time (NYSDEC, 1993). The large pool created downstream by this structure serves as a popular swimming spot for residents. The concrete abutment had caused erosion on the left streambank upstream and downstream from the dam. Rip-rap had been installed along 66 ft of this bank but is unlikely to prevent future erosion at this site (Station 15300).

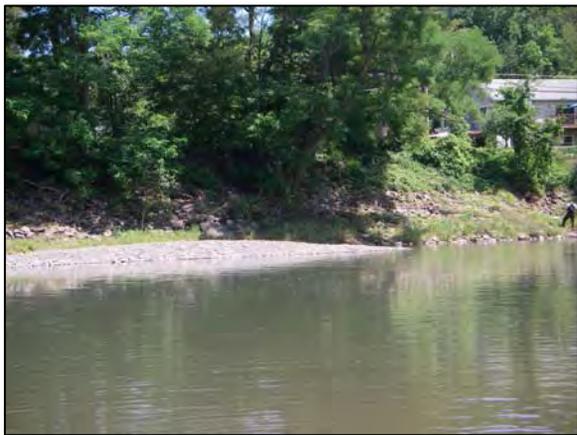
Rip-rap at Station 15150 - looking upstream

Downstream the adjacent land use changes from agricultural and forested to residential and commercial. Many of the homes and businesses along the right streambank suffer flooding due to their location within the 100-year floodplain, or the area which has a 1% chance of being inundated in any given year. Rip-rap had been installed along 704 ft of the right streambank (Station 15150)

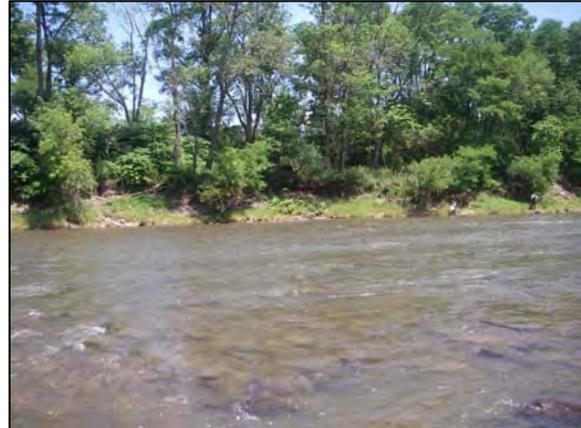
On the opposite bank 434 ft (Station 14400) had scoured during high flow events. This type of erosion is common and part of natural stream process. In stable watersheds, the rate of erosion is slow and a natural healing process usually follows. The stability of this streambank might be improved with plantings of willow *fascines* and sedges.

Bank erosion at Station 14400

Mature trees lined the top of the bank, however increasing the forested buffer width along the stream corridor by at least 100 feet will increase buffer functionality, such as filtering nutrients and pollutants, if any, from the adjacent commercial property. A high quality riparian buffer is especially important at this site because the adjacent commercial property is located within the 100-year floodplain. A dump site including large metal debris in the streambank was documented along this scour (Station 14100). To prevent introduction of this material, and any associated pollutants, into the stream the dump should be removed.

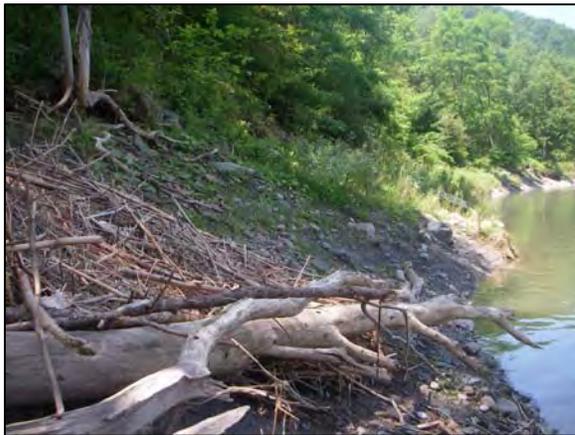
Bank erosion at Station 13650

Just downstream, along the outside meander bend the left streambank had scoured during high flow events along 599 ft (Station 13650). Streambank erosion often occurs on the outside of meander bends where the stream velocity is greatest during high flows. Vegetation had been stripped from the lower bank, but regrowth of vegetation had already begun. This erosion had exposed lacustrine clay deposits along 1,040 ft of the streambed

and bank (Inset B, Station 13770).

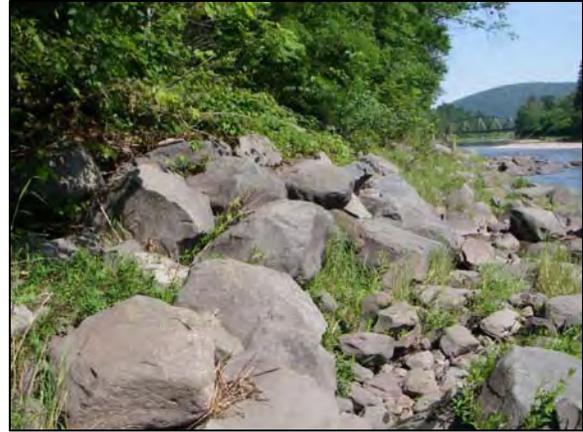
Beginning at Station 12100 downstream to the NYS Route 23 bridge in Prattsville, rip-rap had been installed along 1,035 ft of the County Route 2 road embankment on the left streambank. While some vegetation was established above this rip-rap, additional plantings of native trees and shrubs is recommended at this site. Plantings of shrubs and sedges along the toe of the bank may also provide additional protection against erosion.

Rip-rap at Station 12100

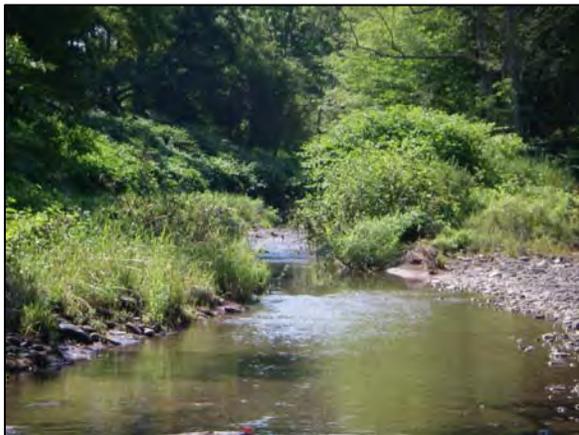
Huntersfield Creek confluence at Station 11800

Huntersfield Creek watershed drains approximately 7.9 mi². As evidenced by deposition upstream and downstream of the confluence, Huntersfield Creek delivers a significant amount of sediment to the Schoharie Creek. A stream feature inventory to identify sediment sources from this tributary is recommended.

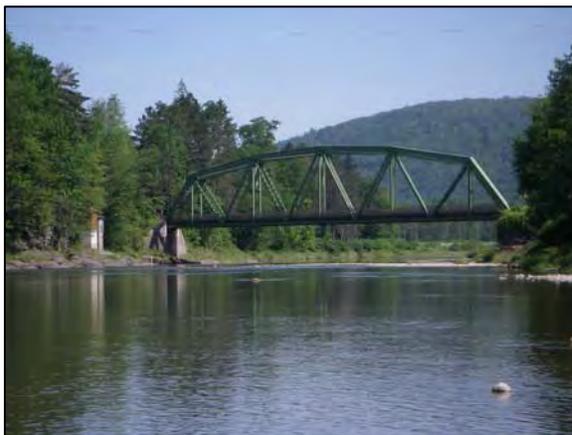
At the downstream end of this management unit the stream passed under the NYS Route 23 bridge in Prattsville (Station 10486). Gravel deposits upstream and downstream of the bridges were noted. Deposits such as these are commonly caused by inadequate sizing of

State Route 23 bridge in Prattsville - Station 10486

the bridge opening. This deposition may also be partly due to the Schoharie Reservoir impoundment downstream. An undersized bridge opening causes water to back up upstream of the bridge, reducing stream velocity, which results in sediment deposition. While bankfull flows may flow freely through this bridge, higher flows backwater, resulting in the upstream aggradation. Flood damage to bridges is typically caused by inadequate

hydraulic capacity of the bridge, misaligned piers and/or abutments, or accumulation of

debris. As bridges are replaced over time, these issues should be evaluated and adjusted if necessary to lessen the probability of flood damage by providing a more effective conveyance channel that promotes water and sediment flow through the bridge opening.
