Neversink River East Branch

MANAGEMENT UNIT 11

Summary of Post-Flood Recommendations

Stream Channel and Floodplain Current Conditions

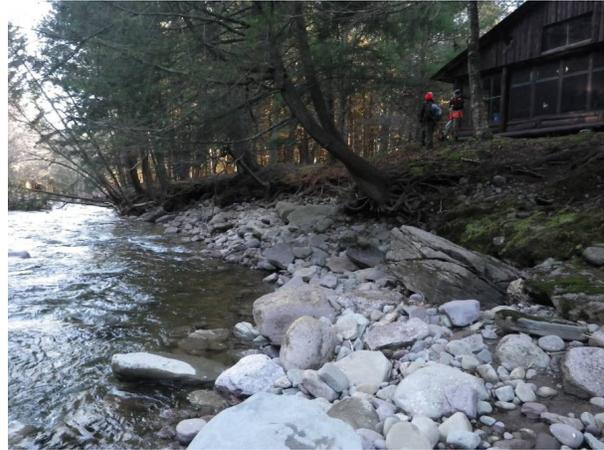
Erosion along the right bank begins at Station 42170, continuing approximately 184 feet to Station 41990 (BEMS NEB11_41800). Assisted restoration was recommended for this site based on conditions documented in 2010 including active undercutting of mature vegetation on the bank as well as the close proximity of a log home to the eroding bank. A side bar had formed along the left bank directly across from the erosion at Station 42020, further increasing pressure on the eroding bank. This depositional area consisted of primarily cobble sized materials and was approximately 50 feet long.

Subsequent flooding has led to several channel adjustments in this reach, including removal of a side bar across from this eroding bank segment and formation of a depositional bench at the toe of undercut bank. This bench should prevent further undercutting during high flow events, and it is likely that it will self-vegetate. This vegetation could further reduce the erosive forces on this stream bank during future high flow events. Therefore, it is possible for this bank to stabilize without treatment (*passive restoration*). It is recommended that this site be monitored for changes in condition.

Eroding bank segment on the right bank. Note newly formed cobble bankfull stage bench at the toe of the slope. (IMG1555)

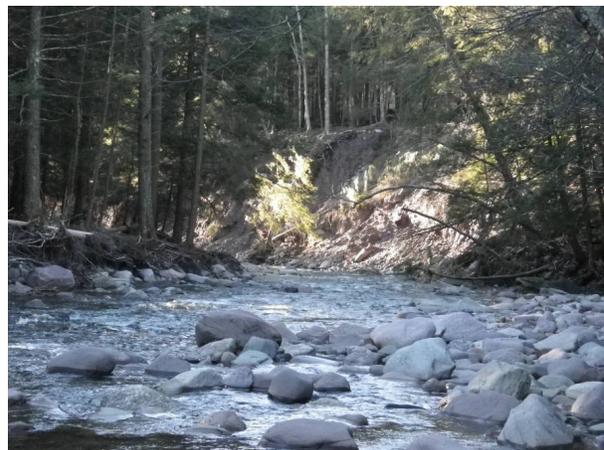
Looking downstream at main channel. (IMG1561)

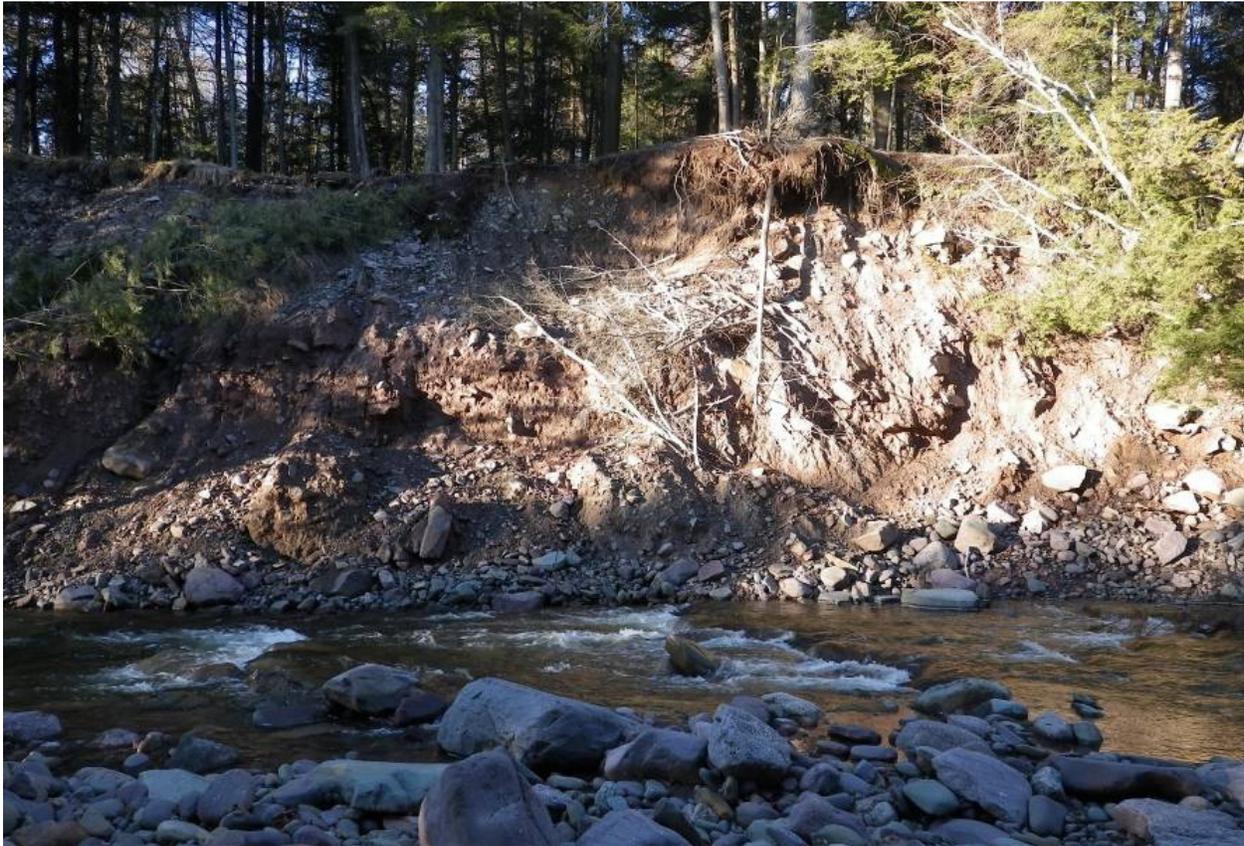
The main channel takes a sharp turn to the left at Station 41420 and continues in a relatively straight alignment for the remainder of EBMU11. A large failure on the right bank begins at Station 41280, continuing downstream over 100-feet downstream until Station 41170 (BEMS NEB11_41100). (See A165, 166 on Pages 6 and 7 for pre-flood condition)

The cause of this mass failure is a combination of processes, including poor drainage on the top of the high terrace, hydraulic erosion at the toe of the bank and rotational slumping near the top. In 2010 large sod mats with trees still rooted in them slid or fell from the top of the 50-foot high bank down to the toe, causing obstructions to stream flow. Since 2010, most of the trees and sod mats have been swept downstream, no longer providing a source of stability or erosion protection to the exposed glacial till in the bank. The large exposure of glacial till in this bank is a potential source of fine sediment and turbidity when entrained under higher flows.

Slope failure on the right bank. (IMG1565)

This failure has become more severe as a result of the additional hydraulic erosion during recent high flow events, suggesting that it will continue to erode and fail during significant flood events. Therefore, *full restoration* is recommended for this site in order to alleviate hydraulic pressure on the bank and improve bank stability. This restoration effort could include installation of a *bankfull* stage bench at the toe of the slope, an increased radius of curvature, and removal of mature trees at the top of the bank that could fall and obstruct flow in the main channel. Furthermore, both in-stream structures like rock vanes and the use of bioengineering techniques to vegetate the exposed slope could help reduce erosive forces on the bank during high flow events.
