Neversink River East Branch

MANAGEMENT UNIT 3

Summary of Post-Flood Recommendations

Stream Channel and Floodplain Current Conditions

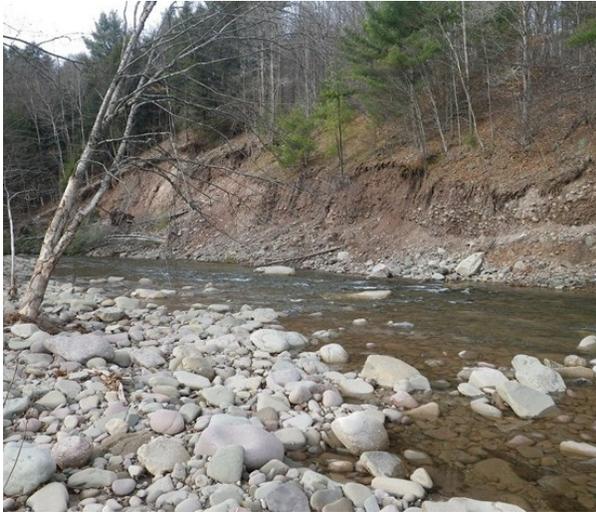
Slope failure on the right bank across from cobble point bar. (IMG1744)

A 440-foot long eroding bank segment with a maximum height of 55 feet from the stream bed was documented extending from Station 9000 to Station 8560 on the right bank across from a cobble point bar. This slope failure was previously documented as three individual eroding bank segments, BEMS ID # NEB3_8800, BEMS ID # NEB3_8700, and BEMS ID# NEB3_8500, which have connected due to hydraulic erosion during flood events since 2010.

Prior to recent flooding, large boulders and sedges had accumulated at the toe of this slope so it was anticipated that this site would remain stable. However, hydraulic erosion due to high near-bank velocities during recent flood events has extended

this eroding bank segment and led to slumping from higher elevations on the slope. Therefore, *assisted restoration* is recommended for this site, including installation of a *bankfull stage* bench at the toe of the slope and use of bioengineering techniques to vegetate the exposed slope and reduce erosive forces on the bank during high flow events.

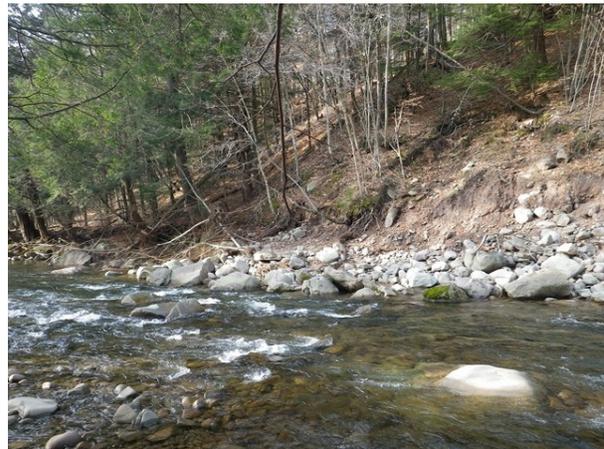
Stabilizing slope failure on the right bank. (IMG1751)

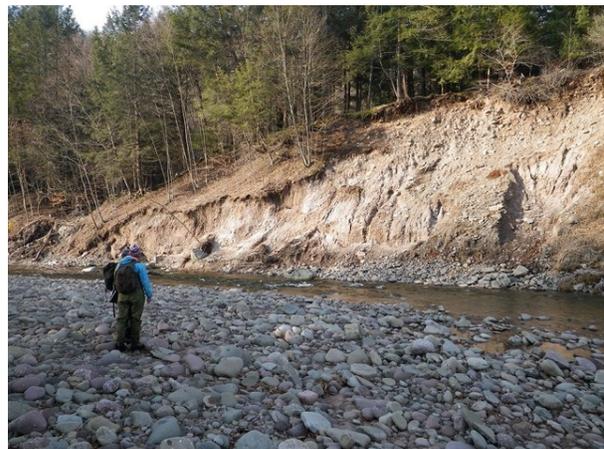
As the channel approaches a hard left turn, there is a relatively severe slope failure that begins at Station 7050 and continues for approximately 260-feet until Station 6790 (BEMS ID # NEB3_6800). The glacial till that makes up this 40-foot high bank is exposed throughout the reach, and represents a source of fine sediment that can be entrained during high flows. The slope failure was most likely initiated by a spring seepage draining through the bank exacerbated by fluvial erosion at the toe of the slope. As the sediment particles become unstable, the bank fails under its own weight and large portions begin to slide down the slope. At the time of the 2010 inventory, several trees had either fallen to the base of the bank or were leaning with their root structures exposed. By the 2011 inventory the trees were gone entirely from the bank. The channel appears to have been overwidened.

Slope failure with exposed glacial till on the right bank. (IMG1756)

Due to the severe angle of this bank, lack of scour protection at the toe and unstable channel dimensions, it is unlikely that this slope will stabilize without treatment. Therefore, *full restoration* is recommended for this site in order to alleviate hydraulic pressure on the bank and establish stability. This restoration effort could include installation of a *bankfull stage* bench at the toe of the slope, an increased radius of curvature, and removal of mature trees at the top of the bank that could fall and obstruct flow in the main channel. In addition, both in-stream structures like rock vanes and use of bioengineering techniques to vegetate the exposed slope could help reduce erosive forces on the bank during high flow events, until the bench develops mature vegetation.

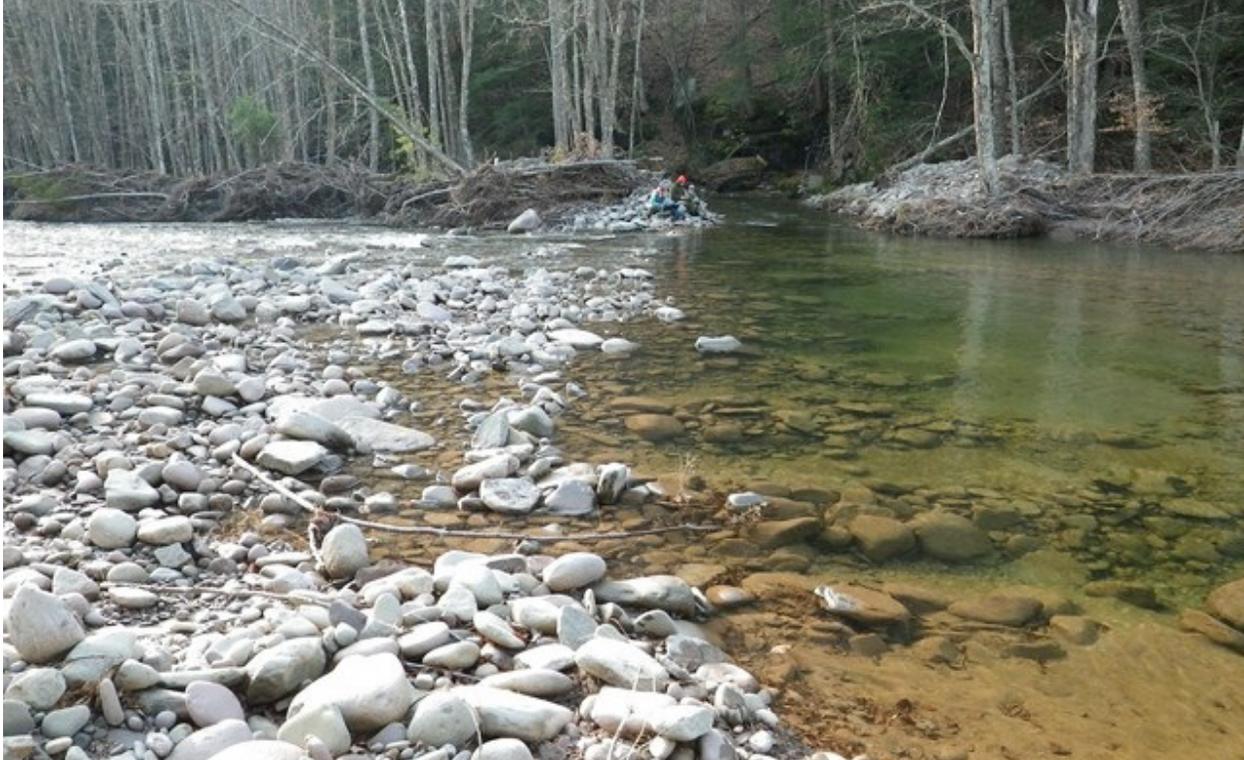
Emergency efforts to realign the channel in this stream reach to protect infrastructure following the recent flood events included construction of a berm across the main channel at this location to divert the majority of the flow into this side channel (Photo IMPG1760).

Berm in the main channel diverting flow into a previously dry side channel. (IMGP1760)

Full restoration is recommended for this stream reach which extends to the convergence of the main channel and side channel near Station 4500 in EBMU2. The restoration should include removal of all berms in this stream reach to restore floodplain connectivity and re-establish an appropriate cross-sectional area for effective sediment transport. The majority of the flow should be returned to the appropriately sized left channel to prevent accumulation of bedload and channel shifting in the future. Flow deflection structures could be considered to prevent erosion of left bank.

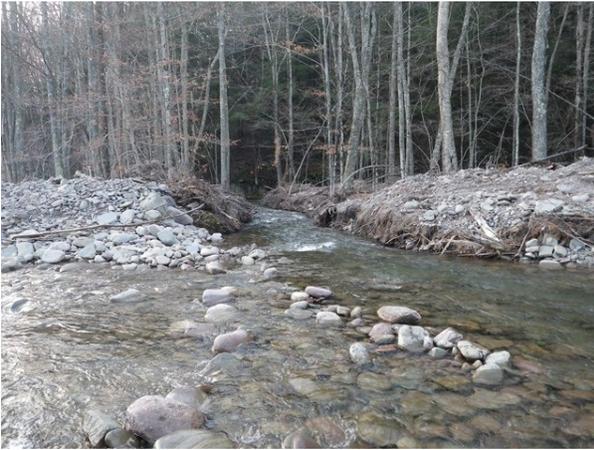
Side channel confined at upstream end by sidecast berms. (IMGP1768)

This is perceived as a less threatening channel alignment; however, the side channel is undersized and cannot convey all of the flow during high flow events. As a result, sediment cannot be passed through the reach effectively, and is accumulates in the reach. This leads to channel shifting toward the left bank. Similar conditions occur just downstream opposite Claryville Post Office (Photo IMPG 1768).

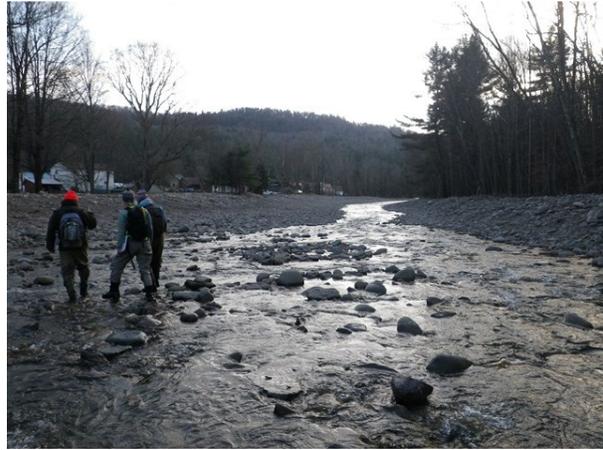
Appropriately sized main channel. Flow is diverted by a berm upstream. (IMGP1769)
