Neversink River East Branch

MANAGEMENT UNIT 9

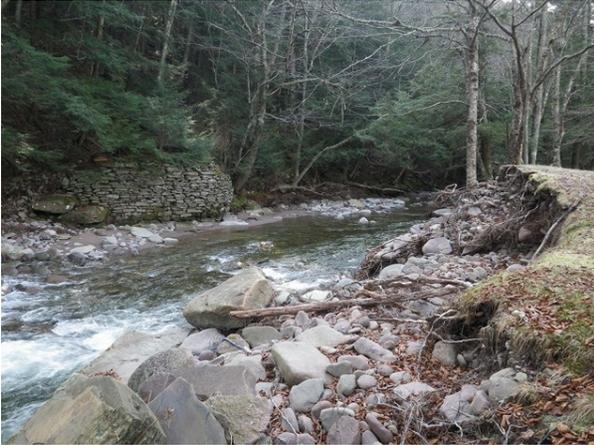
Severe scour at former location of bridge abutment on right bank. (IMG1592)

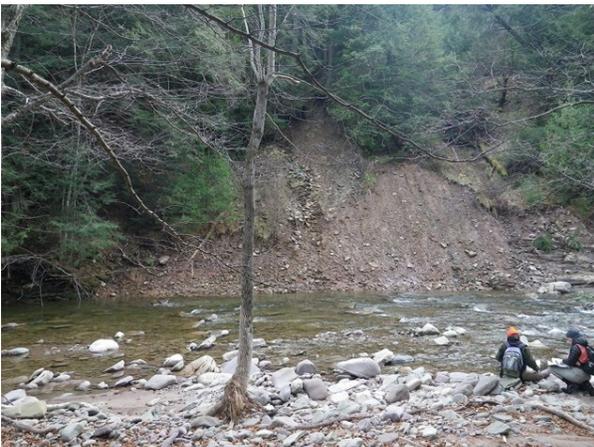
Slope failure on the left bank. (IMG1603)
