# Neversink River Main Branch

## MANAGEMENT UNIT 10

### Summary of Post-Flood Recommendations

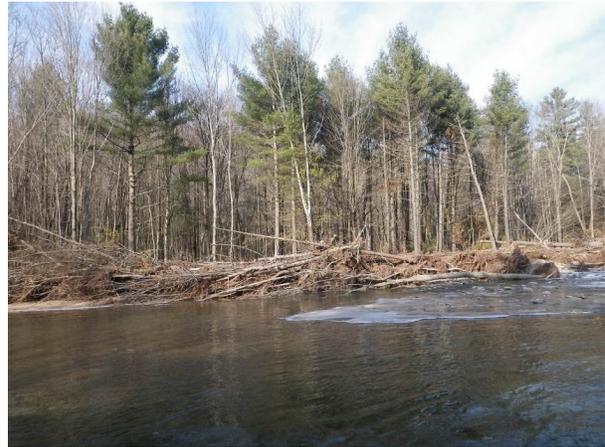
*Large woody debris accumulation on left bank. (IMGP2303)*

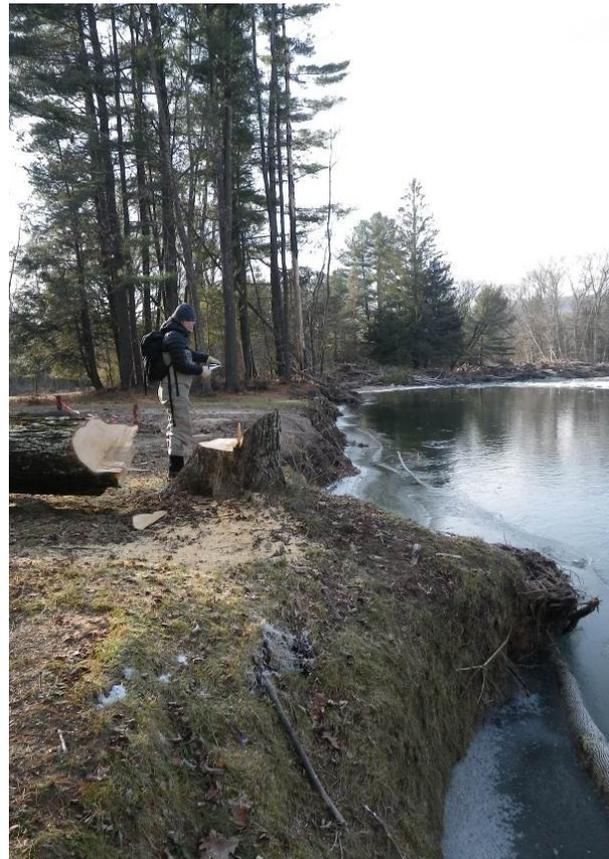
Proceeding downstream, the main channel bends to the right along a long point bar, with 254 ft. of erosion along the left bank, from Station 28280 to Station 28030.

*Erosion on the left bank near Station 28080. (IMGP2304)*

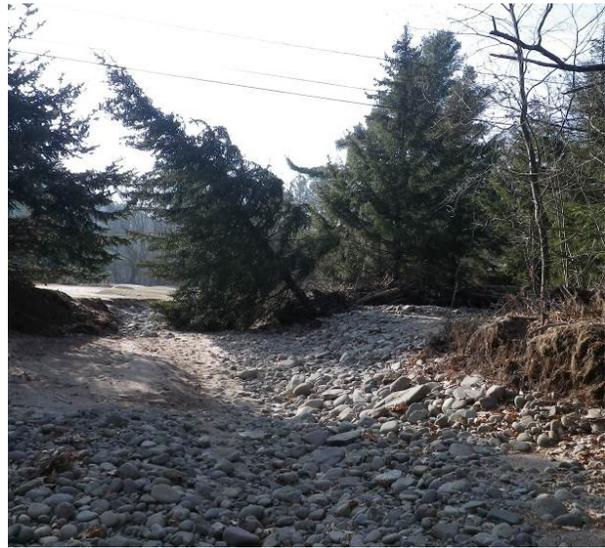
At Station 27700 the right channel thread converges with the main channel, with significant deposition of sand, gravel and cobble. Downstream of the convergence the main channel begins a wide meander to the left. Upstream of this meander, a forested floodplain is formed on the left bank that features several flood chutes including two well-defined side channels that diverge from the main channel near Station 27700. These channels have become more severe during flood events

*Severely scoured flood chute in floodplain downstream of Station 27700. (IMGP2311)*

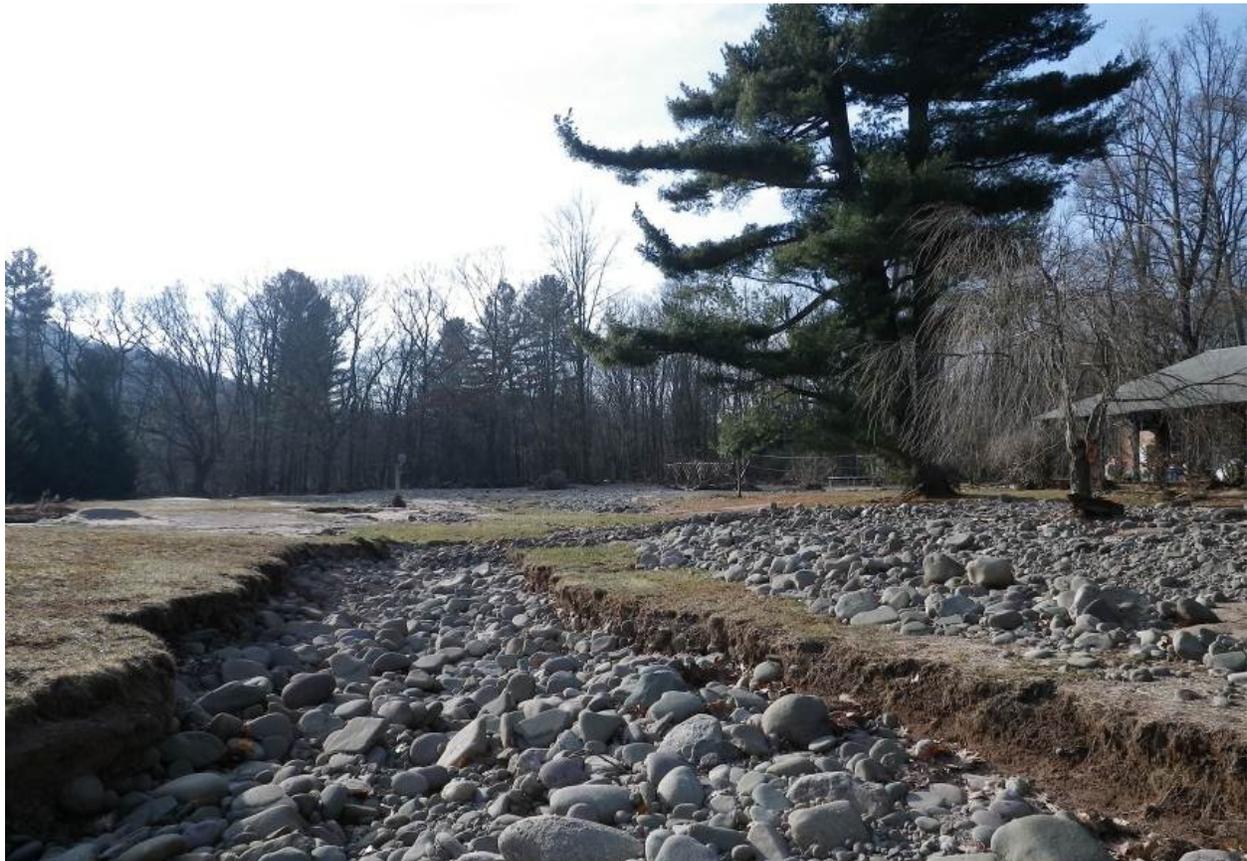
since 2010. In addition, a new flood chute that formed approximately 100 feet upstream of these diversions was the source of locational flooding and destruction of several structures during the flooding associated with Hurricane Irene.

*Flood chute that caused severe damage to structures in the left flood plain near Station 27800. (IMGP2327)*

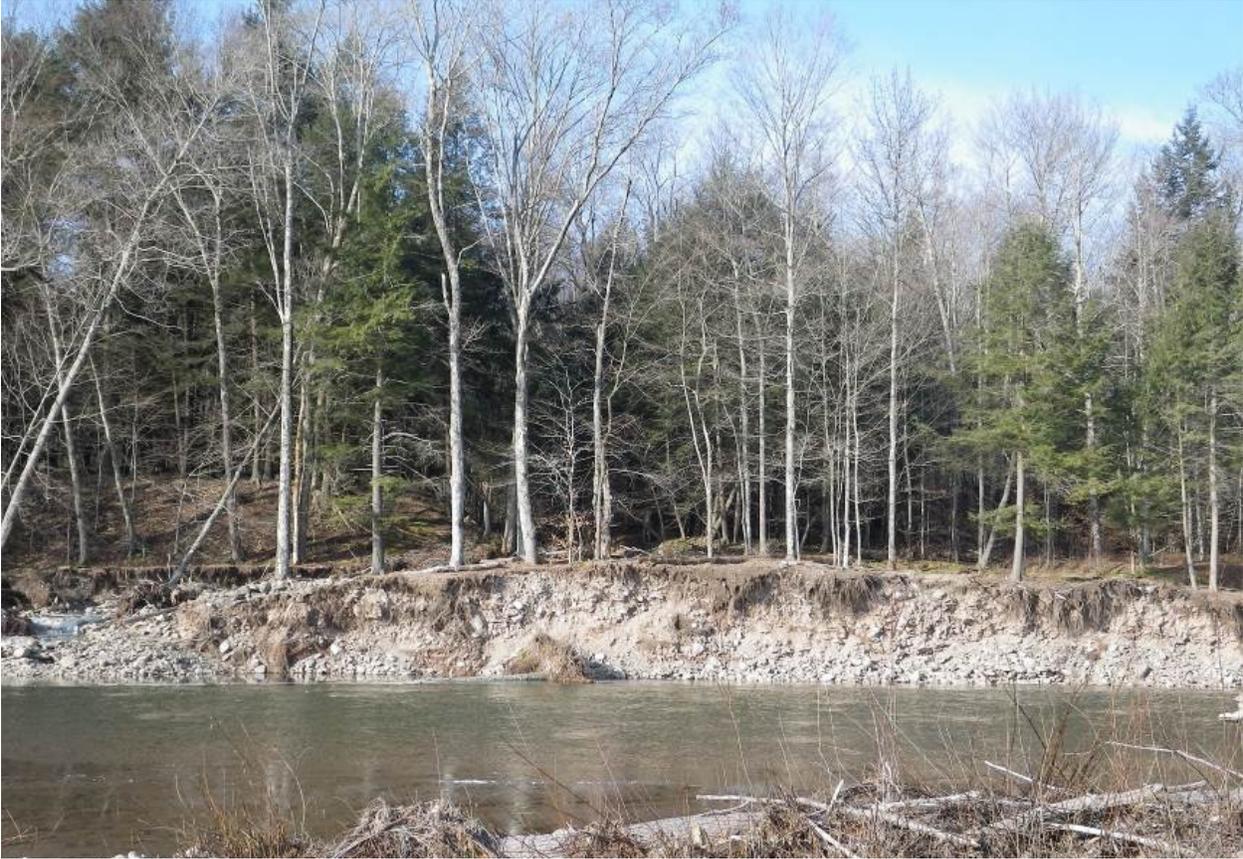
Across from the left bank floodplain, on the outside of the meander bend, 449 feet of the right bank is eroding, exposing alluvial materials from Station 27220 to Station 26680. This bank was identified as a fine sediment source. Sedge that was documented at the toe of the eroding bank in 2010 was no longer present during the survey conducted in December, 2011. MBMU10 ends at Station 26800, where an unnamed tributary enters from the right.

*Eroding bank segment on the right bank near Station 27100. (IMG2329)*

Recommendations for MBMU10 include full restoration of channel dimensions throughout the unit, capable of transporting the sediment supplied from the two branches, and improvement of the riparian buffer on the left bank to improve bank stability. However, as evidenced by the impacts of flooding since 2010, deposition in this reach is the result of sediment dynamics associated with the confluence at the upstream end and the divergence at the downstream end. Therefore as part of the restoration design, it is recommended that this entire MU be included in a comprehensive Local Flood Hazard Mitigation Analysis to investigate hydraulics and sediment transport in the stream corridor, from Station 10500 through the Halls Mills covered bridge downstream. The purpose of the analysis would be to develop a comprehensive solution for reducing flooding threats to this relatively dense population center of the Neversink Valley.
