# Neversink River Main Branch

## MANAGEMENT UNIT 8

### Summary of Post-Flood Recommendations

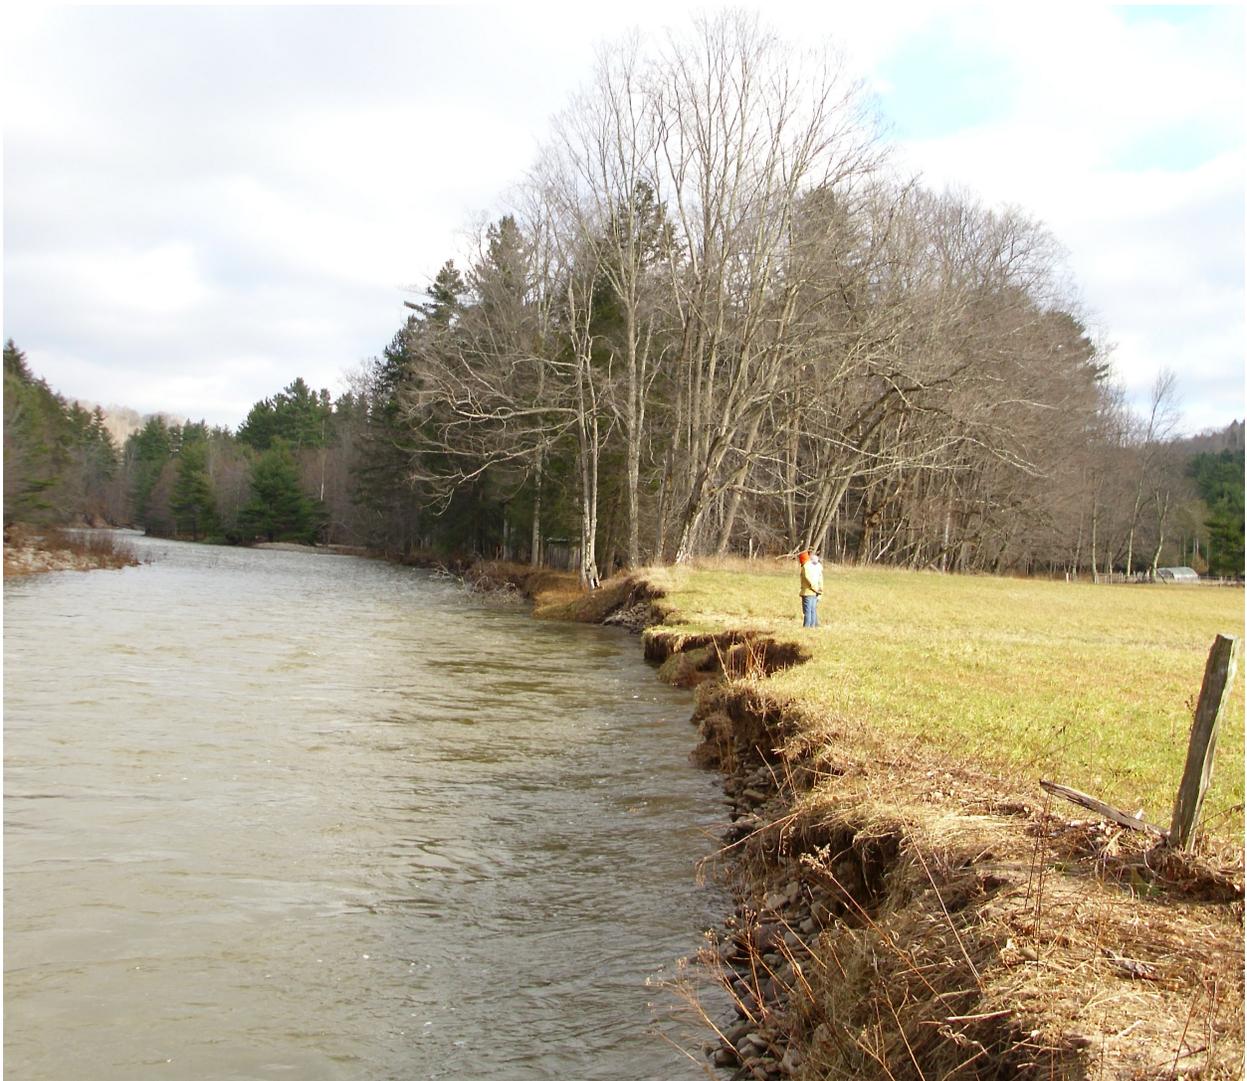
The main channel then meanders slightly left, pulling away from the valley wall at Station 21100 around a depositional bar that is well connected to a vegetated floodplain. The main channel then begins a meander to the right around the depositional bar, against a floodplain terrace. At Station 20600 there is a 180-foot long bank erosion segment of this terrace along a mowed field with no riparian buffer, and the bank at this location has retreated. An analysis of historic channel alignments indicates that the channel has migrated into the field more rapidly in recent years, and it appears that the flood events since 2010 have contributed to this trajectory, worsening the eroding bank segment. Unconsolidated alluvial sediments exposed by fluvial erosion were observed at this location. These unconsolidated sediments are highly susceptible to erosion, highlighting the importance of a healthy riparian buffer in these conditions. A riparian buffer including woody vegetation can strengthen the stream bank and slow erosive forces of higher flows during flood events.

*Streambank with no vegetated buffer protection. (DSCI0318)*

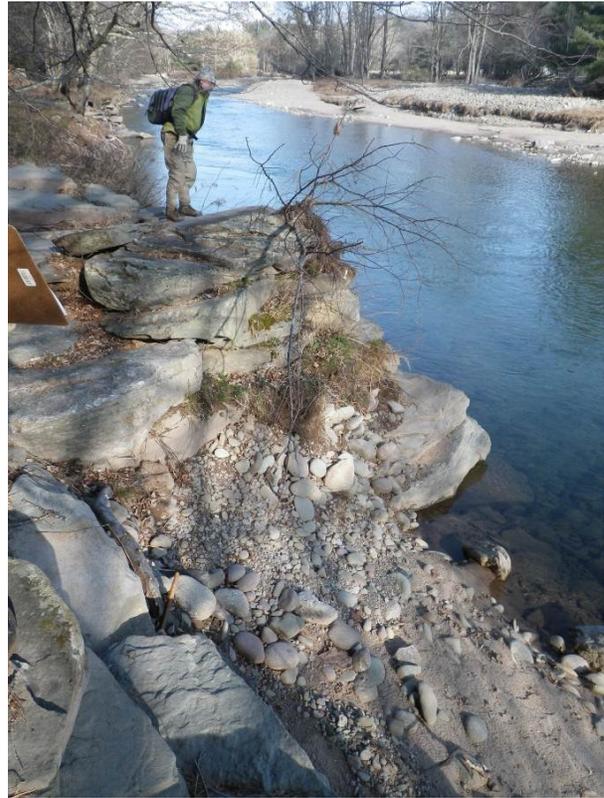
From Station 19800 to Station 19600 there is a placed stacked rock wall revetment protecting the right bank and a lean-to slightly up-slope. This revetment was documented as in fair structure and functional condition, with some indication of damage caused by recent flows. Behind the rock wall, a divergent flood chute through the right floodplain conveys significant flows during overbank flooding.

*Revetment at Station 19800. (IMG0895)*

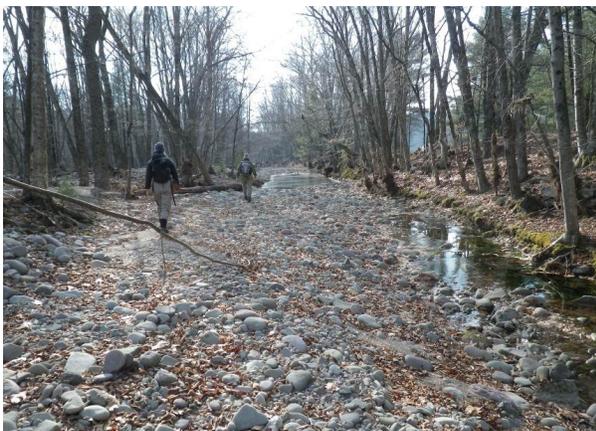
This flood chute has significant consequences related to flood hazard management downstream in MBMU7 and MBMU6. Also at this point a large woody debris accumulation signals the beginning of a center bar depositional formation which splits the stream flow and forces significant flow to the right. The debris accumulation, as well as the aggradation and bar formation associated with the overwidened channel upstream and downstream of the Hunter Road bridge, have increased during flood events since 2010 following predicted trajectories observed during the 2010 survey. The recommendation for *full restoration* of this section of the Neversink River remains unchanged. This would include appropriate treatments for the mowed field at Station 20600, including bioengineered bank stabilization and riparian revegetation. As part of the restoration design, it is recommended that this entire MU be included in a comprehensive Local Flood Hazard Mitigation Analysis

*Flood chute in right floodplain. Facing downstream towards Hunter Road. (IMG0897)*

to investigate hydraulics and sediment transport in the stream corridor, from Station 10500 through the Halls Mills covered bridge downstream. The purpose of the analysis would be to develop a comprehensive solution for reducing flooding threats to this relatively dense population center of the Neversink Valley.
