Neversink River Main Branch

MANAGEMENT UNIT 9

MAIN BRANCH MANAGEMENT UNIT 9
BETWEEN STATION 22090 AND STATION 26790

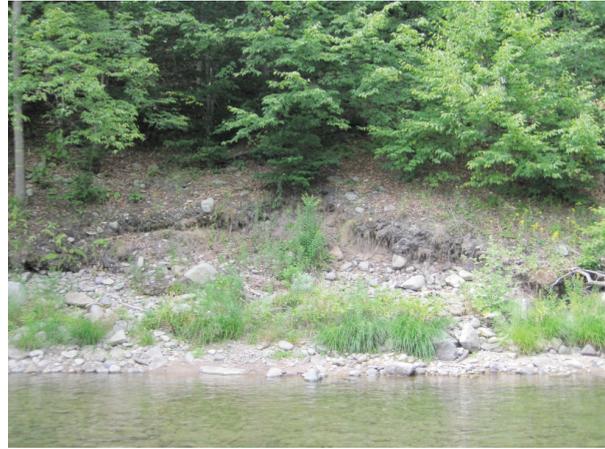
This management unit begins at Station 26790 as the channel bends to the left crossing the valley floor until it is deflected back down valley by the embankment of Claryville Road. The erosion of the left bank continues from MBMU10 for 127 feet. This bank was identified as a fine sediment source. Sedge has established at the toe of the eroding bank indicating that the bank is beginning to stabilize. However, this

is not preventing entrainment of fine sediments higher on the bank slope. (A81) It is anticipated that this bank will revegetate and stabilize without treatment (passive restoration). However, it is recommended that this site be monitored for changes in condition.

Fine sediment source on left bank (A81)

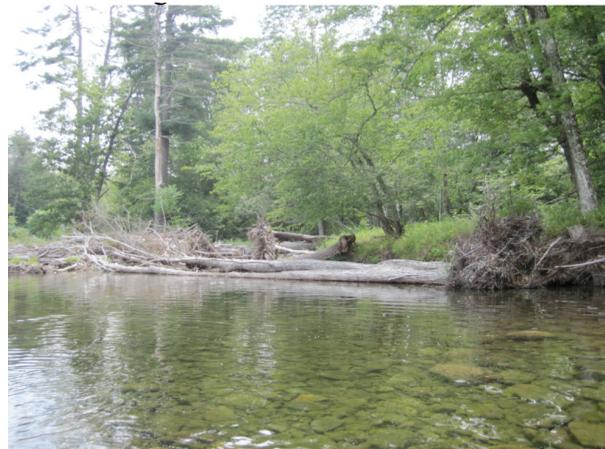
On the outside of the meander bend there is a significant accumulation of woody debris which directs significant flow into a flood chute through the forested floodplain on the right bank, rejoining the mainstem at Station 24500. The floodplain is frequently inundated resulting in extensive large woody debris deposits as well as numerous braided flood chutes throughout.

Woody debris directing flow into flood chute on right bank (A89)

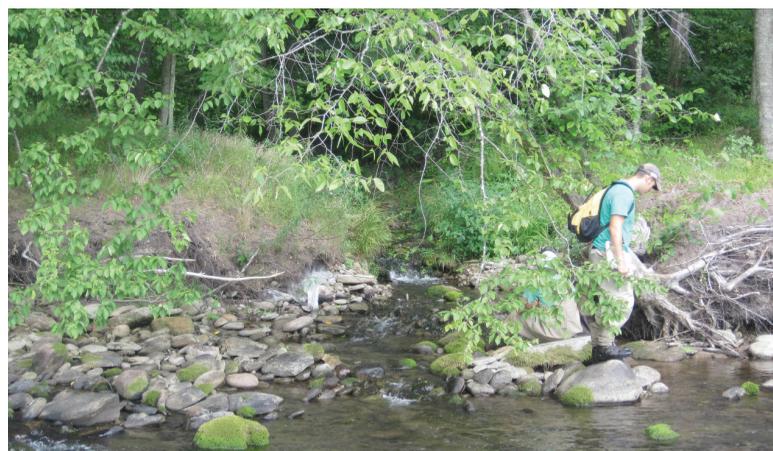
Tributary converging with mainstem on left bank (B429)

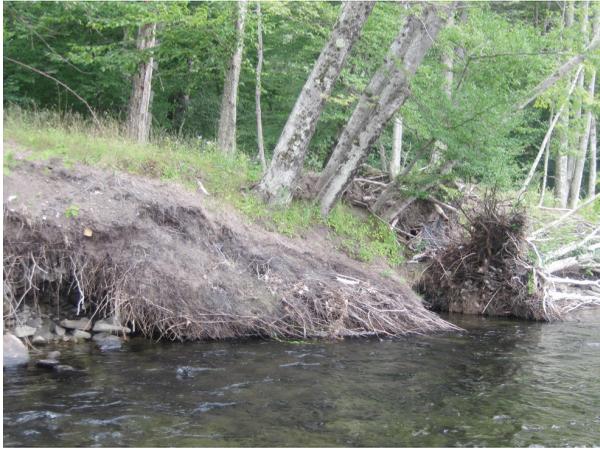
Scour on left bank (B426)

Recommendations for this site minimally include *assisted restoration* using bioengineering techniques to stabilize the eroding bank. The willow growing on the cobble bar forming the inside of this meander could provide a source of materials for the restoration effort. This site should be assessed for possible full restoration including channel realignment to increase the radius of curvature of the meander at this location and reduce toe scour at the bank.

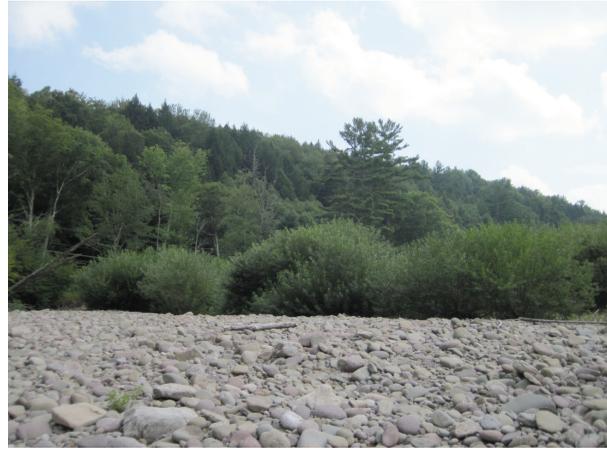
On the inside of the meander bend as the mainstem meanders to the right and meets the Claryville Road embankment, the flood channels from the forested floodplain on the left bank in MBMU10 rejoin the main channel at Station 25800. The main channel is eroding the left bank between Station 25800 and Station 25525. A small unnamed tributary conveying flow parallel to Claryville Road converges with the mainstem from the left at Station 25650. (B429) This minor bank erosion has exposed alluvial materials including silt, sand and cobble. The tight meander curvature is resulting in severe toe scour, undercutting the root structure of a single line of mature trees along the road embankment. Since the bank is unlikely to stabilize without treatment under these conditions, any nearby infrastructure is threatened, including Claryville Road. (B426) The cobble bar forming the inside of this meander is heavily vegetated with willows and sedges, beaver activity was observed. (A93)

Heavily vegetated cobble bar (A93)

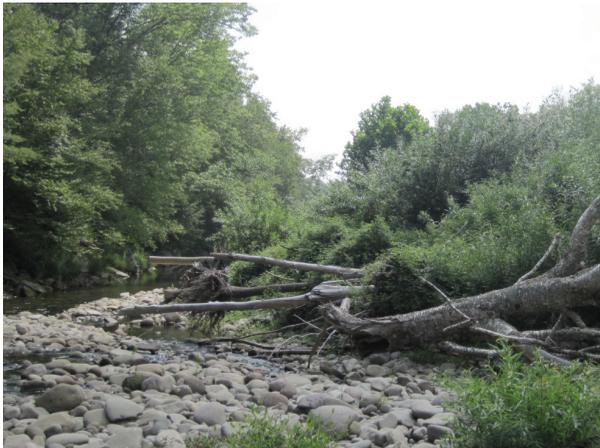
Looking downstream, vegetated center bar (B433)

For the next 2,000 feet the mainstem flows adjacent to Claryville Road between Station 25600 and Station 23600. The Claryville Road embankment is protected by only a narrow riparian buffer. At station 24650 an 18" diameter corrugated metal culvert conveys road drainage from the left valley wall under Claryville Road as a piped outfall with no outfall protection or head wall. There are several significant large woody debris deposits throughout this relatively straight reach contributing to the development of a center bar from Station 24980 to Station 24400 that is vegetated with willow and sedge. (B433) At Station 24500 the flood chute that diverged

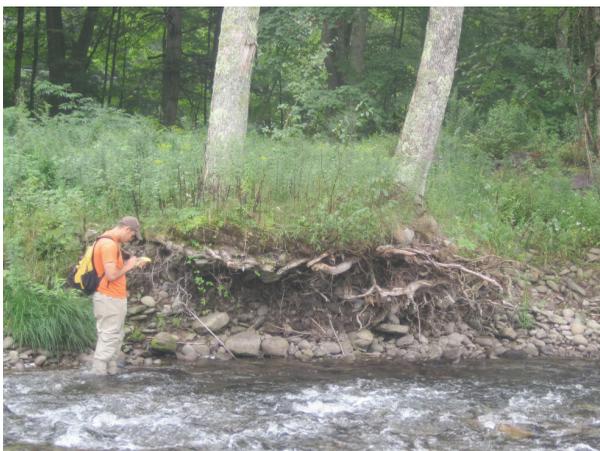
Erosion on left bank (B440)

As the channel begins a bend to the right to cross the valley floor, signs of instability were observed on the left bank, including several revetments, berms and undercut banks. Passive restoration is recommended for these bank segments. (B440) An unpaved access road runs adjacent to the main channel on the left side of the meander bend. The road bed is at an elevation that effectively blocks flow from the main channel from a former side channel and the associated floodplain downstream. This road berm likely reduces the threat of inundation of the field downstream during flood events. Observations included a small stacked rock wall and berm between Station 23800 and 23700, and 251 feet of placed rip-rap revetment between Station 23530 and Station 23290. (B433, B439) The point bar in the inside of this meander bend is vegetated with willow that could be used in bioengineering efforts. (A108) At Station 23100 the channel takes many routes throughout the valley floor. One branch forms a flood chute through the left forested floodplain; the mainstem divides around a center bar, with a second branch of the flood chute described above rejoining the mainstem at Station 22840. Several large woody debris deposits are scattered both along the left bank at the downstream extent of this meander bend and throughout the floodplain on the left bank. Beginning at Station 22550 the channel begins to meander to the left, restricted by the glacial

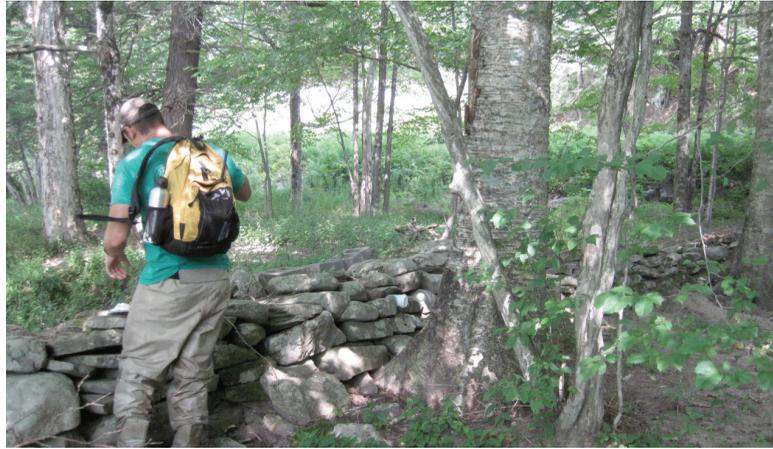
Small stack rock wall and berm in left flood plain (B439)

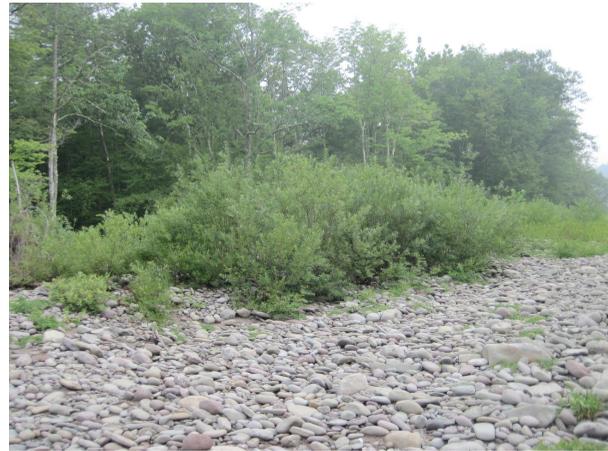
Willow on point bar (A108)

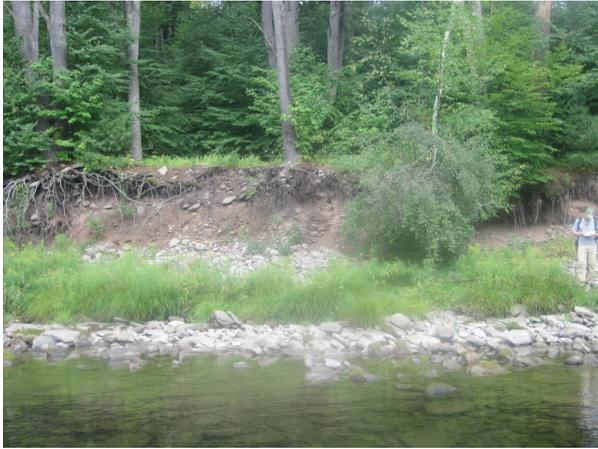
Moderate erosion on right bank (A121)

till terrace at the right valley wall, where moderate erosion was observed for approximately 460 feet to Station 22100, 50 feet upstream of the end of MBMU9. (A121) The downstream 350 feet of this bank is beginning to stabilize through deposition of cobbles and revegetation with grass and sedge at the toe. Three small unnamed tributaries enter from the right in this reach. An accumulation of woody debris was observed at Station 22200. (A125) MBMU9 ends at Station 22090.

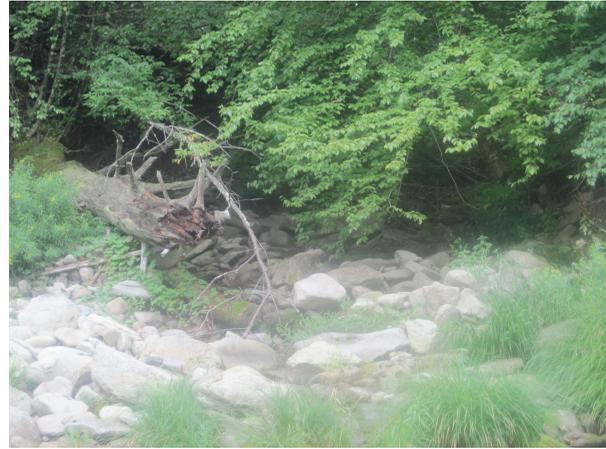
Woody debris at unnamed tributary on right bank (A125)
