# Neversink River West Branch

## MANAGEMENT UNIT 9

WEST BRANCH MANAGEMENT UNIT 9  
BETWEEN STATION 32100 AND STATION 34300

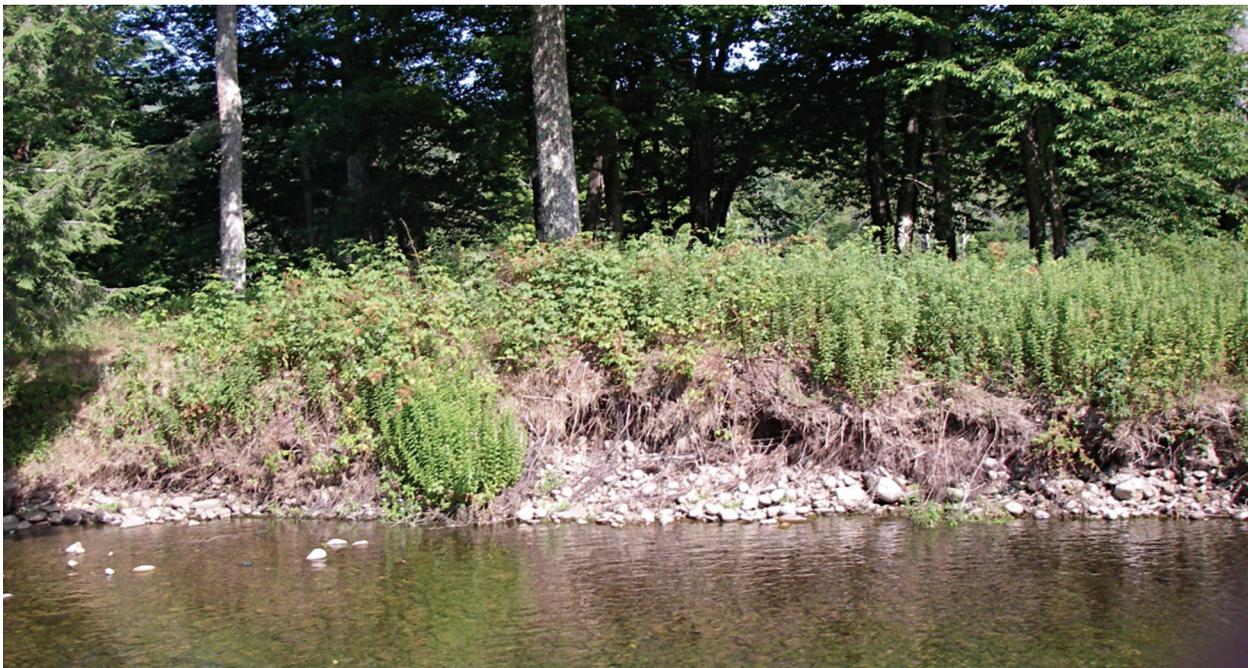
An eroding bank segment was observed extending 300 feet from Station 34275 to Station 33975 (BEMS NWB9\_33975). This site was documented as active; hydraulic erosion during high flow events has led to exposure of alluvial materials in the bank, although some vegetation was observed on the bank in conjunction with hardening at the toe. (*IMPG0276*) It is likely that this bank will revegetate and stabilize without treatment (*passive restoration*). However, it is recommended that this site be monitored for changes in condition.

*Active hydraulic erosion of bank (IMPG0276)*

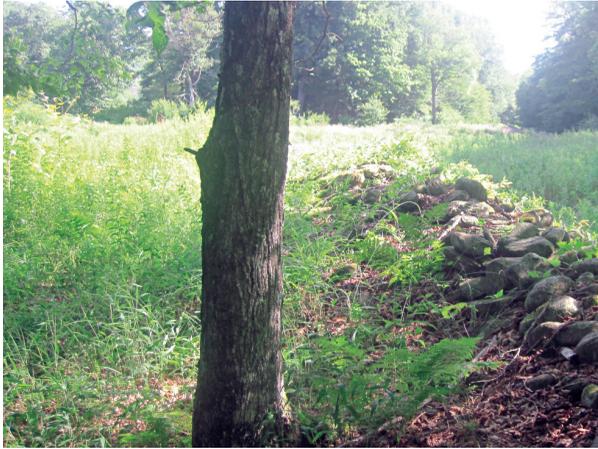
*Stacked stone berm on left bed (A7)*

A depositional feature was observed on the left bed in this location composed of cobble with some grass and sedge vegetation. On the left bank behind this cobble bar a 4-foot high and 4-foot wide stacked stone berm was observed extending 85 feet between Station 34300 and Station 34215. It appeared that the berm was constructed to block a currently dry side channel that flows adjacent to the left valley wall as the main channel curves slightly right towards Frost Valley Road. This channel converges with the main channel at the end of the meander near Station 33500. The 1980 stream center line shows this dry side channel as conveying the majority of the flow historically. (A7)

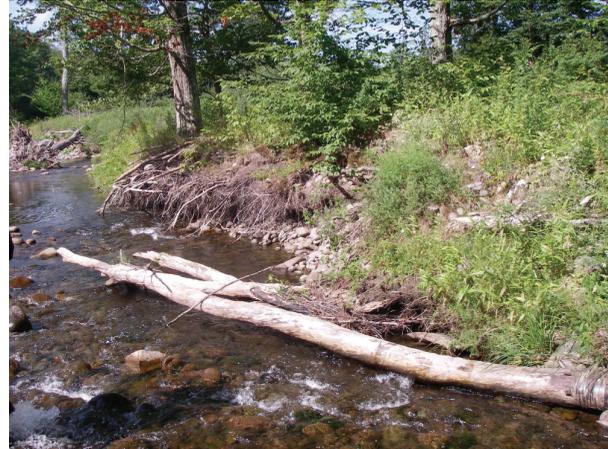
*Fallen trees along right bank (IMPG0277)*

Downstream of the eroding bank segment on the right bank there is a series of three fallen trees from the right bank across the channel near Station 33800. (IMPG0277) Near Station 33700 a perennial stream conveying flow from a cleared field on the right bank joins a short side channel formed around a large wood obstruction. (IMGP0281).

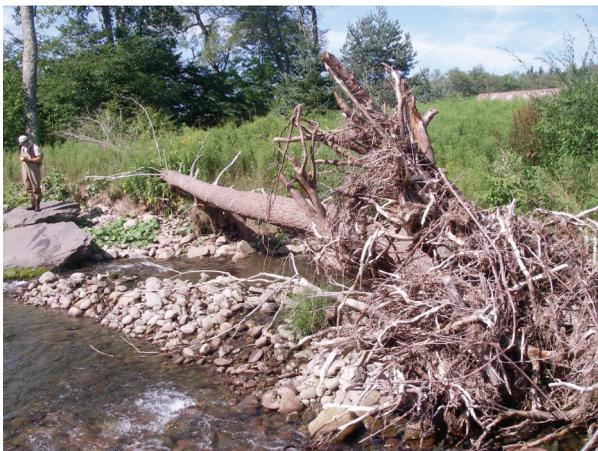
*Perennial stream conveying flow around large obstruction (IMPG0281)*

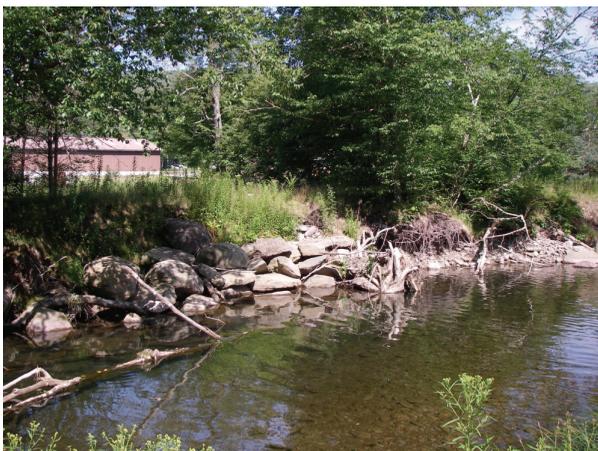
*Stacked rock revetment (IMPG0286)*

A stacked rock revetment with scour and erosion at the toe was observed for 100 feet on the right bank from Station 33700 to Station 33600. The

revetment was documented in fair structural and functional condition. The erosion into the toe of the failed erosion was documented as active caused by hydraulic erosion (BEMS NWB9\_33600). Review of the aerial imagery available for this bank reveals several garages and equipment staging areas on the right bank behind this bank failure site; the revetment was most likely designed to stabilize the bank and protect this property. (IMGPO286)

Recommendations for this site include investigation of past management activities and potentially *full restoration*. This project would require geomorphic and sediment transport analyses of the reach to identify appropriate restoration design and would likely include placement of *flow deflection structures* to reduce erosive forces on the banks as well as *assisted restoration* using *bioengineering* techniques to establish a riparian buffer and stabilize the eroding bank as well as redirection of the main channel in this reach.

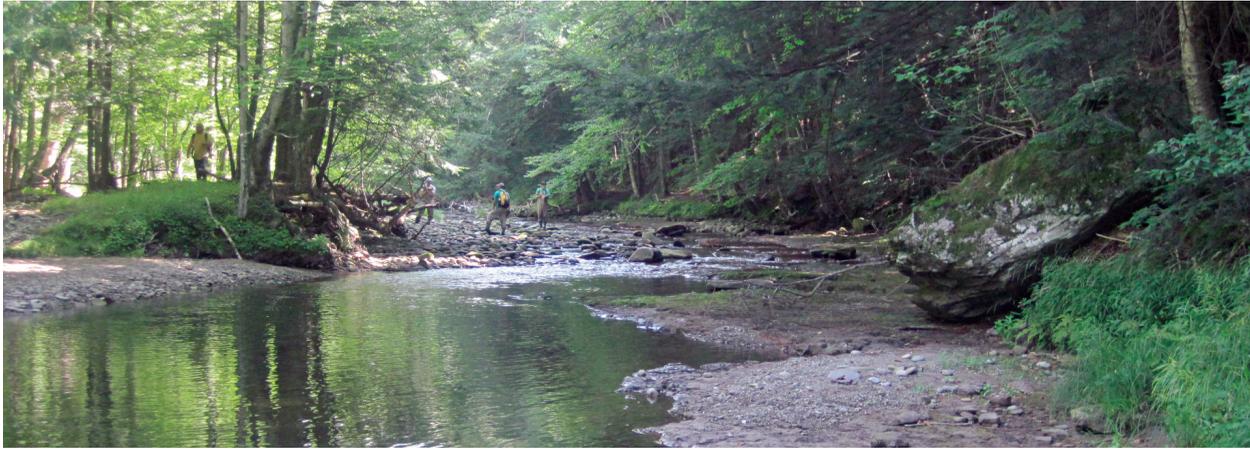
*Shale bedrock providing grade control on left bed (A16)*

Downstream of the failed revetment the main channel flows adjacent to exposed shale bedrock providing grade control on the left bed at the apex of a wide meander bend against the left valley wall. (A16). Across from the apex of the meander bend near Station 33100 cut branches were observed forming a woody debris jam on the right bank. (IMPG0295) It appeared that these branches were placed to provide bank stabilization in this location, but the structure was documented in poor structural and functional condition. It is recommended that the purpose and design of this structure be further investigated with consideration of replacement of this structure with a more effective stabilization technique if necessary.

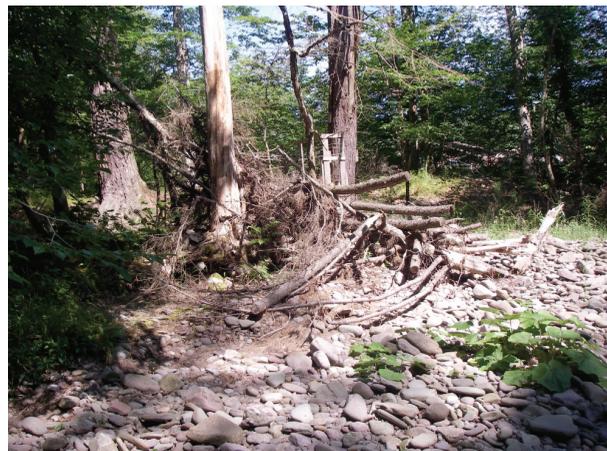
*Woody debris jam forming on right bank (IMPG0295)*

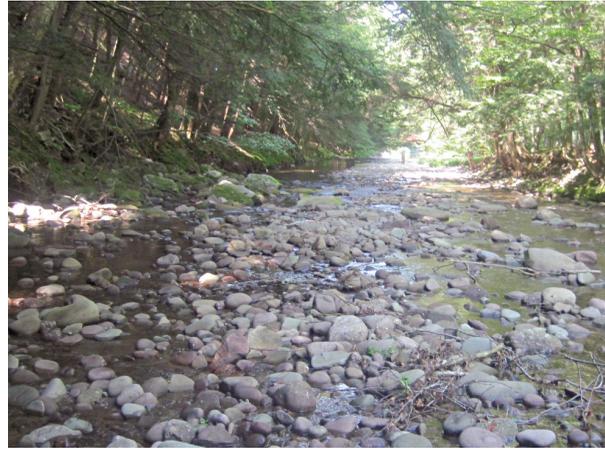
The shale bedrock grade control ended near Station 32900. A series of two transverse bars, natural longitudinal grade adjustment structures in the cobble bed, were observed at Station 3288 and Station 32550. (A18, A20)

*Transverse bar (A18)*

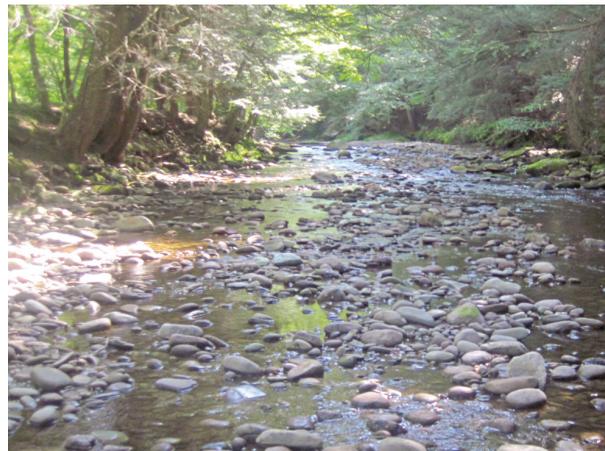
*Transverse bar (A20)*

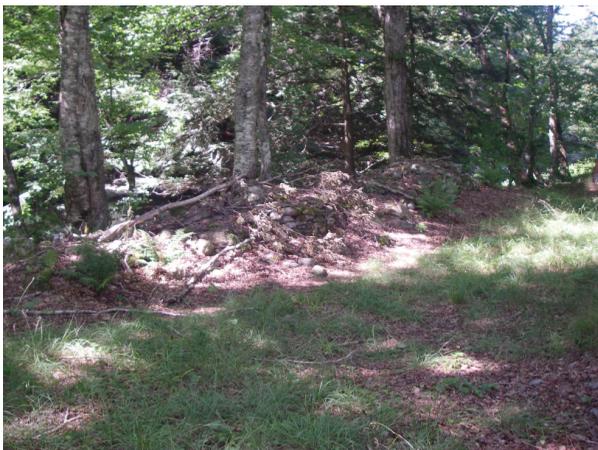
A stacked stone berm was observed extending 50 feet perpendicular to the main channel at Station 32450. The berm was approximately 4 feet high and 4 feet wide, and appeared to be protecting a recreational trail maintained by Frost Valley YMCA. (IMG0300) Across from the berm an intermittent tributary conveying concentrated runoff joins the main channel. Based on the observed flow contribution it is possible that this tributary drains a surface water storage area up slope, which is further evidenced by a terrace visible in the topography of the otherwise steep left bank in this location. (A22)

*Stacked stone berm perpendicular to stream (IMG0300)*

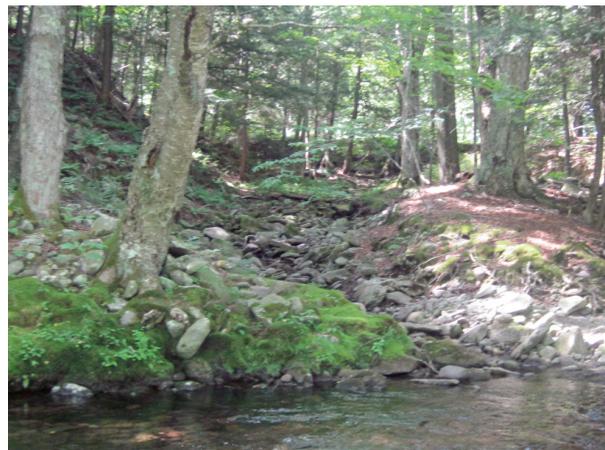
*Intermittent tributary conveying concentrated runoff (A22)*

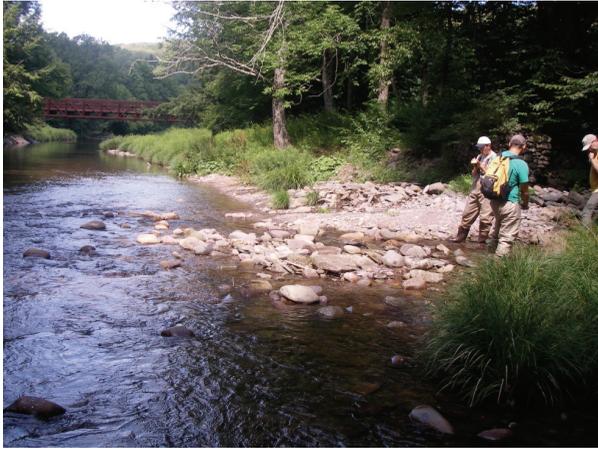
Slightly downstream, near Station 32300 the High Falls Brook tributary joins the main channel from the right bank conveying drainage from the north side of High Falls Ridge. Old mortar abutments were observed on both bank of High Falls Brook at the convergence. It is possible that these mortar abutments

*High Falls Brook confluence (IMPG0302)*

are remnants from the sawmill formerly located on High Falls Brook upstream of the confluence. (IMGP0302) A headcut was observed in the main channel slightly upstream of the private bridge.

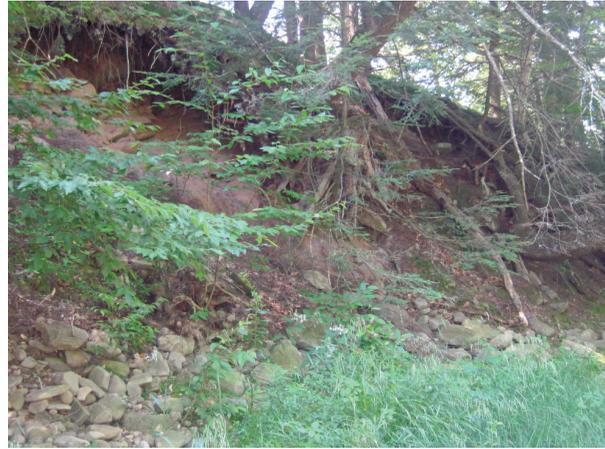
*Eroding left bank (A23)*

An eroding bank segment was observed on the left bank across from the High Falls Brook confluence, extending 75 feet from Station 32275 to Station 32200 (BEMS NWB9\_32200). Vegetation and hardening was observed at the toe of the erosion site while active undercutting was observed at the crown of the bank failure 20 feet above the bankfull height on the left bank. (A23) It is possible that this erosion is caused by piped flow from land uses up slope on the left bank. Recommendations for this site include further investigation of surface runoff to best characterize the bank failure and identify possible restoration efforts.
