Management Unit 3
Greene County - Town of Hunter
Cross Section 34 to Cross Section 65

Management Unit Description

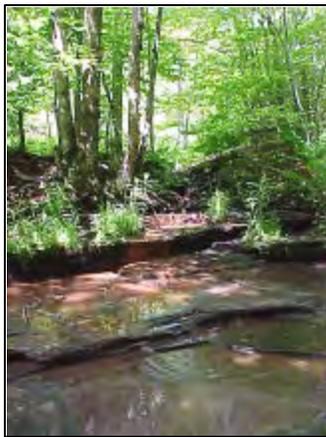
Figure 5 Tributary

(Fig. 5). As seen in the photo, this tributary releases *turbid* water into Stony Clove Creek. As

this turbid water enters the creek, it is quickly diluted. The source of this turbidity should be investigated. The tributary is not classified under the NYS DEC best usage classification system. At the end of the reach the bedrock channel narrows into a “*sluiceway*” and the flow velocity increases until the stream drops into a large pool.

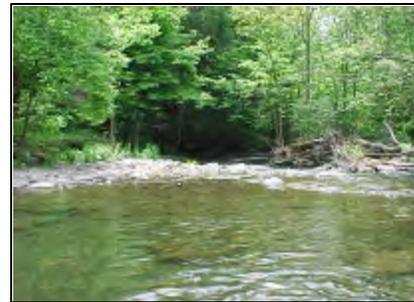
**Figure 6 Cross-section 37 Stream
Type B3c**

(Fig.6). The reach is moderately entrenched with gentle 1.9% slope. On the left stream bank is a bedrock ledge and on the right bank, an area along NYS Route 214, formerly a gravel pullout, has recently been vegetated with shrubs. This vegetated area will help to buffer the stream from the effects of stormwater runoff from the roadway.

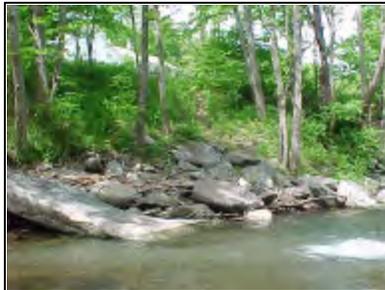
Figure 9 Rip-Rap

At the end of this reach the stream flows over a waterfall, known locally as Edgewood Falls (Inset H). This 154 ft. reach of A1a stream type is a bedrock waterfall which drops into a deep pool. As the stream runs out of the pool it meanders closer to NYS Route 214. At the end of this reach, 42 ft. of rip-rap, composed of large stream rocks, have been placed on the right bank (Fig.9).

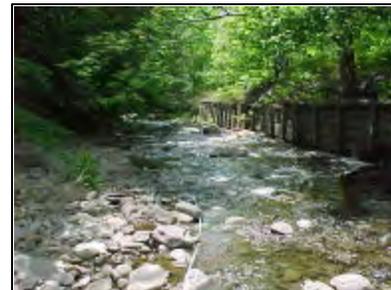
**Figure 10 Cross-section 40
Stream Type B3**

The next 79 ft. reach of B3 stream type is moderately entrenched and the dominant channel bed material size decreases to cobble (Fig. 10). The stream flows against a high steep right T-wall bank, approximately 200 ft. in length, at the top of which is NYS Route 214 (Inset D). Constructed by the NYS DOT, this wall secures the road embankment toe at a severe constriction point in the stream corridor.

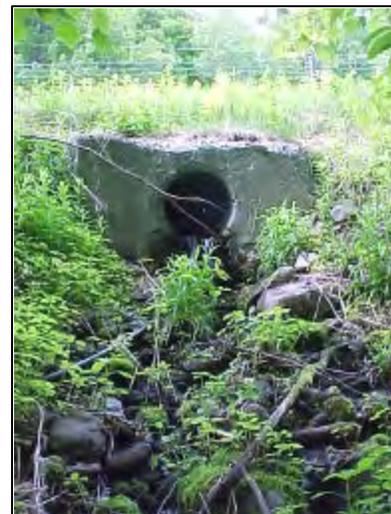
Figure 12 Culvert outfall

A stormwater culvert with a concrete headwall outfalls from the right stream bank, dropping stormwater onto a fairly steep slope before entering the stream (Fig. 12). This is normally a cause for concern because it may result in bank erosion but this drainage way has large cobble bed material providing some protection from

erosion. Immediately downstream from this culvert a small unnamed tributary enters the creek from the right bank. This tributary is not classified under the NYS DEC best usage classification system.

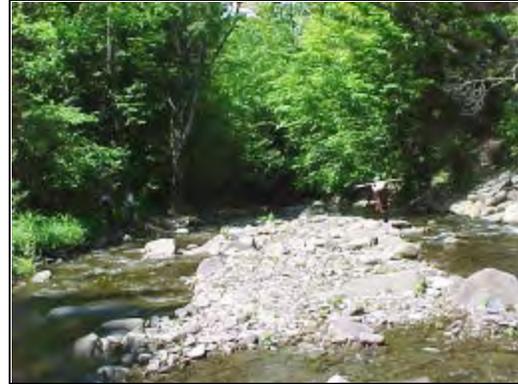
**Figure 16 Cross-section 47
Stream Type B3c**

Approximately midway through this rip-rap section, the stream becomes moderately entrenched and slope flattens to 0.3%. The stream type changes to B3c for this 106 ft. stream reach (Fig. 16). Figure 16 illustrates how this flattening of the slope can result in the deposition of sediment and the raising of the stream bed, a process known as

aggradation. When a stream begins to aggrade, it becomes wider and shallower, causing the stream to become divided into multiple threads with *central bars*. Central bars direct streamflows against both right and left outside banks, frequently resulting in erosion, and potentially exacerbating further the overwide condition.

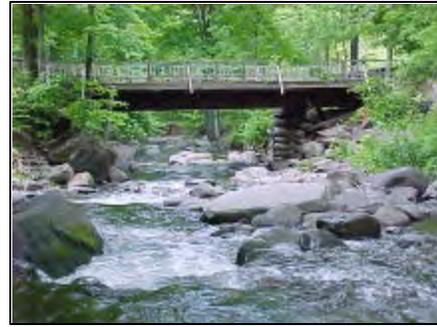
**Figure 19 Cross-section 51
Stream Type F3b**

The stream becomes entrenched as it approaches a private bridge, and the slope decreases to 3.6% (Inset B). The stream type changes to F3b for the next 131 ft. (Fig. 19).

This private bridge has a plank deck with log abutment. This bridge sustained damage during the 1996 flood event. A DEC permit was issued to repair the bridge and install rip-rap adjacent to the abutments. Bridges are likely erosion sites during high flow events, when *backwater* elevates the water surface upstream of the bridge, increasing slope, depth and shear stress through the bridge opening. Abutments are prone to scour as a result.

Downstream of bridges, turbulence called *backeddy scour* can further undermine abutments and adjoining bank revetment.

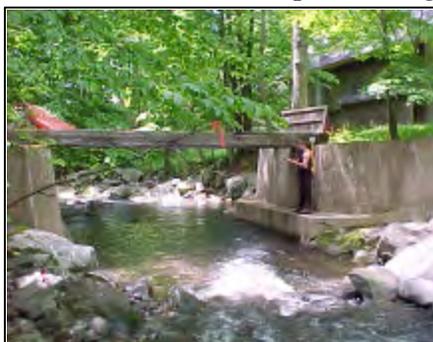
Figure 22 Abandoned Bridge

Continuing downstream, the stream begins to meander to the left. The stream must pass through another bridge abutment (Fig. 22). The permit

history indicates repairs at this site following most major floods, in order to address abutment scour. This bridge, which does not have a deck, is currently abandoned. However, the concrete abutments continue to impact stream morphology. Options for removal should be evaluated.

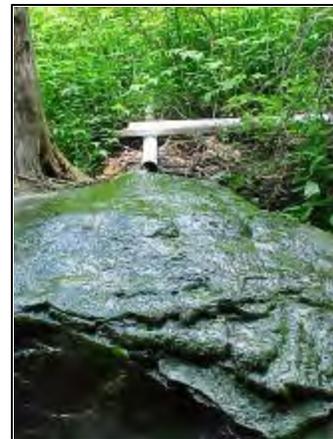
Figure 21 Piped tributary

Approximately 180 ft. downstream, another ephemeral tributary has been piped, and enters the creek from the right bank through a PVC pipe (Fig. 21).

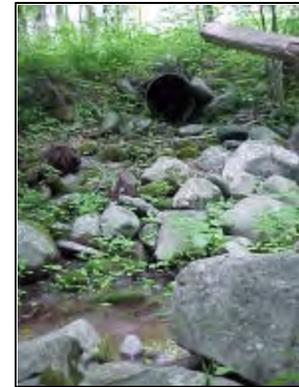
Figure 23 Culvert

A corrugated stormwater culvert enters from the right on the outside of the meander bend (Fig. 23). This culvert outlet is lined with large cobbles, is set back from the active stream channel, and enters the stream at a low angle. All these conditions reduce the risk of erosion from stormwater runoff.

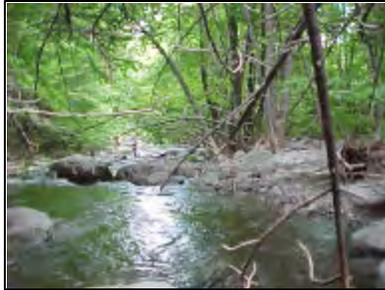
**Figure 24 Cross-section 57
Stream Type C3b**

The slope of this reach increases slightly to 3.6%. Bank erosion monitoring site #6 is located on the left outside meander bend of this reach (Inset E). This eroding bank measures 64 ft. in length. Although the face of the bank is bare soil, the top of the bank is well vegetated with trees and shrubs. A small unnamed tributary runs down the face of this bare bank, possibly contributing to the erosion (Fig. 25). Ongoing monitoring of this site should include an evaluation of the upland drainage issue.

The BEHI score of site #6 is ranked “High”, the third highest prioritization category in terms of its vulnerability to erosion. However, this bank erosion site is considered a low priority for restoration due to its small eroding area (687 ft²) and its lack of significant threat to infrastructure or water quality. According to Rubin’s 1996 stream corridor geology map, the stream throughout most of this reach is cut through unconsolidated deposits.

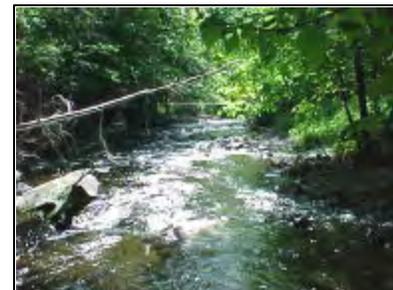
**Figure 27 Cross-section 60
Stream Type B3c**

As the stream slope decreases to 1.2%, the stream type changes to B3c for the next 127 ft. (Fig. 27). Bank erosion monitoring site #7, which is approximately 165 ft. in length, is located along the left outside bank (Inset A). High flows have scoured the vegetation from the face of this bank.

The BEHI score of site #7 is ranked “High”, the third highest prioritization category in terms of its vulnerability to erosion. Although this bank erosion site has large area (2129 ft²), it is considered a low priority for restoration due to its lack of significant threat to infrastructure or water quality. Rubin (1996) identified unconsolidated deposits here.

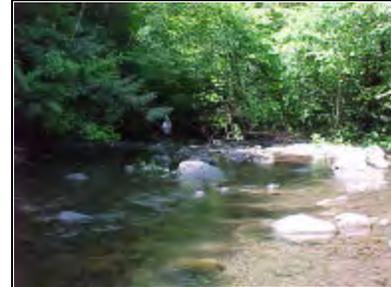
**Figure 30 Cross-section 64
Stream Type D3**

Continuing downstream, slope decreases to 1.3% and the channel widens. This D3 stream type continues for 193 ft (Fig. 30). While this reach has three channels, it is not a

classic, unstable D stream type, with active gravel bars and channels that migrate through aggrading bed

material. While this reach appears aggradational, it is exhibiting trends toward self-recovery. As the *side-channels* revegetate, the morphology is stabilizing, developing a floodplain and consolidated channels.

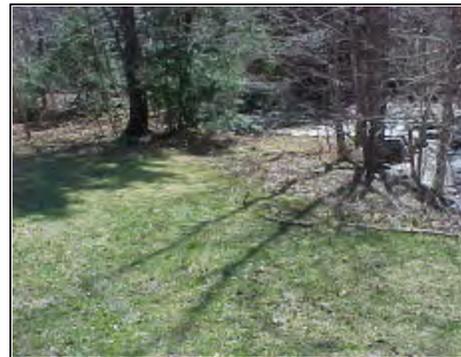
Figure 34 Planting Site #7

Planting site #7 is located on the right bank at Edgewood Falls (Fig. 34). Currently, this area is grass with a few trees at the top of a high bank. To improve this upland buffer, it is recommended to plant this mowed area with native trees and shrubs.

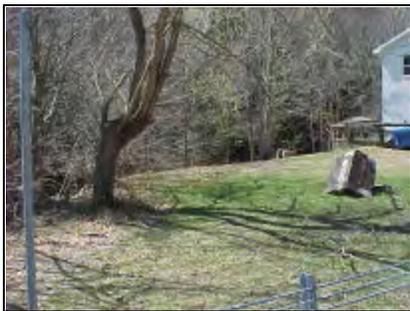
Figure 35 Planting Site #8

Planting site #8 is located at a two-family residence (fire#2504) on NYS Route 214 (Fig. 35). There is a large grass lawn area and scattered trees along the steep stream bank. Increasing buffer width by at least 20 ft. could increase buffer functionality while still allowing a significant lawn area.

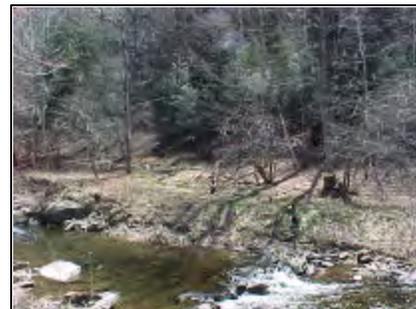
**Figure 36 Planting Site #9
Left Bank**

Planting site #9 is located at a residence (fire#2474) on NYS Route 214 (Fig. 36). There is currently a grass lawn area with a few trees at the top of the stream bank, which is armored with rip-rap.

Inserting plant materials into the soil between rip-rap rocks, or *joint planting*, is recommended at this site.

Joint planting will strengthen and increase the longevity of this rip-rap, while adding aesthetic and habitat value. Increasing buffer width by at least 20 ft. could increase buffer functionality and improve stream bank stability while still allowing a significant lawn area. The left bank at this site could also benefit from tree and shrub plantings along the stream bank and upland buffer. The stream channel at this site is over-wide and aggrading. In-channel plantings of sedges and willows could encourage the stream channel to narrow into a more stable morphology.
