Management Unit 6

Greene County - Town of Hunter
Cross Section 107 to Cross Section 116

Management Unit Description

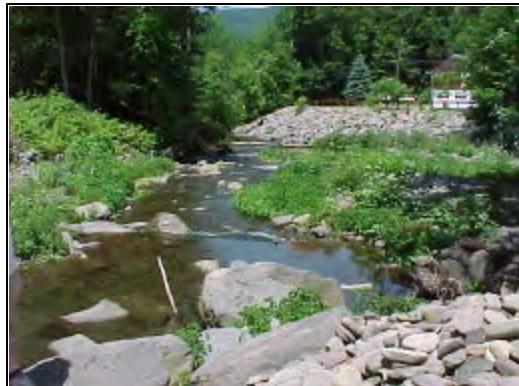
Figure 5 Left stream channel

As the stream emerges from underneath this bridge, the stream is split into three channels. One channel flows directly against the left bank (Fig. 5). Bank erosion monitoring site #14 is located along 75 ft. of this bank (Inset G). This bank has been undercut causing loss of vegetation, including trees, from the top and face of the bank.

The Bank Erodibility Hazard Index (*BEHI*) score of site #14 is ranked “High”, the third highest prioritization category in terms of its

vulnerability to erosion. Previous geologic mapping did not identify lodgement till or glacial lake clays at this site, and none were identified during the stream feature inventory. This bank erosion site is considered a medium priority for restoration because of its threat to infrastructure downstream but has a small eroding area (551 ft^2) and does not threaten water quality.

One reason that bank erosion site #14 is rated a low priority for a restoration project is its small size and lack of water quality threat (Inset G). However, as discussed in the riparian vegetation section, this site could benefit from vegetation and minor bank grading.

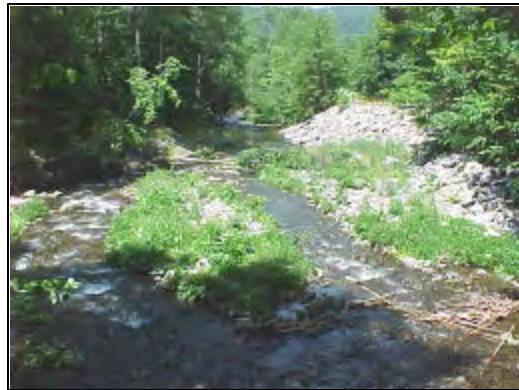
At low flows, the right stream channel, which passes through the large culvert, splits into two channels as it comes out of the culvert (Fig. 6). The bed elevation of these channels is higher than the channel flowing along the left stream bank. *Aggradation*, or a rise in stream bed elevation due to sediment deposition, is occurring as a result of insufficient sediment transport capacity in these channels. A lateral bar is building along the right

stream bank and a mid-channel bar is forming at the outfall of the large culvert. Both bars are beginning to vegetate, as can be seen in Figure 6.

Figure 6 Right stream channels

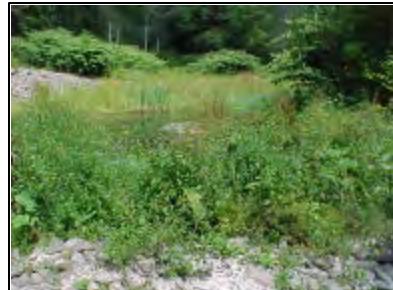
At the end of this straightened reach, beyond the right stream bank, there is a wetland area at the downstream end of an abandoned channel (Fig. 9). The stream may use this abandoned channel and wetland area during flood events as an overflow channel. The United States Geological Survey topographic map indicates that the wetland also receives a small, unnamed tributary originating across NYS Route 214 (USGS, 1981). The wetland apparently drains subsurface to the Stony Clove, as there was no evident surface flow emerging from the wetland at the time of the inventory. This wetland area does not appear on NYS or Federal regulated wetland maps.

Figure 9 Wetland Area

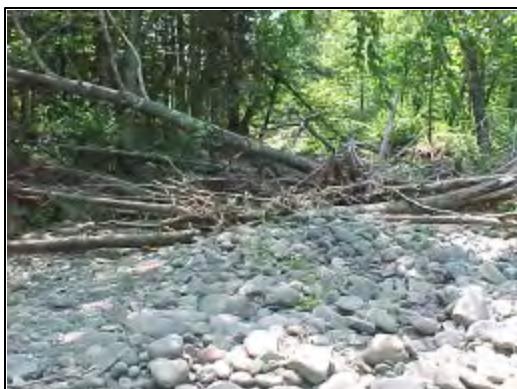
Figure 10 Overflow Channel

Beyond the left bank is an overflow channel used by the stream during high flows (Fig. 10). Woody debris moved during high flows has been deposited at the top of this channel.

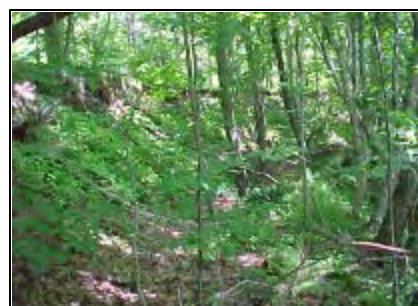
Bank erosion monitoring site #15 is located along the high right bank (Inset A). High *shear stress* during flood events has eroded the toe of this bank leading to a 56 ft. long bank failure. This failure has left the stream bank raw, and exposed underlying clay. At the downstream end of this eroding bank is a debris jam.

The high bank with shallow slope angles and exposed silts/clays is indicative of a common form of bank failure associated with the glacial lake deposits known as *rotational failure*. A 680 ft. *rotational failure* has occurred above the failing bank (Fig. 11). A rotational failure is typically a deep-seated failure which occurs in cohesive materials when a block of disturbed, bank material slides along a curved failure surface (fault). The block tends to rotate (appears to "slump") back toward the bank as it slides, in a rotational slip (Fig. 12) (USDA, 2003).

Figure 11 Rotational failure at BEMS #15

The rotational failure does not threaten any road infrastructure but has uncovered some buried utilities, which are at risk as the stream bank continues to fail, and may present a safety hazard.

The BEHI score of site #15 is ranked “Very High”, the second highest prioritization category in terms of its vulnerability to erosion. While this site presents a water quality concern, it is rated a medium priority for restoration because of its lack of threat to infrastructure and its small actively eroding area (931 ft^2).

Bank erosion site #15 is considered a medium priority because of its threat to water quality (Inset A&B). This site is contributing turbidity to the stream. While not directly threatening infrastructure, the potential for *geotechnical* failure presents an indirect threat to downstream reaches in the form of significant debris and sediment loading. The site should be monitored closely for acceleration of the failure.

Recommendations for this site include woody debris management, realignment of the active stream channel to relieve stress on the right bank, and installation of a well-vegetated bench along the bank failure. Abundant woody debris in the area could be installed as *root wads* along the right bank. Root wads are often used in stream restoration projects to deflect stream flows away from the banks, while improving fish habitat. In-depth survey and design would be required to plan a stream restoration project at this site.

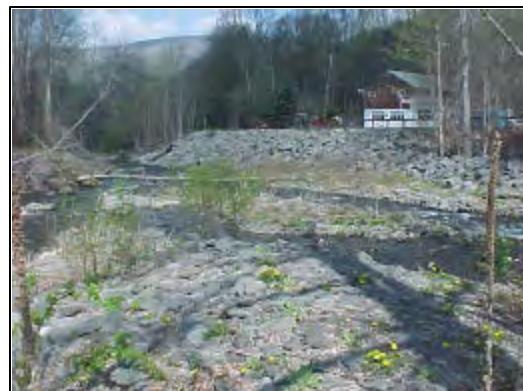
Figure 17 Planting Site #25

Planting site #25 is located at the top of the management unit, downstream from the only road crossing in the unit (Fig. 17). This crossing has caused stream channel to split into three separate channels. The channel along the left bank has caused toe erosion and bank failure. Rip-rap has been installed along the right bank.

One recommendation for this site is to install in-channel plantings of native willows and sedges, to force the two right channels to rejoin. It is also recommended to *joint plant* the existing rip-rap, by inserting plantings into the soil between the openings in the rip-rap rocks. Joint planting will strengthen and increase the longevity of this rip-rap. These plantings will also improve the aquatic habitat by providing shade, thereby cooling water temperatures.

Additional plantings and *willow fascines* may be installed along the toe and face of the left stream bank. This stream bank is actively eroding making it a difficult planting site. However, it may be possible to stabilize this bank solely with vegetation with the proper design.

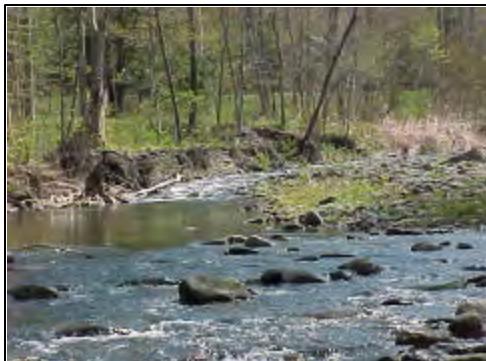
**Figure 18 Planting Site #26
Right Bank - Looking Upstream**

Planting site #26 is located along the reach of C3b stream type between cross sections 110 to 112. The right stream bank is experiencing some minor erosion (Fig. 18), while there is a gravel bar along the left stream bank. Japanese Knotweed is beginning to establish on the disturbed right bank. The upland area is mainly cobble material (Fig. 19).

Recommendations for this site include installation of native willows and sedges along the right stream bank. These plantings will protect the bank from erosion, while providing shade for the deep pool in the reach. Japanese Knotweed at the site should be removed. For the upland area, tree and shrub plantings are recommended to increase the density and functionality of the upland stream buffer.

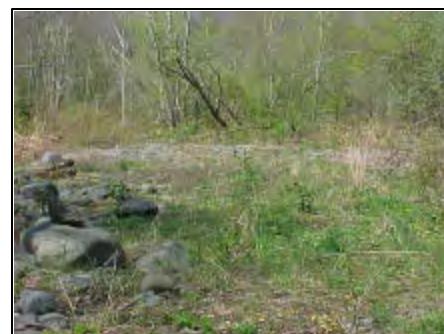
**Figure 19 Planting Site #26
Upland Area**

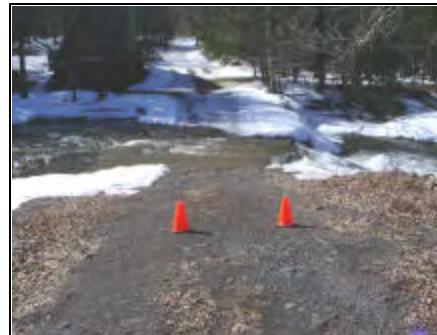
At the upstream end of this management unit, the stream splits into three channels as it must pass a road crossing (Inset H). The majority of the stream passes through the culvert bridge on the right side of the stream at low flows. The remaining stream flow flows straight and falls into two smaller culverts which pass under the road crossing just above the stream grade level. Higher flows spill directly across the roadway, rendering it impassable and requiring significant maintenance after flood flows ebb.

This overflow also occurs during smaller rain events, when debris clogs the two smaller culverts. This road crossing causes channel instability downstream by dividing channel forming flows and creating a barrier to sediment transport.

The private road crossing at the top of this management unit has been severely damaged in past flood events. This infrastructure threat is discussed in the management unit #5.

Figure 21 Road Crossing
March 21,2003 (967cfs)

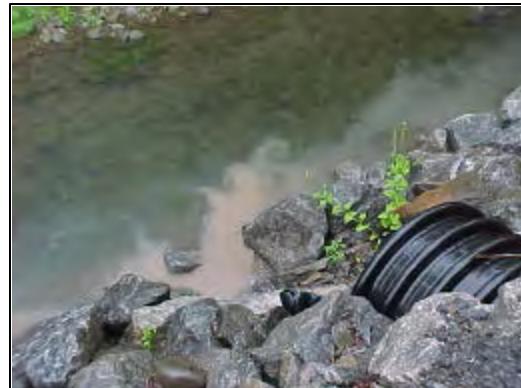
As shown in Figure 23, the culvert at the top of the management unit does contribute sediment into the Stony Clove Creek. The majority of this sediment is washed off of a dirt road on the opposite side of NYS Route 214. While the culvert outfall does not offer

Figure 23 Culvert During Rain Event

evident opportunities for treatment of this problem, options for treatment of the turbidity source, or appropriate stormwater retrofit technology installed on the opposite shoulder of NYS Route 214 should be evaluated.
