Management Unit 18

Ulster County - Town of Shandaken
Between Cross Section 172 & 173 to Chichester Bridge

Management Unit Description

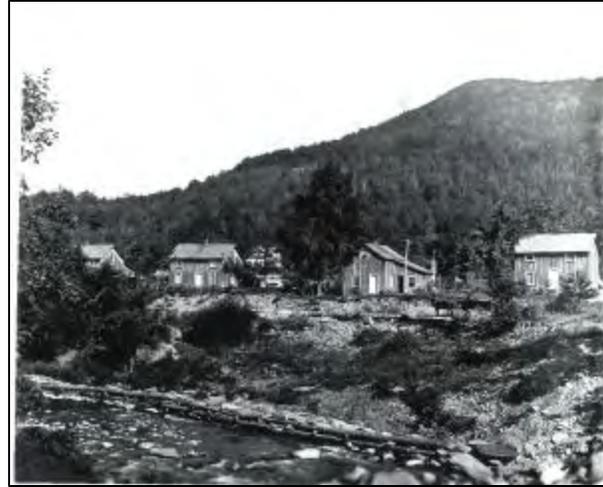
Figure 2 Revetment along a till bank, Stony Clove Creek
Courtesy of the Gale Collection

Stream channels incised into lodgement till tend to have unstable stream banks that are often oversteepened and fail by episodic mass wasting. As a result, historically they were frequently revetted, as shown in the image of log cribbing in Figure 2. Logs were plentiful, and able to be moved into place readily with a horse team at low flow, but big enough to withstand being pummelled by ice and boulders during spring floods.

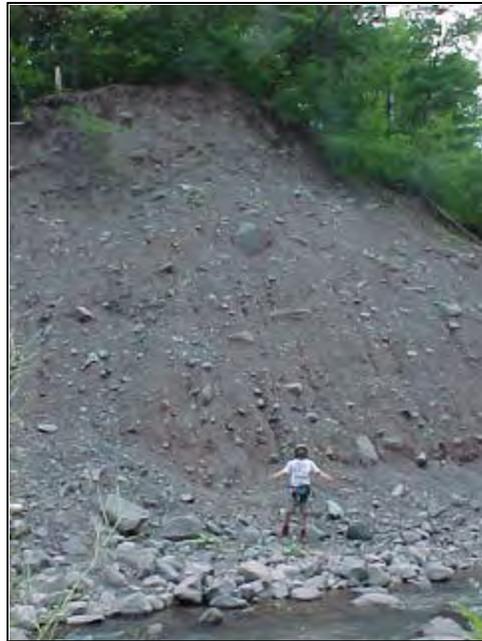
**Figure 6 Severe Bank Erosion
Stream Type F3**

Beginning at the top of this management unit, there is approximately 607 ft. of severe erosion (Inset H) on the left stream bank. This is a continuation of bank erosion site #24 discussed in the previous management unit.

The *thalweg*, or deepest part of the stream channel flows up against the left valley wall (Fig. 6). The hillslope is being undermined by toe erosion, resulting in the mass wasting of the bank. This erosion has left the face of the stream bank unvegetated. The exposed lodgement till soil has a high silt and clay content, contributing sediment through both *wet and dry ravel* and yielding a significant suspended sediment load during rainfall events. Clay inputs into a stream are a serious water quality concern because they increase *turbidity*, degrade fish habitat, and can act as a carrier for other pollutants and pathogens.

Most of the stream banks within the management unit are considered unstable, and 25% of the stream banks are experiencing major erosion. The erosion (Inset H), located at the top of the management unit, is a continuation of bank erosion monitoring site #24. This is a large failure contributing significant amounts of fine soil and clay, as well as mature trees, to the creek. This failure could constitute a severe flood hazard for downstream reaches due to the potential for trees to be introduced into the stream from the eroding stream bank during large floods. These trees can create debris jams at bridges or mid-channel bars and may shift the flow pattern of the stream across roads and residential properties.

Restoration of the erosion site discussed above should be considered in the context of a larger restoration project area, to extend from the railroad bridge abutments in Management Unit #16, to the NYS Route 214 bridge at Chichester, at the downstream end of Management Unit #18. Taken as a whole, this larger project would represent the highest priority restoration in the Stony Clove Creek. Recommendations to restore the reaches in Management Unit #18 include installing a series of rock vane structures to control grade and direct erosive forces away from banks. A lower, bankfull floodplain bench, vegetated with native tree and shrub species, should be established between the active channel and the eroding banks. In-depth survey and design would be required to plan a stream restoration project at this site, including geotechnical assessment of the

high bank. Providing opportunities for activities such as fishing and kayaking should be considered as a secondary objective of the project.

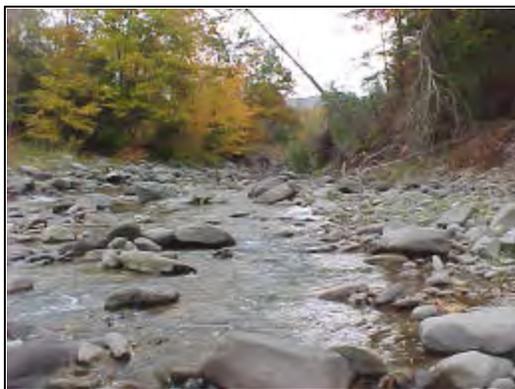
**Figure 8 Cross-section 174
Stream Type B3c looking upstream**

As stream slope decreases to 1.3%, the stream type transitions to B3c for this 388 ft. reach (Fig. 8). The channel straightens and becomes moderately entrenched as it gains limited access to its floodplain towards the end of the reach. The left stream bank decreases in height but continues to erode throughout this reach.

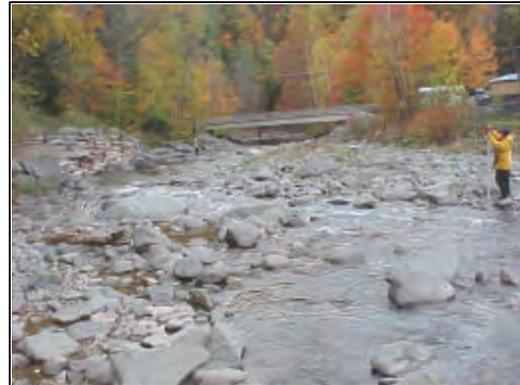
**Figure 9 Cross-section 175
Stream Type B3**

As the channel widens and gains limited access to its floodplain, the stream type changes to B3 for the remaining 231 ft. of this management unit (Fig. 9).

This reach is overwide. Deposition of bed materials is common in overwide channels because they lose their ability to transport the stream's *bedload*. Under these conditions streams often *aggrade*, or rise in stream bed elevation due to excessive deposition. A large gravel bar has formed along the right stream bank. As can be seen in the aerial photograph (Fig. 17), aggradation often causes the stream to become divided into multiple threads.

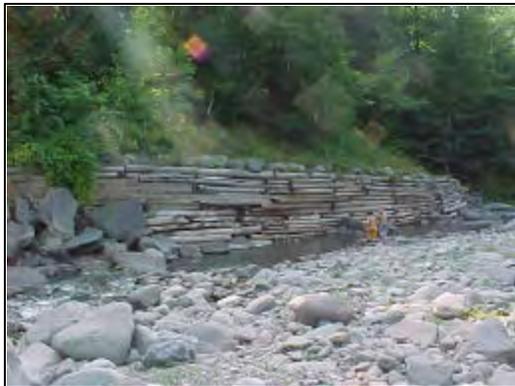
Figure 10 Log cribbing August 16, 2001

The thalweg flows directly against the outside of the left meander bend of this reach, causing repeated erosion damages over the years due to the high *shear stress* endured by this bank during flood events. This bank has been heavily armored with 85 ft. of rip-rap (Inset G) and 112 ft. of log cribbing (Inset F and Fig. 10) to protect the private residence at the top of the bank.

Due to an exceptionally high amount of precipitation between August and December 2003, this log cribbing has deteriorated, leaving the residence vulnerable. The landowners plan to install a stacked rock wall, tentatively scheduled to be built in

38% of the stream banks in this management unit have been treated with some form of revetment. However, there are no immediate threats to roadways in this management unit. Failure of the log cribbing (Inset F) on the left stream bank at the end of the

management unit poses a threat to a residential property. The condition of this revetment has rapidly declined in recent years, and retrofit is planned for the near future. Modifications to this revetment should include a toe treatment that extends deeper than anticipated stream bed scour depths. Vegetative applications on the face of the revetment and upper bank would increase the strength and longevity of these measures while enhancing the habitat function and aesthetic value of the treatment.

summer 2004, to protect their property. To ensure this stacked rock wall is effective, a solid footing for the wall must be *keyed-in*, or dug into a trench, below the level of streambed scour. If possible, trees or shrubs should be planted through the rock wall as it is being built. The rootmass of these plantings will add to the cohesive strength behind the wall, while also improving the aesthetics of the wall. Silt fabric should be laid behind the rock wall to keep fine soil material from filtering out through the cracks in the rocks when the soil is saturated. This *pipng* of soil through the revetment can result in so much soil loss that

the bank above the wall may collapse. The potential for this type of collapse on this bank is considered high, because the bank extends well above height of the wall, and these conditions will produce high *hydrostatic pressure* behind the wall during wet years. The soils in this area are a mixture of clays, sands and gravels, often in very stratified layers

which can move easily under the pressure of *artesian springs*. The stacked rock wall should extend only slightly higher than the floodplain on the opposite side of the stream and *bioengineering* planting options should be considered to stabilize the bank above the wall.

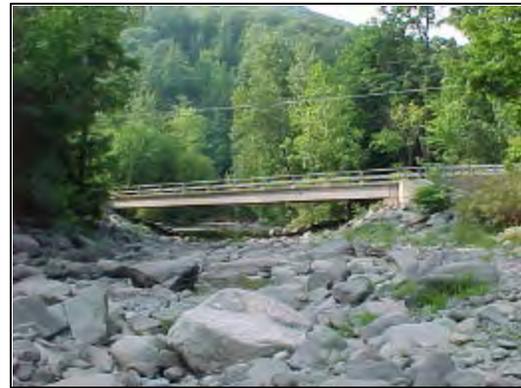
Figure 11 NYS Route 214 bridge

As mentioned previously, a large gravel bar has formed along the right stream bank (Fig. 11). Gravel deposits upstream of bridges are commonly caused by inadequate sizing of the bridge opening. An undersized bridge opening causes water to back up upstream of the bridge, reducing stream velocity, which results in sediment deposition. In high stage, the

floodwater may seek conveyance through alternative paths, forming new channels around the bridge constriction, as appears to have happened at this site. Additional *floodplain drainage*, using culverts set at the floodplain elevation under the north bridge approach, may help mitigate this problem. While bankfull flows appear to flow freely through this bridge, higher flows appear to backwater, resulting in the upstream aggradation.

Entrenched conditions in the upstream reaches of this management unit have resulted in channel incision as the channel bed—both the bedload pavement and the clay sub-pavement—is scoured deeper than it is refilled during floods. As the sediment exported from those reaches during flood flows approaches the Chichester Bridge, backwatering and overwide channel conditions hamper the channel's capacity to continue transporting those materials, and deposition is the result. Accelerated bar development, noted in the reaches just upstream of the Chichester Bridge, confirms aggradational processes at work here. Installation of flood plain drainage, and/or reduction of the width/depth ratio of the channel under NYS Route 214 would reduce the backwater conditions and improve sediment transport continuity at the bridge.

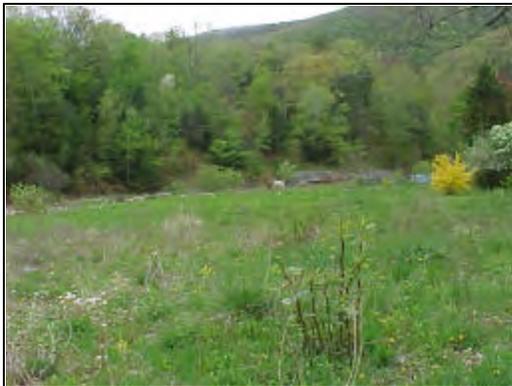
Figure 14 Planting Site #48

Planting site #48 includes parts of eight separate residential properties, on the right stream bank, at the downstream end of this management unit. These upland areas are currently large backyards mowed to the edge of the stream bank (Fig. 14).

Recommendations for this site include planting native trees and shrubs along the edge of the stream bank and the upland area. Buffer width should be increased by the greatest amount agreeable to the landowners, but increasing the buffer width by at least 20 feet will increase the buffer functionality and improve stream bank stability while still allowing a significant lawn area.
