Management Unit 21
 Ulster County - Town of Shandaken
 Cross Section 189 to confluence with Esopus Creek

Management Unit Description

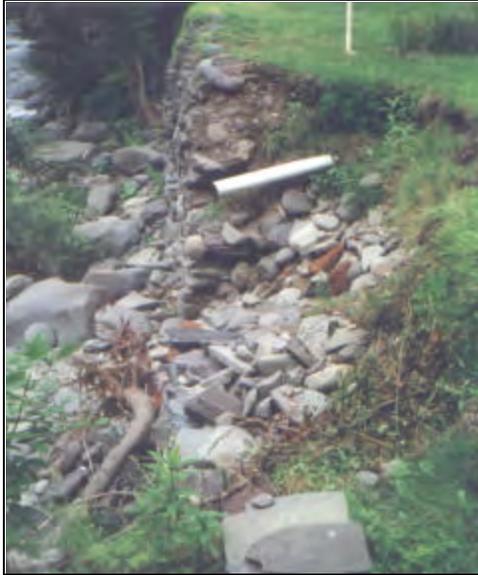
Figure 5 Erosion at Cardillo Property August 2, 1996

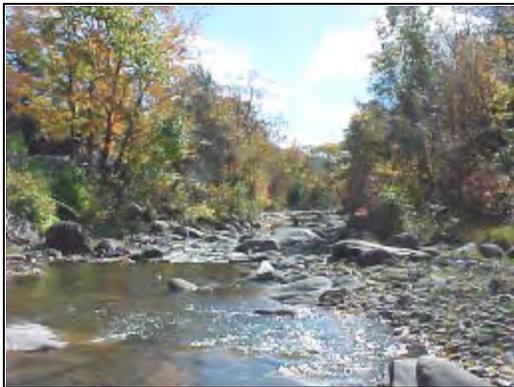
**Figure 8 Cross-section 193
Stream Type B3 looking upstream**

As channel slope steepens to 2.3%, stream type transitions to B3 for the next 513 ft. (Fig. 8). Beginning at the top of this reach, the stream flows away from NYS Route 214. The left floodplain has been developed with residences immediately adjacent to a steep stream bank, requiring extensive revetment. A 406 ft. long stacked rock wall stabilizes the left stream bank at the top of this reach (Fig. 9).

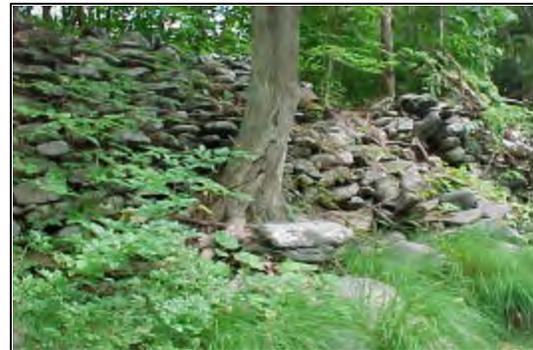
Figure 9 Stacked Rock Wall

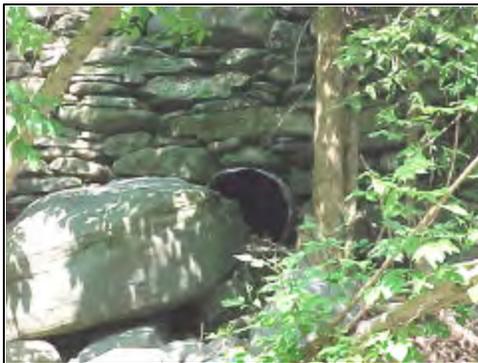
Figure 10 Culvert

The culvert outfall is lined with large rocks, reducing the risk of erosion from stormwater.

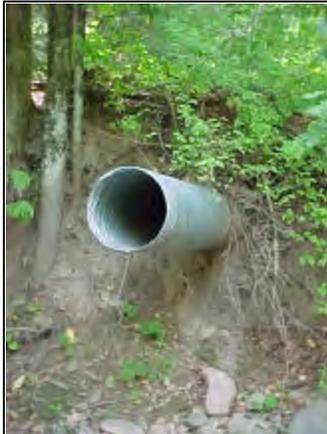
**Figure 12 Hanging culvert
on back-channel**

On the right stream bank there is a back-channel that still carries flood flows. Although not documented in the historical photography, heavy erosion on the right stream bank of the abandoned channel suggests that it may have carried the main flow of the Stony Clove Creek in the past. A stormwater culvert projects from the right stream bank of this back-channel (Fig. 12). This culvert is presumed to have been installed approximately flush with the stream bank.

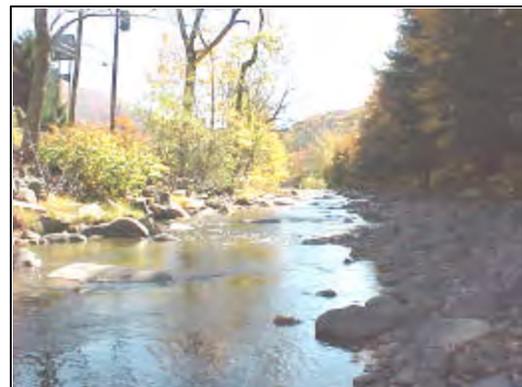
Downstream of this reach, the stream once again becomes entrenched and the slope decreases to 1.0%. Stream type changes to F3 for this 864 ft. reach (Fig. 13). Gravel has been deposited along the right stream bank. Bar development is common in flat stream reaches because flow velocities are slower and less capable of moving bed load than are steeper reaches. Gravel bars help maintain channel stability during flood events. In stable streams, the bars will erode away while the channel is in flood stage. The bars are then rebuilt as flow decreases, helping the stream

**Figure 13 Cross-section 197
Stream Type F3**

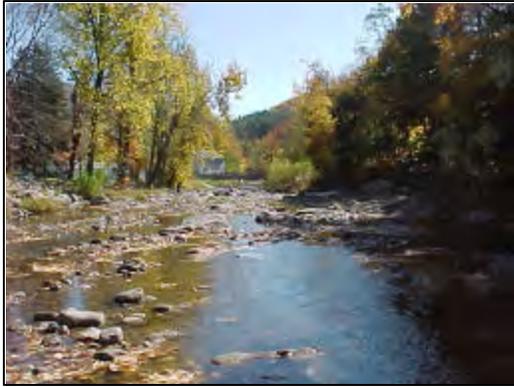
Figure 14 Deposition at Cross-section 198 Stream Type F3

This reach becomes overwide and shallow at its downstream end (Fig. 14). Deposition is common in overwide channels because they lose their ability to transport the stream's *bedload*, resulting in *aggradation*, or a rise in stream bed elevation. Overwide channels

typically offer poor fish habitat due to warmer water temperatures and filling of deep pools.

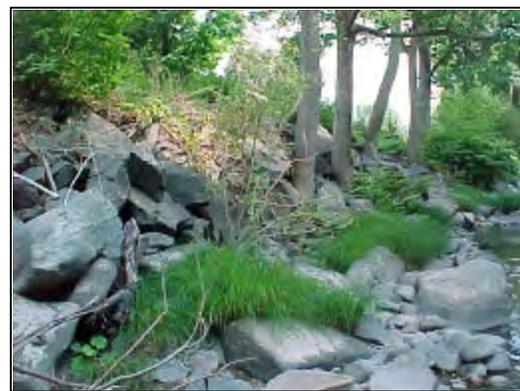
Beginning at the upstream end of this overwide section, 94 ft. of rip-rap runs along the left stream bank to protect NYS Route 214 (Inset C). This rip-rap is vegetated, with trees and shrubs on the face, and sedges along the toe of the stream bank (Fig. 15). This vegetation will increase the strength and longevity of this rip-rap.

Figure 15 Rip-Rap

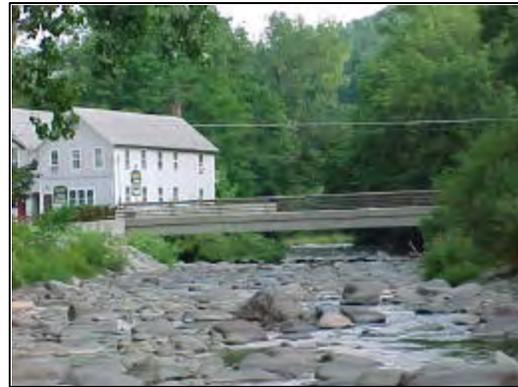
As the stream approaches the Main Street Bridge (Inset E) it remains over-wide and shallow (Fig. 17). This bridge (Bridge #1018780) was last replaced in 1993 and is maintained by the NYS Department of Transportation (NYS DOT).

Figure 17 Main Street Bridge

Bridges often cause stream instability because they constrict stream flow through a narrow area. An undersized bridge opening causes water to back up upstream of the bridge, reducing stream velocity, which results in sediment deposition. In high stage, the floodwater may seek conveyance through alternative paths, forming new channels around the bridge constriction. This bridge has experienced repeated damage during flood events.

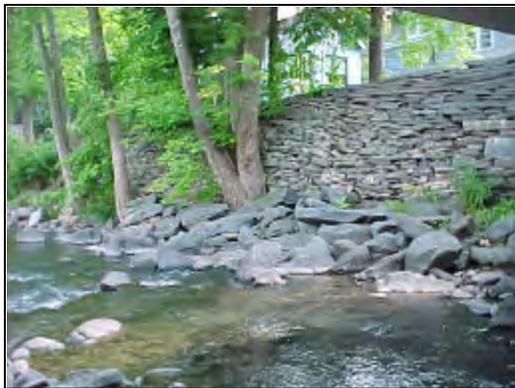
Figure 18 Stacked Rock Wall

As the stream emerges from under the bridge the right stream bank has been stabilized with a 142 ft. stacked rock wall (Fig. 18). The following 148 ft. of stream bank has been stabilized with a high concrete wall and buttressed with gabion baskets at the toe of the wall (Inset A). Several homes are located very close to the edge of this wall.

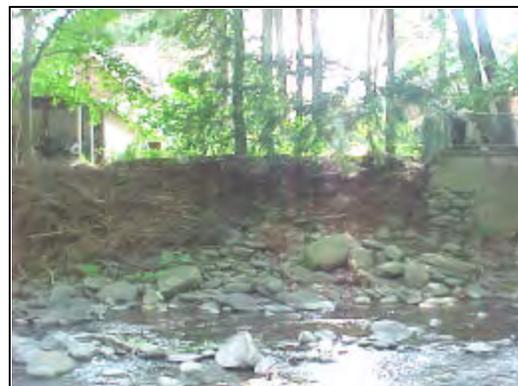
As the concrete wall ends, the right stream bank has begun to erode, threatening the adjacent home (Fig. 19). Due to the severity of erosion on this bank, it was not identified as an appropriate site for the Streamside Planting Program. More extensive *bioengineering* stabilization treatments would likely be effective in this setting, however.

Figure 19 Erosion on right stream bank

The one eroding bank is located downstream from the Main Street Bridge, on the right bank. A residence adjacent to this bank may be threatened if this erosion continues. While this site was not included in the Stony Clove Creek Streamside Planting Program due to the extent of the erosion and adjoining bank treatments, more intensive *bioengineering* treatments would likely be effective in this setting.

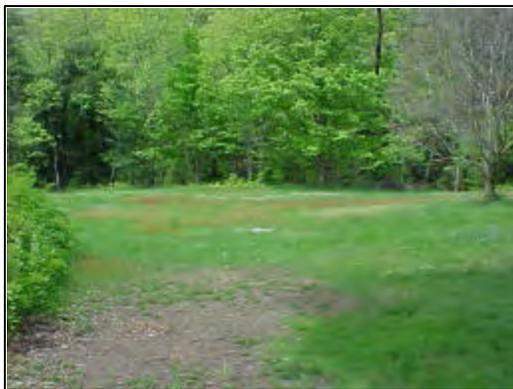
Figure 23 Planting Site #56

Planting site #56 is located at the residence on the left stream bank at the upstream end of the management unit (Fig. 23). This stream bank has a narrow vegetated buffer and the upland area is mowed lawn.

Native trees and shrubs should be planted in the upland area. Increasing the stream buffer width by at least 20 feet will improve stream bank stability and buffer functionality while still allowing a significant lawn area.

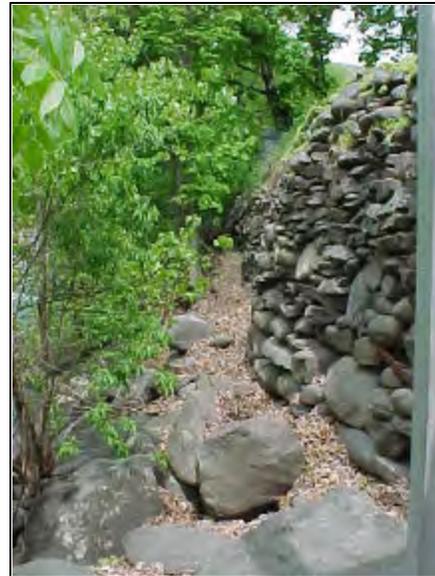
Figure 24 Planting Site #57

Planting Site #57 is located on five residential properties on the left stream bank (Inset H). The stream bank at this site has been stabilized with a stacked rock wall (Fig. 24). At the top of the bank are lawn areas with several trees and shrubs.

Native willow planting along the toe of the stacked rock wall to encourage the development of a low bench is recommended. A well-vegetated bench will reduce flood water velocities near the bank. This site may be difficult to access due to the small residential lot sizes and narrow setbacks between adjacent houses.

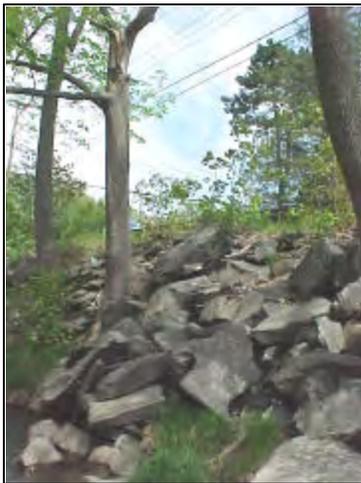
Figure 25 Planting Site #58

Planting site # 58 is located on the left stream bank rip-rap along NYS Route 214 (Inset G). This rip-rap currently has young maple trees and Japanese Knotweed growing through the rocks and sedges along the toe of the stream bank (Fig. 25). Woody debris has also been dumped along this stream bank.

While not an example of *joint planting*, the trees growing through this rip-rap area illustrate how vegetation can improve the stability and longevity of revetment. This area should be monitored to ensure the continued success of this vegetation, and augmentation of the existing trees with shrub plantings should be considered.

Removal of the Japanese Knotweed, which is an invasive non-native species, is recommended at this site. Japanese Knotweed does not provide adequate erosion protection because it has a very shallow rooting system.

The practice of dumping yard clippings, including loose brush, on the stream bank is not recommended. This practice can kill existing bank-stabilizing vegetation, inhibit growth of new vegetation and thus contribute to bank instability. As grass clippings and leaves decompose they contribute unnecessary nutrients to the stream, depleting the dissolved oxygen needed by fish and other aquatic organisms.

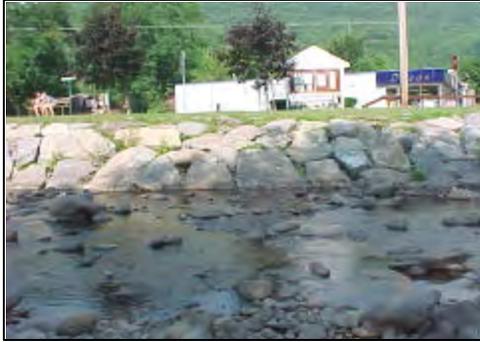
Figure 26 Planting Site #59

Planting site #59 is located on the left stream bank at the Simpson Mini Park in Phoenicia (Inset B). This stream bank has been stabilized with rip-rap, and a grass area at the top of the bank is maintained as open space (Fig. 26).

This reach of stream is overwide. The development of a vegetated gravel bar on the right side of the stream indicates that the stream is slowly recovering its stable form, but additional plantings of native willows and sedges in the left margin of stream channel will accelerate this recovery. It is also recommended to *joint plant* the existing rip-rap, by inserting plantings into the soil between the rocks. Joint planting will strengthen and increase the longevity of this rip-rap. These plantings will also improve the aquatic habitat by providing

shade, resulting in cooler water temperatures. To provide protection against toe erosion, willow *fascines* should be planted along the toe of the stream bank. These planting should be spaced to provide views of the creek.

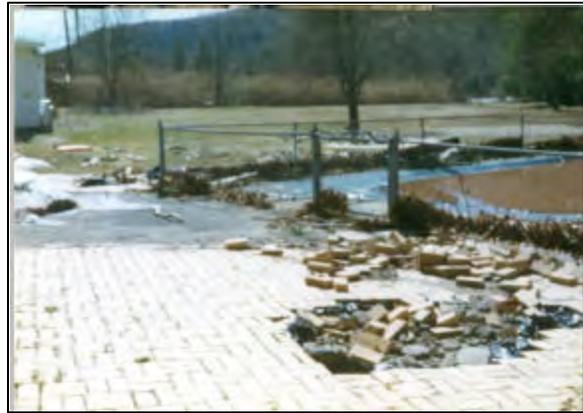
During several recent flood events, the Stony Clove Creek overtopped its banks in this reach. Figure 28 shows damage at a residence on the left stream bank between cross sections 190 and 191 caused by the flood of 1996. The stream flooded the backyard, causing severe damage to a brick patio. Note the dark brown, sediment-laden water left on top of the swimming pool cover as the floodwaters receded.

Figure 28 1996 Flood Damage

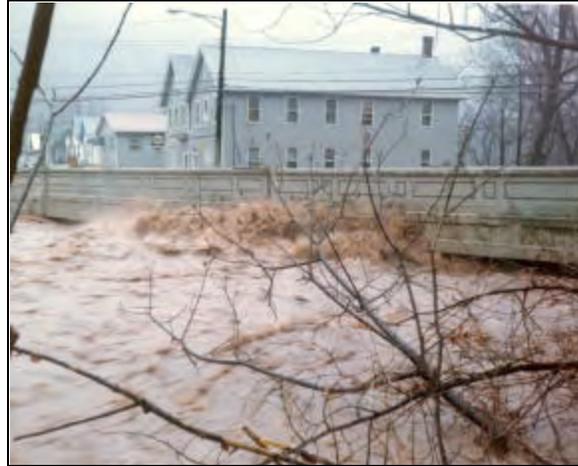
Figure 29 Main Street Bridge - 1980 Flood

The Main Street Bridge was replaced in 1993 by the NYS DOT, and the center pier was removed, significantly increasing flood conveyance capacity (Fig. 29).
