4. Water Quality and Ecological Health

Chestnut Creek Stream Management Plan

5. Public Infrastructure Concerns and Interests

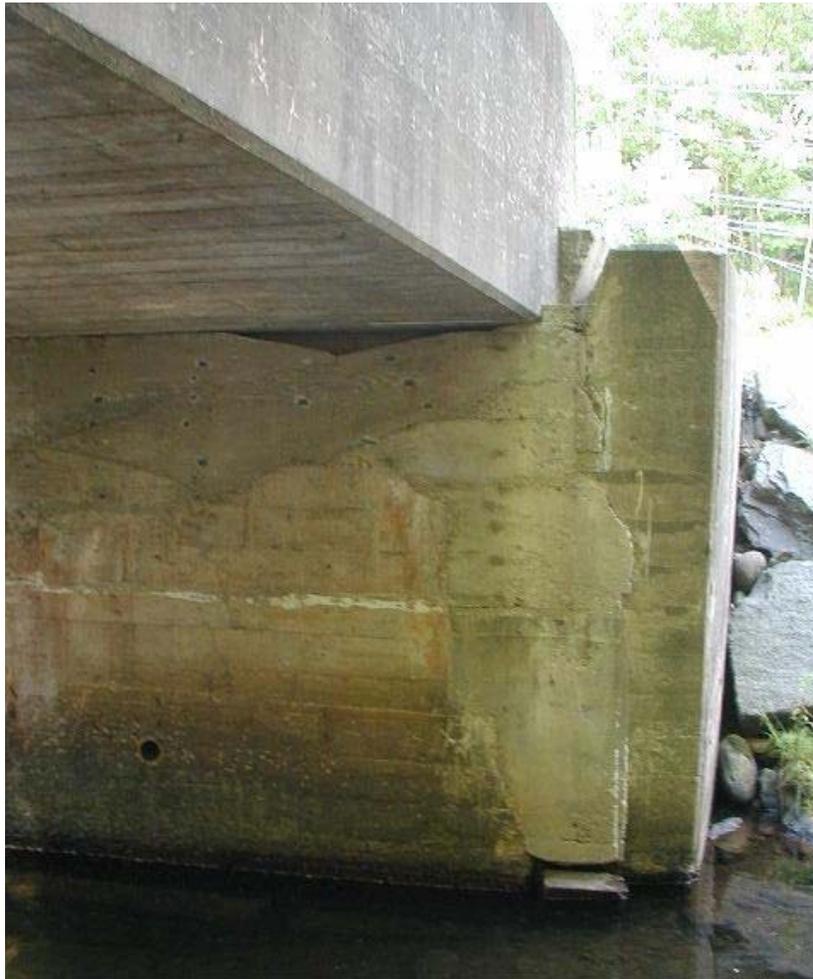
Mohr Bridge. Photo taken by Lori Kerrigan, SCSWCD.

Mohr's Bridge - This bridge is located across from Maschio's Restaurant concerns the Highway Department because the abutment closest to the road is being undercut. If Mohr's Bridge collapses it may cause damage to Route 55 and will be addressed as deemed necessary.
