C. Chestnut Creek Management Unit 3

1. Summary Description

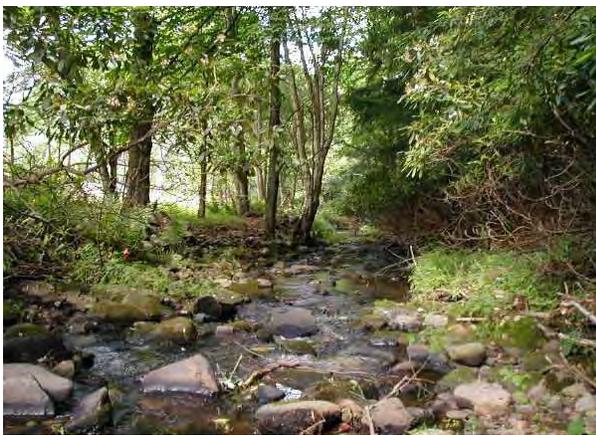
Photo 1. Looking downstream from above XS-52.

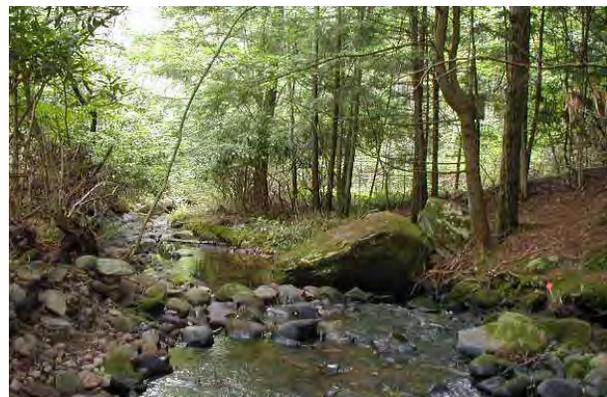
Photo 5. View looking downstream at XS-55. Shows a forested riparian habitat.

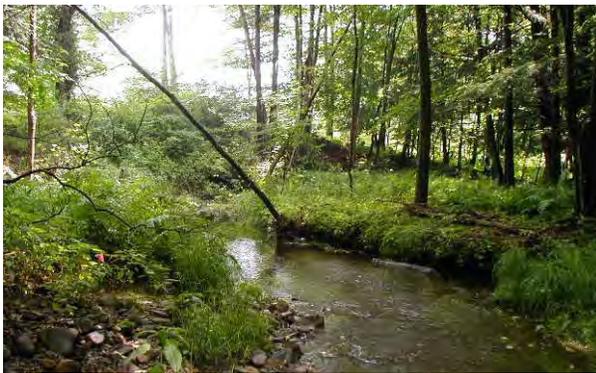
Photo 6. View looking downstream at XS-41, C-type stream.

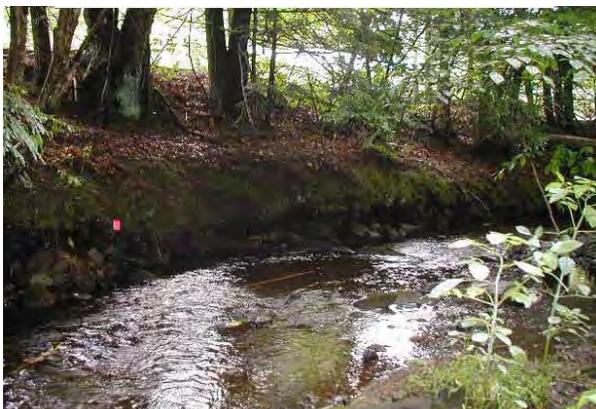
Photo 7. View looking downstream from right bank towards left bank at XS-44, B-type stream.

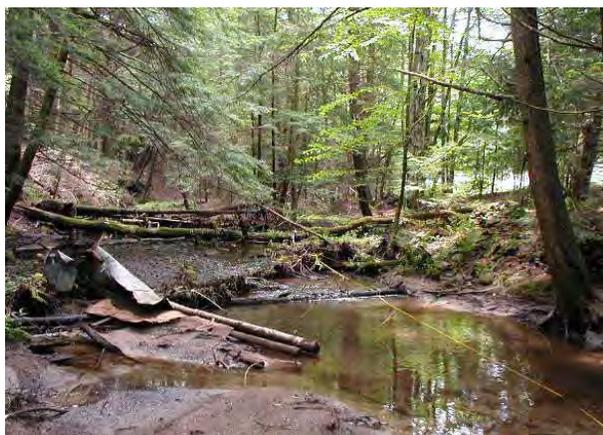
The 2001 Stream Assessment Survey identified several debris jams and other dam-like structures, both human-made and natural (Photo 8). Debris jams and other channel obstructions may cause problems by trapping sediment, which initiates and/or accelerates the development of gravel bars and reduces channel capacity. Debris jams can cause an increase in flood stage and result in bank erosion. Alternately, small blockages that don't span the entire channel width, can create and maintain beneficial physical habitat, as well as assist in controlling stream channel *incision* and degradation. Although the current debris jam appears stable, regular monitoring can detect a potential future problem. The monitoring should include an inventory of the debris jam to include the potential future problems such as risk of sudden release of the sediment and debris.

Photo 8. View looking upstream from below XS-47. Sediment has accumulated due the debris jam shown above.

5. Promote floodplain protection, which is critical in maintaining stream stability in moderately entrenched reaches.
6. Monitor the areas containing debris jams and channel blockages for changes in channel stability.

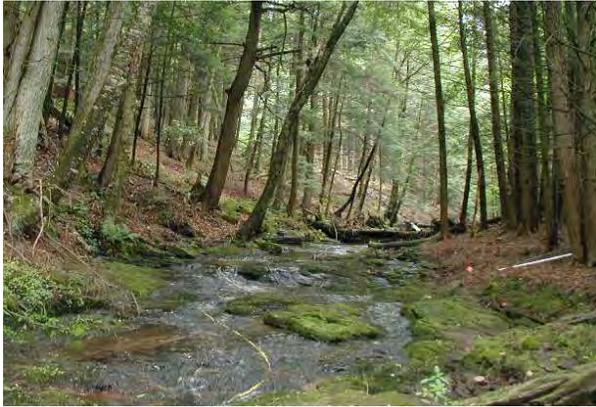
bedrock currently provides grade control along a portion of the unit (Photo 9), thereby preventing channel degradation.

Photo 9. View of bedrock, looking upstream from below XS-48.

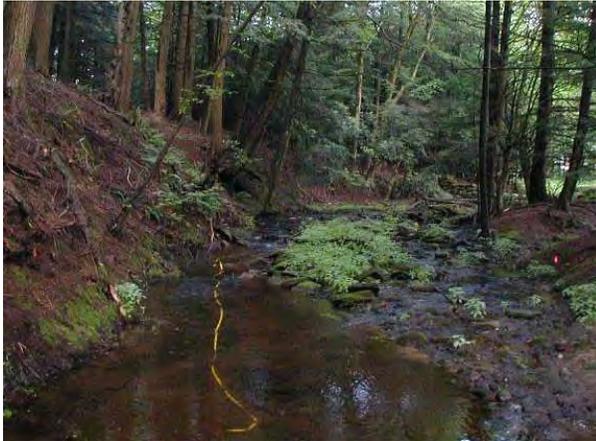
Preliminary observations indicate that most of the channel along this management unit is laterally stable (i.e., bank erosion rates are low) which includes areas along high banks (Photo 10). Mature trees and shrubs also provide lateral control along the majority of the management unit. The 2001 Stream Assessment Survey determined that 117 feet (2.4%) of the streambanks are actively eroding. The erosion occurs in three small sections ranging from 15-50 linear feet and mostly consists of slightly undercut areas along low banks (Photo 11). The erosion appears local in nature, should require little or no intervention, and potentially adds to the fish and wildlife habitat.

Photo 10. View looking upstream towards dam at XS-46.

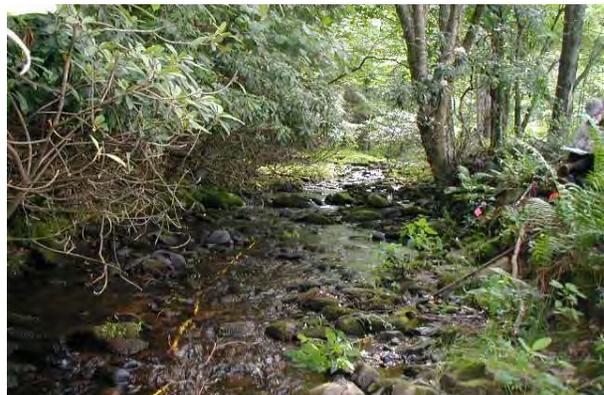
The riparian area in Management Unit 3 is generally stable and consists of mature trees and shrubs (Photo 12). Vegetated riparian zones act as buffers against pollution and are therefore very important in mitigating the adverse impacts of human activities. Forested riparian buffers facilitate stream stability and function by

Photo 12. View looking upstream at XS-53, with cobble bed.
