# East Kill Management Unit 7

Town of Jewett –Station 37758 to Route 296 Bridge (Station 26386)

This management unit began at Station 37758, and continued approximately 11,372 ft. to Route 296 Bridge (#1045150) in the Town of Jewett.

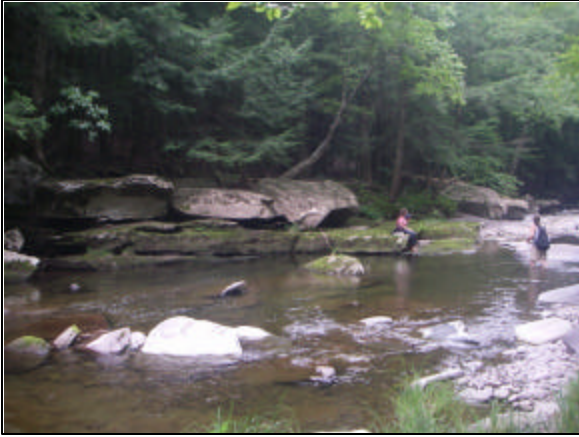
*Bedrock at Stations 37268 - 36553*

from other areas, which started in management unit #6 and continued through the beginning of management unit #7. As the stream gently meandered to the right, there was bedrock (Stations 37268 - 36553) along the left stream bank and bed for approximately 715 feet. Along this stretch of the stream sediment size increased with many boulders in the stream and bedrock extending across the channel along the downstream half

of the bedrock section. The bedrock provided lateral control by limiting stream bank erosion; it also provided grade control for the channel by preventing *degradation* or *downtcutting* of the stream, the process by which streambeds and floodplains are lowered in elevation by eroding downward into the stream bed over time.

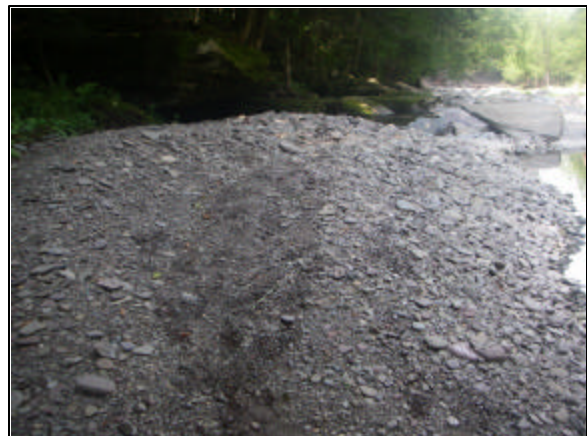
Throughout the bedrock controlled stream channel there was excessive deposition, or accumulation of sediment on the channel bed including, full channel aggradation, a center bar, a side bar (Station 36946) along the left, and a *point* bar along the right. A point bar is a depositional feature usually located on the inside of a meander bends, and caused by a decrease in sediment transport capacity. At the downstream end of the bedrock channel there was abundant woody debris along both stream banks (near Station 36550). The woody debris along the right bank appeared to contribute to some minor localized scour upstream and downstream of the debris.

*Side bar at Station 36946*

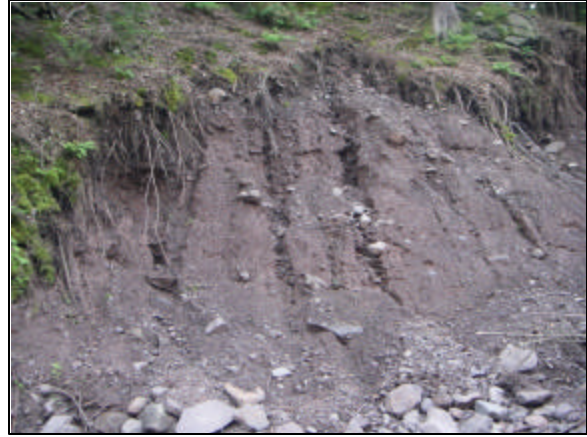
Following the bedrock, there was a *mass failure* (Stations 36548 – 36336, (Figure 4.7.1, Inset D), a large slope failure associated with a down-cutting stream channel and undermined support of steep slopes. This mass failure had resulted in an erosion area of approximately 5,311 ft<sup>2</sup>, exposing areas of mixed till and compromising mature trees along

the left stream bank. During high flows and times of active erosion, a significant amount of clay may enter the stream from this bank due to the lacustrine clay exposure (Stations 36540 – 36334) along the stream bank and the left channel bed. Clay inputs into a stream are a serious water quality concern because they increase *turbidity*, degrade fish habitat, and can act as a carrier for other pollutants and pathogens. Excessive sediment deposition continued downstream.

*Clay exposure at Stations 36540 - 36334*

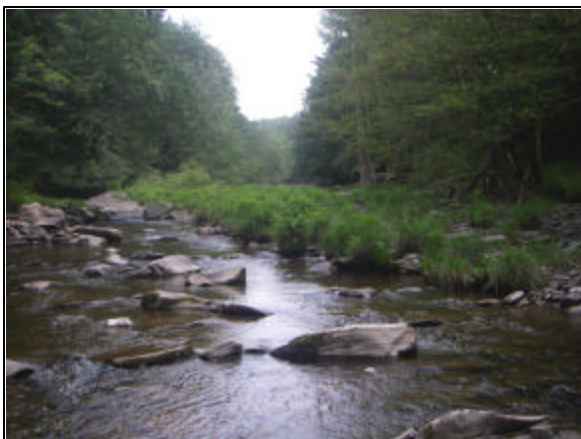
*Transverse bar at Stations 35300 - 35182*

deposition continued. There was a *transverse bar* (Stations 35300 – 35182), or diagonal accumulation of sediment, with a three foot drop into the main stem; there was also full channel aggradation and a side bar along the right stream bank. Along approximately 120 feet of the left bank, there was a clay exposure (Stations 35244 – 35124) at the toe of the undercut bank.

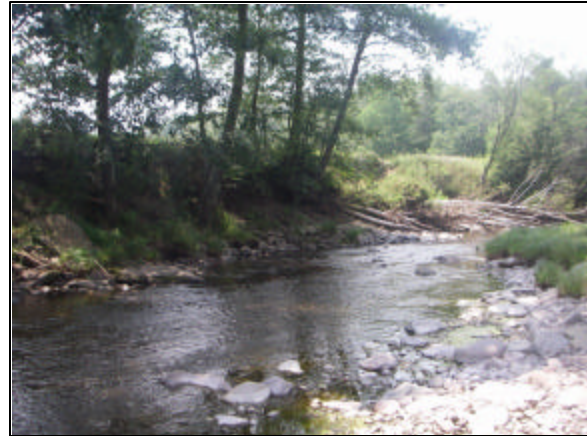
As the stream meandered to the right, there was an erosion area of approximately 2,918 ft<sup>2</sup> along the left bank. Stream bank erosion often occurs on the outside of meander bends where the stream velocity is greatest during high flows. Mature vegetation had been compromised resulting in a fallen tree across the channel that provided a minor obstruction (Station 35026) at low flows and contributed to localized scour upstream.

*Erosion at Stations 35137 - 34845*

There was a narrow riparian buffer along the bank, beyond which there was an open agricultural field, with herbaceous vegetation to the top of the bank. Recommendations for this area are similar to those of the previous erosion site that was located along agricultural fields, including riparian plantings of native trees and shrubs to enhance the buffer width to the greatest amount agreeable to the landowner, and to improve buffer functionality.

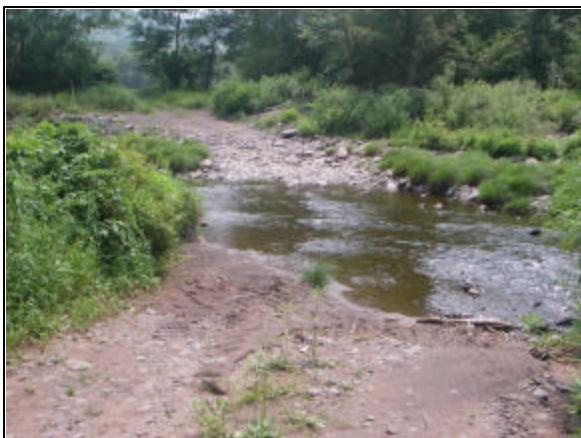
At the downstream end of this erosion site, there was a stream crossing (Station 34825) that provided access to the agricultural fields along the left side of the stream. Maintenance of this crossing may provide a sediment source for continued aggradational conditions downstream of the crossing. Just downstream of the crossing there was a channel *divergence* (near Station 34800) where a flood chute split off from the main channel. Flood chutes convey flow through a

*Stream crossing at Station 34825*

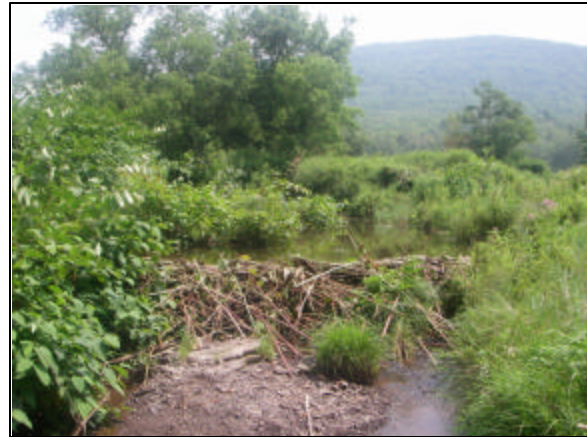
Just before the stream made a sharp turn to the left, there was a beaver dam (Station 34670) along the right stream bank that contributed to upstream backwater conditions. While beaver impoundments can sometimes be a nuisance, beavers have historically played a beneficial and ecologically important role in the stream system. Beaver activity adds organic debris

*Beaver dam at Station 34670*

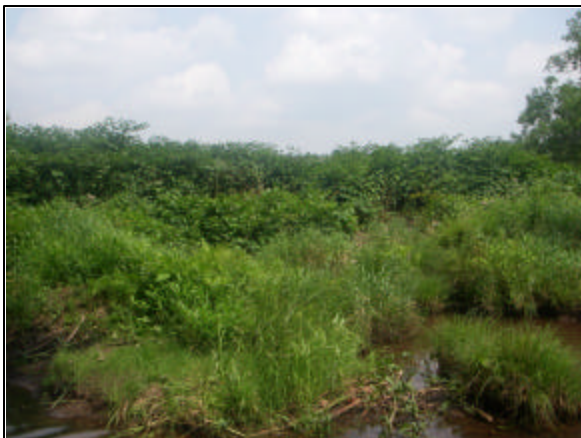
*Japanese knotweed at Station 34666*

Near the beaver dam and tributary, there was also the first observed Japanese knotweed stand (Station 34666), along

approximately 100 feet of the right stream bank. Japanese knotweed is an invasive non-native species which does not provide adequate erosion protection due to its very shallow rooting system and also grows rapidly to crowd out more beneficial streamside vegetation. The width of this knotweed stand was approximately 50 feet, therefore eradication at this location would be difficult. To prevent continued localized spread of this stand, this site should be carefully managed (See Section 2.7 Riparian Vegetation). Due to the amount of knotweed and its proximity to the stream edge, this stand will likely provide a source for continued downstream establishment of knotweed stands from broken stems caused by high flows and beaver activity. Planting hardy native shrubs at the toe of the bank may help to reduce the potential for erosion at this site and provide a buffer to minimize the broken knotweed stems from entering the stream and populating the downstream bed and bank.

The best means for controlling knotweed is prevention of its spread, therefore, efforts should be made to ensure that all fill brought into the area is clean and does not have fragments of knotweed or other invasive plants. If Japanese knotweed sprouts or small stands are observed, they should be eradicated immediately to avoid further spread within this unit and downstream management units.

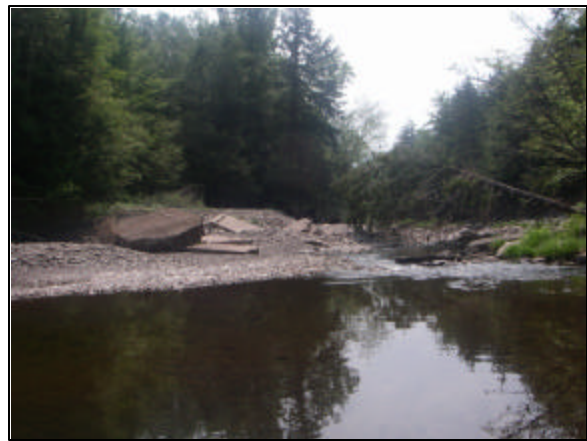
*Concrete abutment remains at Station 34619*

Just downstream there were the remains of an old concrete abutment (Station 34619) along both stream banks. The remains did not appear to have a significant impact on the stream channel at low flows. However, during high flows they may contribute to the aggradational conditions along this stretch of the stream and may provide some localized lateral control.

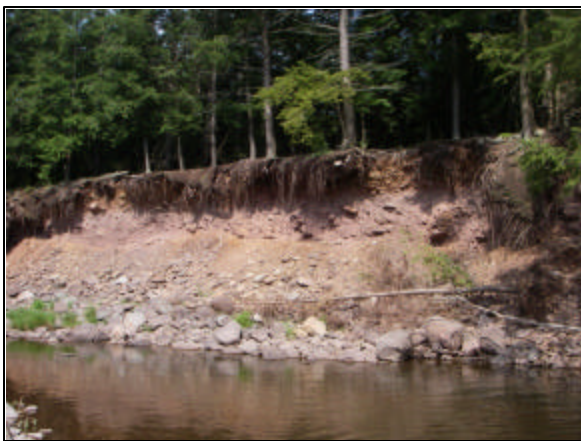
*Mass failure at Stations 34559 - 34461*

As the stream continued to meander to the left, there was a mass failure (Stations 34559 – 34461) along the right. Streambank erosion often occurs on the outside of meander bends where the stream velocity is greatest during high flows; along this section of stream, the thalweg flowed up against the toe of the bank undermining the steep slope, exposing mixed till and compromising mature

trees along the bank. During high flows and times of active erosion, a significant amount of clay may enter the stream from this bank; this poses a water quality threat due to the turbidity associated with clay exposures. To study erosion along this reach, this bank has been monumented as a Bank Erosion Monitoring Site (BEMS # 06EK2085, Station 34559). A cross-section and long profile survey were conducted to collect baseline data. In the future this cross-section can be resurveyed to calculate the bank's erosion rate. It is recommended that monitoring of this site continue.

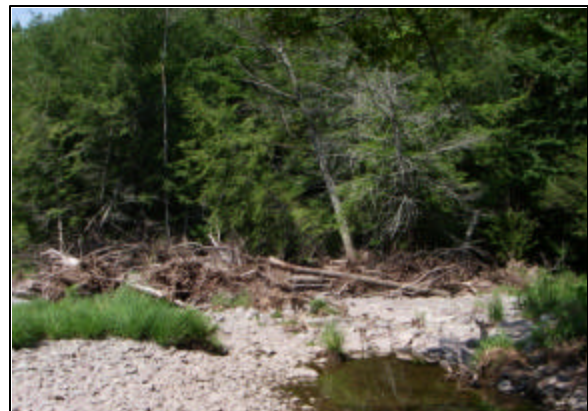
At the downstream end of the bedrock there was significant woody debris (Stations 33069 – 33009) accumulated along approximately 60 feet of the right stream bank. At the time of the assessment, it appeared to contribute to the excessive sediment deposition upstream of the debris and localized scour along the right bank. There was a small patch of knotweed just downstream.

*Woody debris at Stations 33069 - 33009*

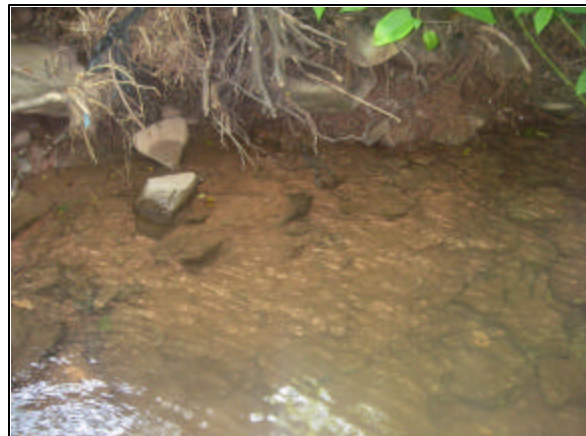
Along the main channel, downstream of the first divergence, there were multiple woody debris accumulations and excessive sediment deposition along both stream banks. Along this meander bend a stream disturbance permit (near Station 31438) was issued following the flood in 1996. The permit was issue for debris removal, stream bank

*Clay exposure along secondary channel*

stabilization measures and excavation of sand and gravel to restore stream flows to pre-flood conditions. There was also a stand of Japanese knotweed along approximately 46 feet of the left stream bank.

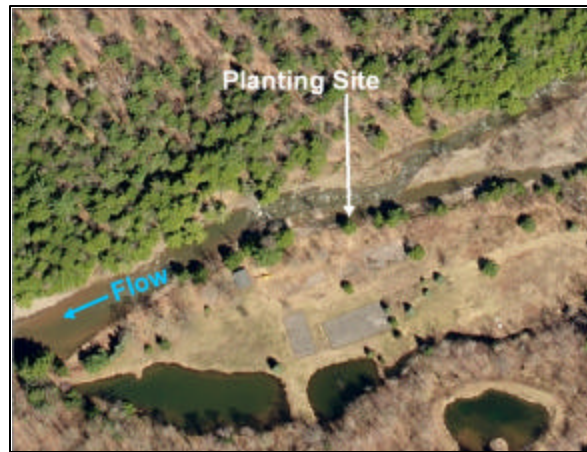
Just downstream of the split channel convergence, a potential riparian planting site was identified along the left stream bank (Station 30576). Recommendations for this

*Riparian planting site at Station 30576*

site include augmentation of the existing buffer with the planting of additional native trees and shrubs along the streambank and the upland area. Buffer width should be increased by the greatest amount agreeable to the landowners. Increasing the buffer width to at least 100 feet will increase the buffer functionality and protect the stream from nearby land uses. Adding vegetation is particularly critical since there is relatively little land separating the pond from the stream. During high flows the area between the pond and stream may be at risk of becoming saturated and washing downstream.

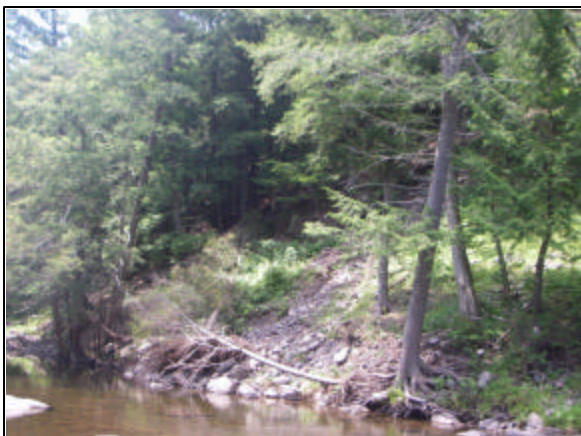
*Erosion at Stations 30442 - 30309*

Continuing downstream, there was a mass failure (Stations 30442 – 30309) along the right stream bank. This mass failure had resulted in an erosion area of approximately 5,322 ft<sup>2</sup>, compromising mature trees along the bank. Although this bank was a significant erosion site, it appeared to be slowly recovering, with herbaceous vegetation becoming established on the face

of the bank. However, without deep-rooted shrub and tree species, this bank may continue to erode during future high flows. This erosion site may self recover with time; however, it may also be a good candidate for remediation using vegetative toe and bank protection. Prior to proceeding with any work, this site would require a more detailed site assessment. Opposite the eroding bank there was a water intake pipe (Station 30370) through a stand of Japanese knotweed (Stations 30370 - 30047, Figure 4.7.1 Inset B) along approximately 323 feet of the left stream bank. Aggradational conditions persisted through this stretch of the stream.

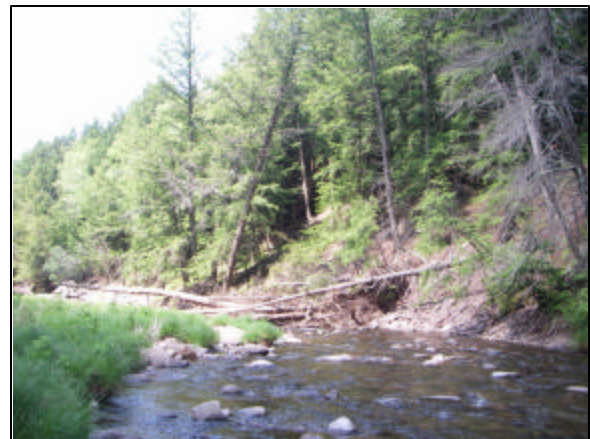
*Mass failure at Stations 29657 - 29235*

As the stream gently meandered to the left the *thalweg*, or deepest part of the stream channel, flowed up against the right stream bank causing a mass failure (Stations 29657 – 29235). Along this erosion site, the steep forested bank was undermined resulting in an erosion area of approximately 12,667 ft<sup>2</sup> and compromising mature trees along the bank.

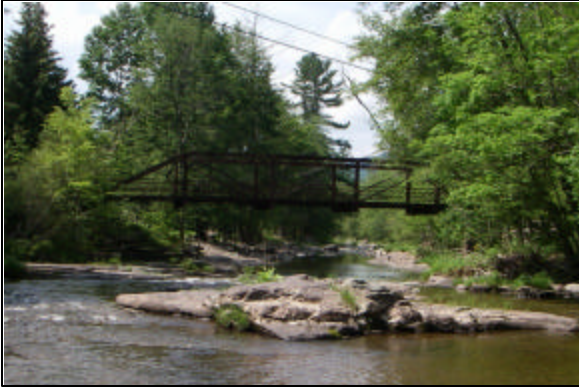
*Bridge at Station 28817*

The bedrock channel continued through the Beaches Corners Road Bridge (Station 28817, Bridge # 3201150). This bridge may constrict stream flow during periods of very high water, but it appeared to have an adequate span that would pass most flows effectively. At the time of the assessment, aggradational conditions were noted downstream of the bridge. If this bridge is replaced in the future, it is recommended that a hydraulic analysis be conducted in order to determine the appropriate bridge width that will provide the capacity to convey flood flows through the opening. Downstream of the bridge, there were multiple stands of Japanese knotweed along the left stream bank.

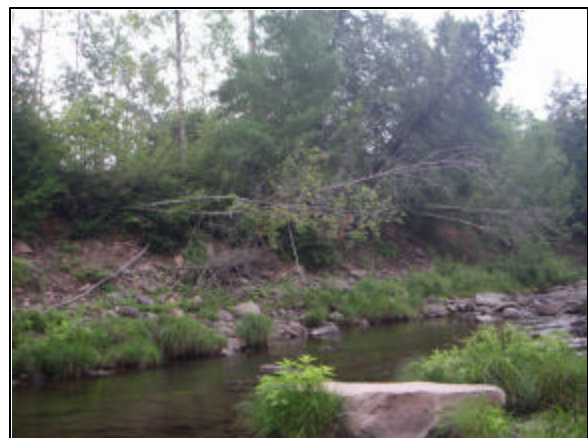
After the stream flowed under the bridge, it was laterally confined along the right due to the encroachment of Beaches Corners Road. The stability of the road embankment was compromised due to the erosion (Stations 28151 – 27800) along approximately 351 feet of the right stream bank. At the start of the erosion the bank was beginning to fail, moving downstream, the erosion worsened with fallen trees, exposed soil and minimal herbaceous vegetation. There was a narrow forested riparian buffer between the stream and Beaches Corners Road along the upstream portion of the erosion site. The

*Erosion at Stations 28151 – 27800  
photo orientation – looking upstream*

buffer had fewer mature trees along the downstream portion of the erosion. Recommendations for this site include the augmentation of the existing buffer with the planting of additional native trees and shrubs along the streambank and the upland area. Prior to proceeding with any work, this site would require a more detailed site assessment.

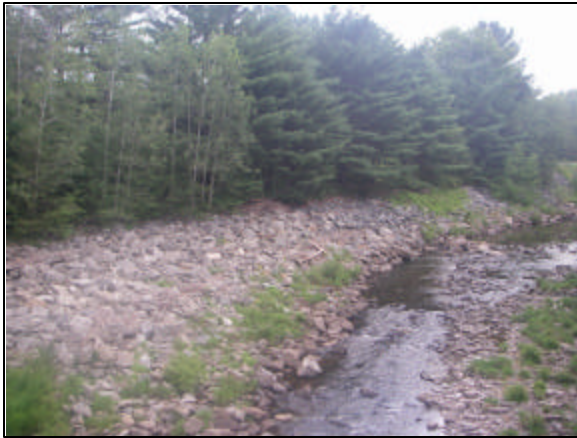
*Rip-rap at Stations 27224 – 26386  
photo orientation – looking upstream*

Continuing downstream, aggradational conditions persisted including point and side bars, and there were multiple patches of Japanese knotweed. The stream continued to flow close to Beaches Corners Road and the right embankment was reinforced with approximately 838 feet of rip-rap (Stations 27224 – 26386). The rip-rap appeared to be in good functional condition; the toe of the bank was stabilized with large rock, while the top of the bank had smaller rock that appeared to be in fair structural condition. The type of rock varied moving downstream as well. There was a small amount of herbaceous vegetation that had established itself along the rip-rap, and some Japanese knotweed interspersed along the revetted bank. Removal of this Japanese knotweed is recommended to prevent the spread of this invasive specie (See Section 2.7 Riparian Vegetation), and native shrub and sedge species should be interplanted through this rip-rap to help strengthen the revetment, while enhancing aquatic habitat. The riparian buffer beyond the rip-rap installation was sparse along the upstream portion of the revetted bank, with some shrubs and mown grass to the edge of the bank. The risk to bank stability can be minimized by maintaining mature trees along the top of this bank.

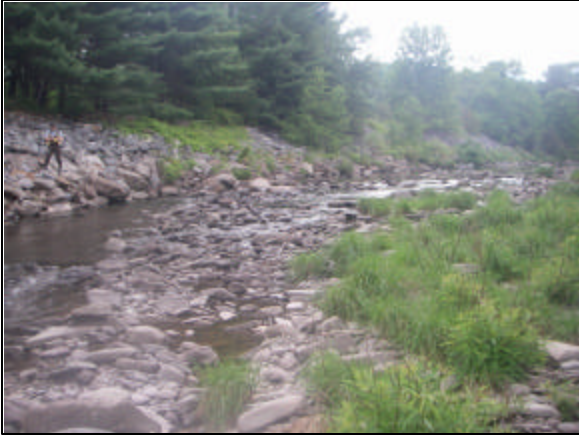
*Transverse bar at Stations 26555 - 26483  
photo orientation – looking upstream*

This management unit ended at the Route 296 Bridge (Station 26386, Bridge # 1045150, Figure 4.7.1 Inset A). There was a transverse bar (Stations 26555 – 26483) upstream of the bridge. Aggradational conditions such as this are commonly caused by inadequate sizing of the bridge opening. An undersized bridge opening causes water to back up upstream of the bridge, reducing stream velocity, which results in sediment deposition. While bankfull flows may flow freely through this bridge, higher flows may backwater, resulting in the upstream aggradation. If this bridge is replaced in the future, it is recommended that a hydraulic analysis be conducted in order to determine the appropriate bridge width that will provide the capacity to convey flood flows.
