# West Kill Management Unit 14

## Management Unit 14

Between Station 20415 and Station 18646

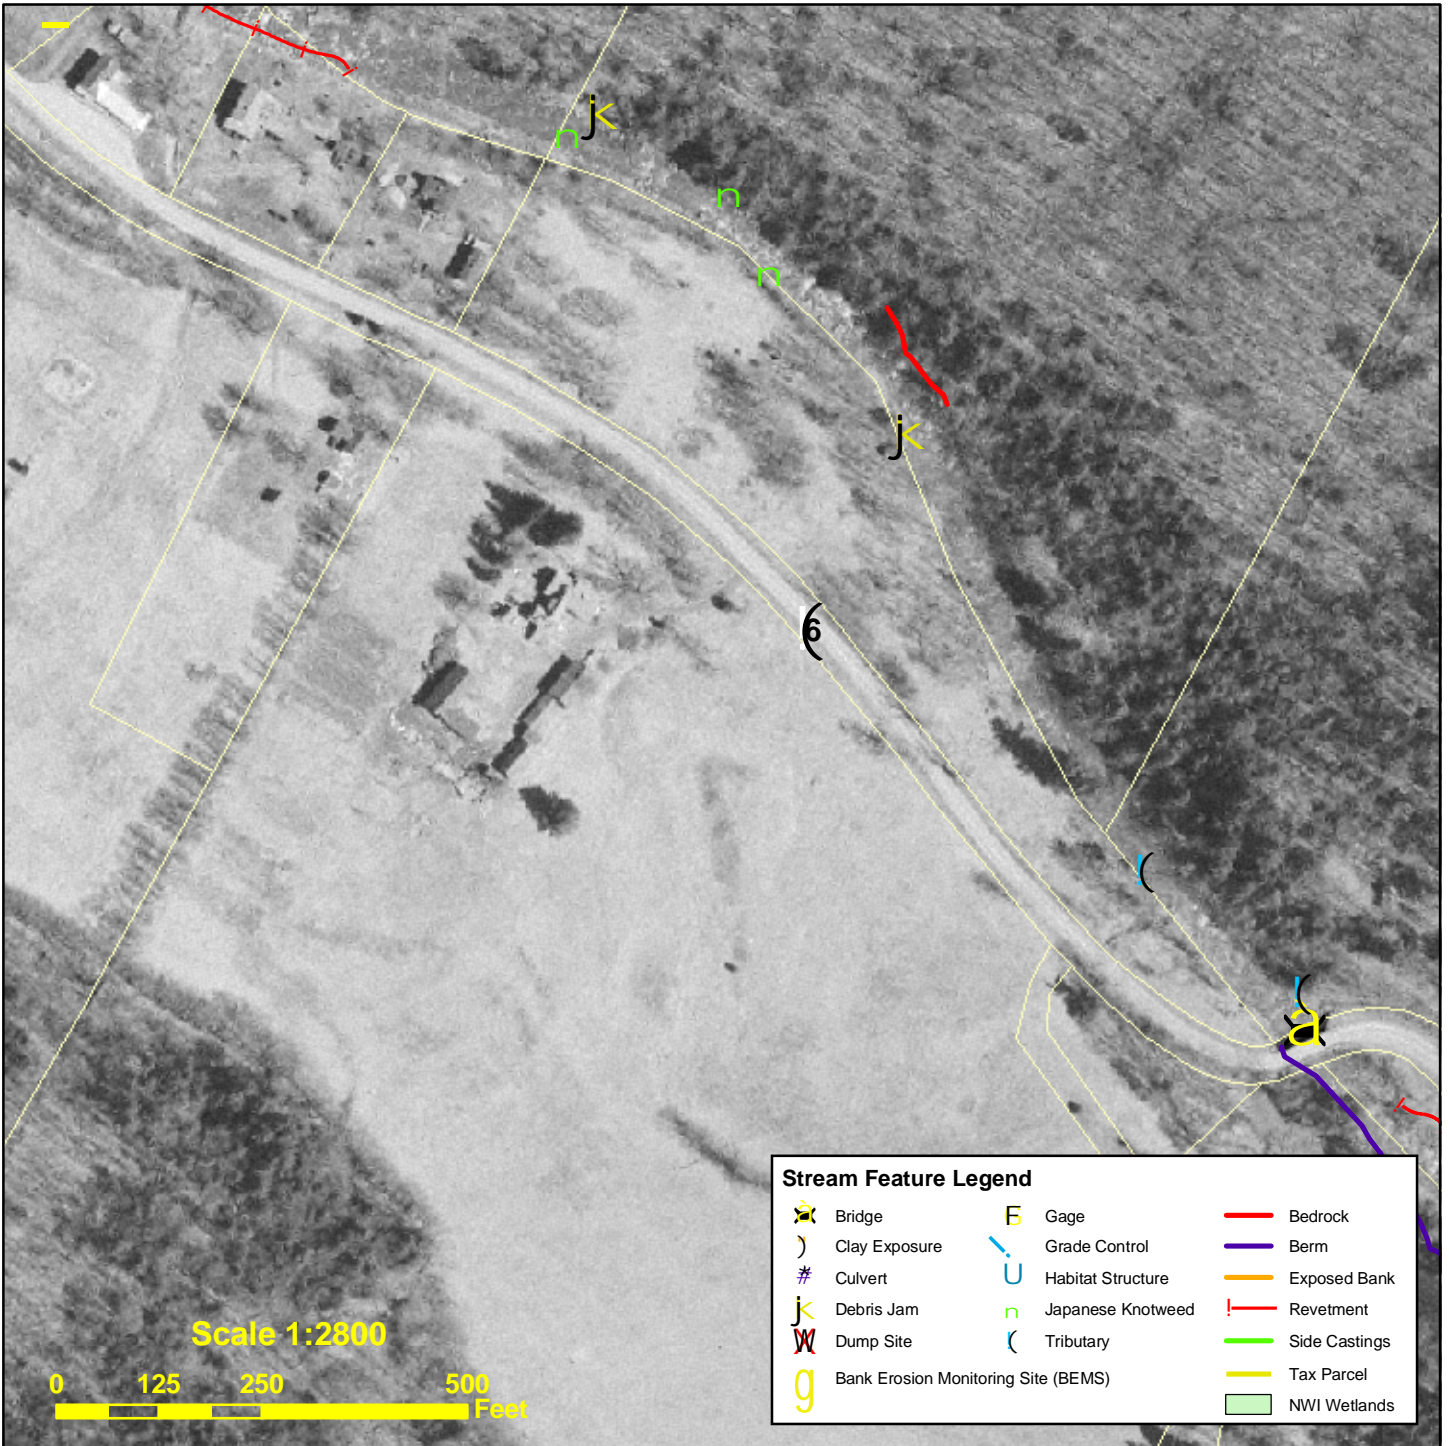
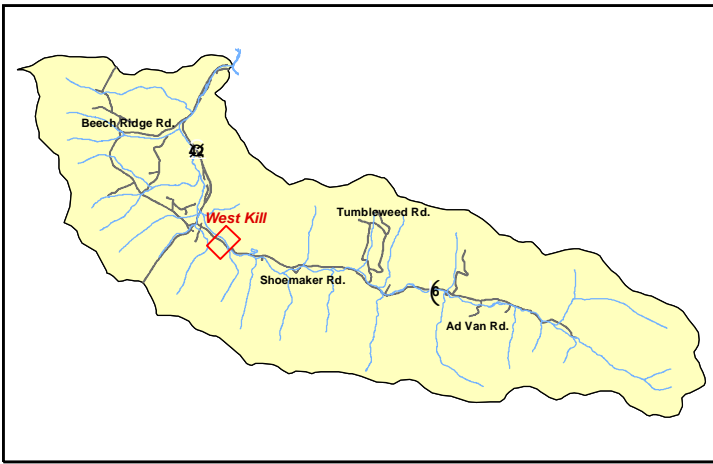
Figure 4.14.1 2004 aerial photography with stream feature inventory and tax parcels

The 2004 stream feature inventory revealed that there were no signs of active erosion along 1769 ft. of total channel length (Fig. 4.14.1). Revetment has been installed on 3%

(61.4 ft.) of the stream length. No berms were identified in this management unit at the time of the stream feature inventory.

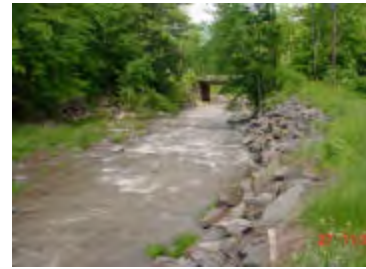
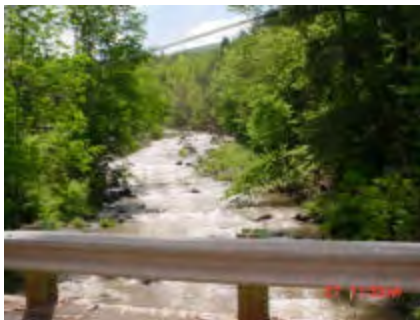
**Route 6 bridge, looking upstream**

Greene County Route 6 bridge (Inset H, Fig. 4.14.2) marks the upstream end of Management Unit 14. The bridge is old, but in fair condition. The span of this bridge is inadequate to convey bankfull flows without flow constriction and backwater. The bridge has no rock scour protection and significant abutment scour is evident. Increased water surface elevations upstream of this bridge have resulted in flooding

of the hamlet during larger flood events, which flank the bridge to the south. This bridge is scheduled for replacement in 2006, and coordination with Greene County Highway Department is recommended to ensure application of appropriate channel dimensions to the bridge design. The bridge design should be evaluated from a hydraulic perspective to determine the impact it will have on flooding in the hamlet.

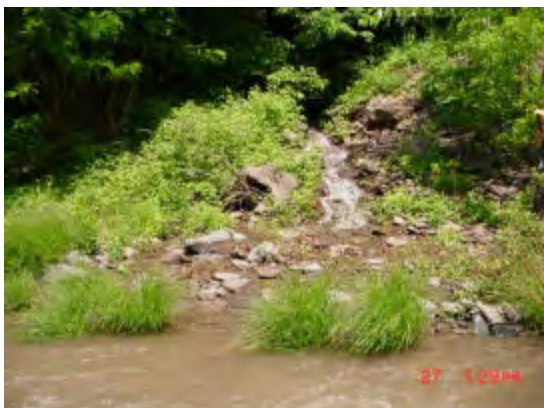
**Tributary, right**

An unnamed tributary joins the West Kill from the right, just downstream of the bridge abutment. The tributary confluence is perched, but well vegetated and fairly stable.

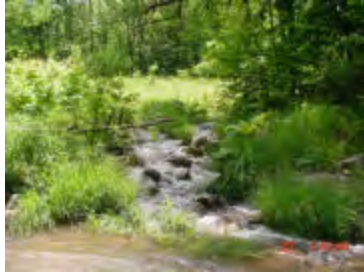
**Tributary, left**

A larger unnamed tributary (Inset D, Fig. 4.14.2) finds its confluence approximately 250 ft. downstream of the bridge. The tributary flows from the left, delivering flow and sediment from a 0.6 mi<sup>2</sup> catchment. The mouth is well connected and stable, with vigorous vegetation on both banks. A monumented cross-section (Station 20135) has been established immediately downstream of the mouth of the tributary to verify the B3c stream type.

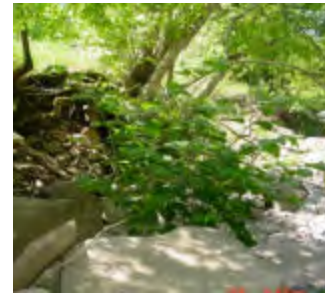
**Knotweed**

During the 2004 and 2005 inventory, three stands of Japanese knotweed (*Fallopia japonica*), an invasive, exotic shrub species that can grow rapidly to crowd out more appropriate streamside vegetation, were observed between Stations 18975 and 19300 (see Inset E and F, Fig.4.14.2). A program for eradication of Japanese knotweed throughout the West Kill valley is recommended.

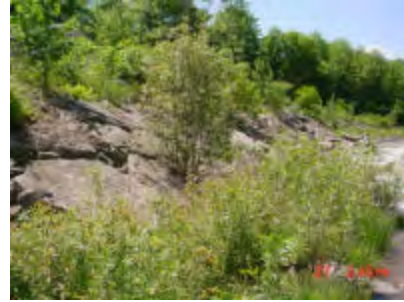
**Rip Rap, left**

As Management Unit 14 ends, 214 ft. rip-rap is found on the left bank behind residential structures. The rip-rap continues into Management Unit 15. The riparian buffer beyond the rip rap installation is in poor condition, with mown grass to the edge of the bank. The risk to bank stability can be minimized by maintaining mature trees along the stream margin, including a critical buffer zone extending approximately 75 ft. from the centerline of the stream (Fig. 4.14.4). The risks and benefits

associated with management of streamside vegetation will depend partly on the current channel conditions, and local channel surveys are recommended at each site. Recommendations for this area include interplanting of the rip rap, and enhancement of the riparian buffer with planting of ecologically appropriate tree and shrub species in the adjacent mown lawn.
