# Neversink River West Branch

## MANAGEMENT UNIT 3

WEST BRANCH MANAGEMENT UNIT 3  
BETWEEN STATION 5700 AND STATION 10300

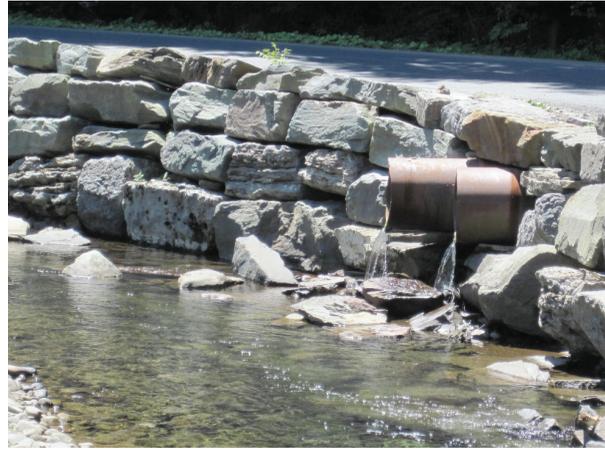
is constructed of dumped stone and rip rap. The brook outlet from Round Pond is conveyed through two 48-inch diameter smooth steel pipes through this revetment near Station 10280. (A282) The revetment was documented in good structural and functional condition although deposition on the left bank appeared to be directing flow toward the revetment, which could be causing scour below the water level. It is recommended that this revetment be inspected for structural stability. (A286)

*Stacked rock revetment protecting Frost Valley Road (A282)*

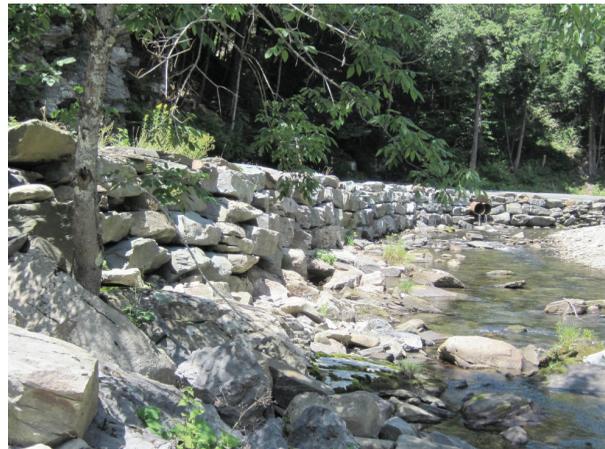
*Dumped stone and rip rap revetment (A286)*

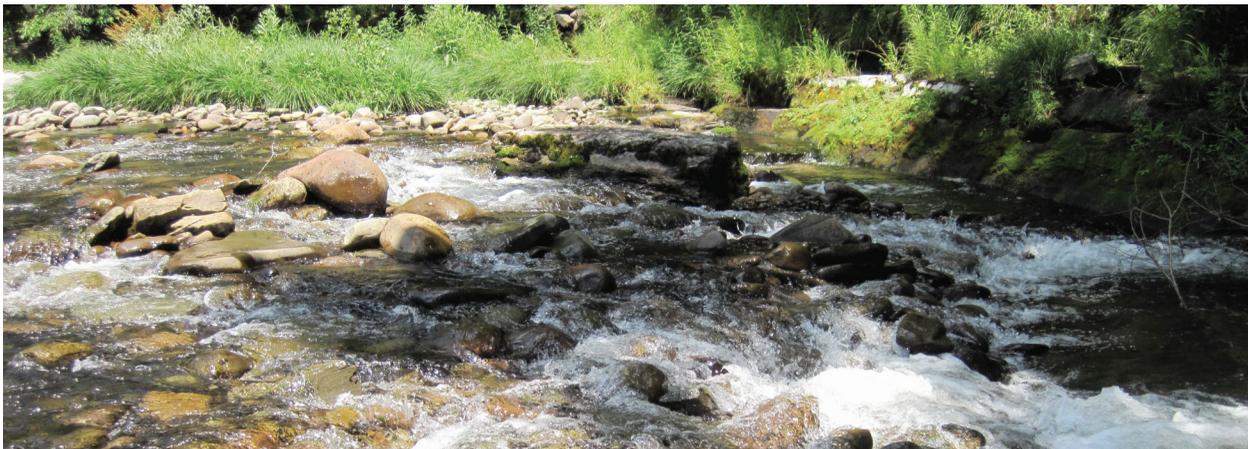
Near Station 9620 the main channel begins to flow adjacent to the left valley wall. An intermittent tributary was observed joining the main channel at Station 9600 conveying flow from the left valley wall. A headcut was also observed near Station 9600. Downstream of the head cut the main channel takes a sharp turn to the west, flowing in a straight channel confined by the valley wall on both banks for most of the management unit. (A291)

*Headcut in main channel (A291)*

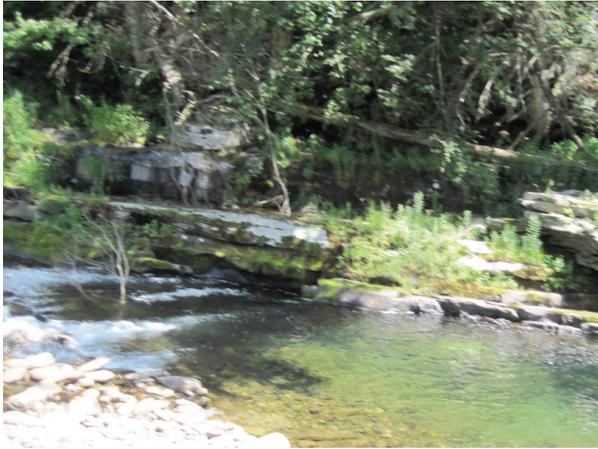
Exposed bedrock was observed forming a lateral and grade control on the left bed and bank of the main channel from Station 9640 to Station 8900. Across from the bedrock a 60-foot side cobble side bar was observed on the right stream bed, extending 450 feet to Station 9100. (A293, A294)

*Lateral and grade bedrock control (A293)*

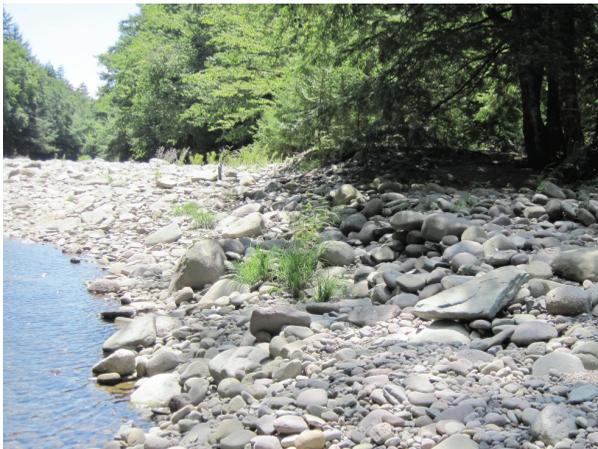
*Cobble side bar on right stream bed (A294)*

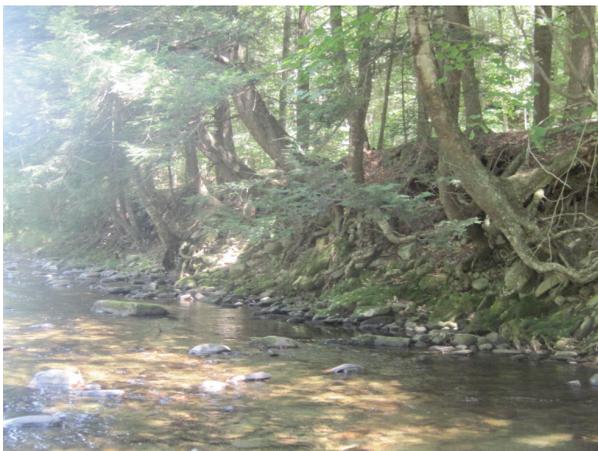
*Inactive eroding bank segment on left bank terrace (A300)*

An inactive eroding bank segment was observed on the left bank terrace from Station 8800 to Station 8700. (BEMS NWB3\_8700) This bank site was documented as originally caused by hydraulic erosion and fluvial entrainment but it has since been stabilized by hemlock and birch growth on the top of the bank. It is recommended that this bank be left to further revegetate and stabilize without treatment (*passive restoration*) and that the site be monitored for changes in condition. (A300)

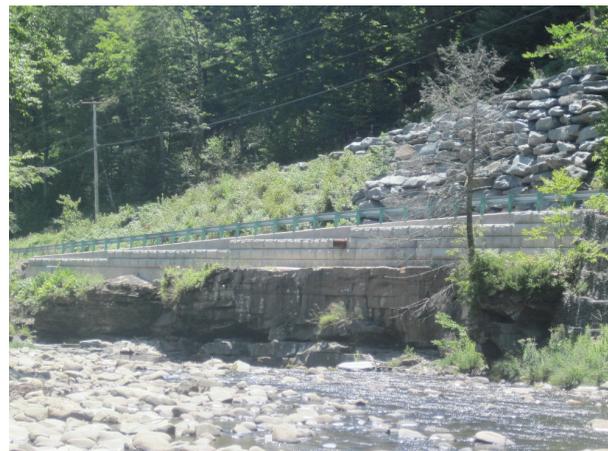
At Station 8600 the main channel begins to flow within 50 feet of Frost Valley Road, eventually flowing directly adjacent to Frost Valley Road at Station 8450. A revetment constructed of varying materials on the right bank extends 500 feet from Station 8680 to Station 8180. The beginning 100 feet of the revetment are constructed of stone gabion baskets, and the remainder is constructed of stacked rock revetment on a concrete and bedrock foundation. The revetment was documented in good structural and functional condition. (A302) Portions of this revetment between Station 8470 and Station 8300 are potential riparian buffer improvement areas.

*Stacked rock revetment on concrete and bedrock foundation (A302)*

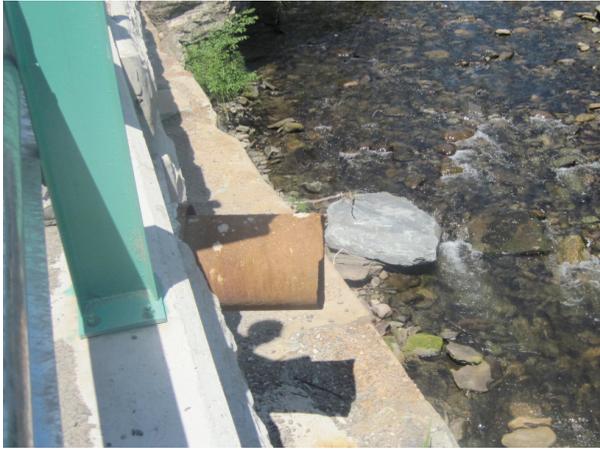
*Piped outfall conveying flow from right valley wall (A304)*

Two piped outfalls conveyed flow from the right valley wall through the revetment wall to the main channel. The first, located near Station 8450, was constructed of a 12-inch diameter smooth steel pipe with a 4-foot outfall and good outfall protection. (A304) The second, located at Station 8280, is constructed of a 12-inch diameter plastic pipe with a 5-foot outfall and good outfall protection. (A308) It is recommended that the water quality impacts of this outfall be investigated to better understand and possibly mitigate the water quality implications of this conveyance.

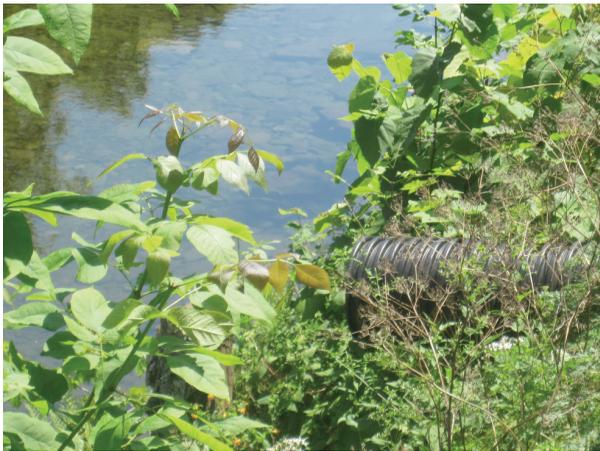
*Piped outfall conveying fall from right valley wall (A308)*

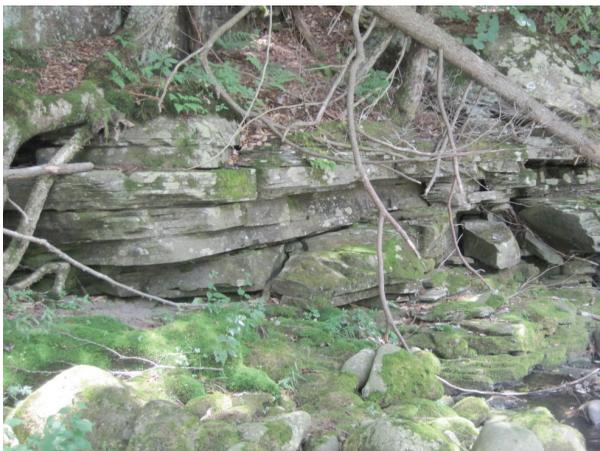
Downstream of the revetment the main channel no longer flow adjacent to Frost Valley Road, with a this forested buffer between the road and the channel for the rest of WBMU3. Exposed bedrock was observed on the left bank from Station 7800 to Station 7460. This bedrock is acting as a planform control, constraining lateral migration of the main channel at this location. In intermittent tributary conveying flow from the left valley wall over the bedrock was observed near Station 7800. (A310) Two large boulder obstructions were observed in the main channel near Station 7000, and more exposed bedrock forming a planform

*Exposed bedrock on left valley wall (A310)*

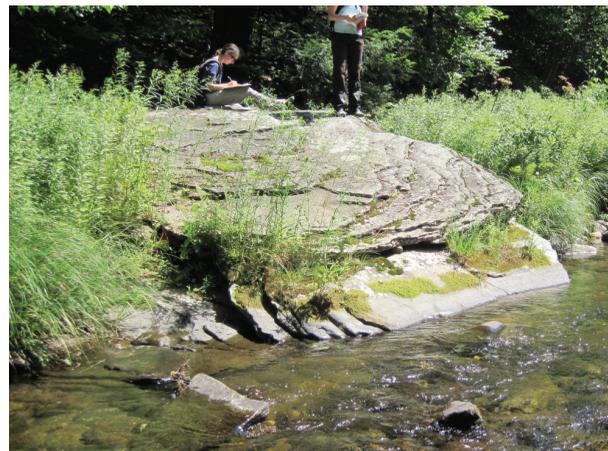
*Boulder and bedrock planform control (A318)*

control was observed on the right bank from Station 6800 to Station 6130. An intermittent seep was observed flowing over this exposed bedrock near Station 6620. (A318, P7290172)

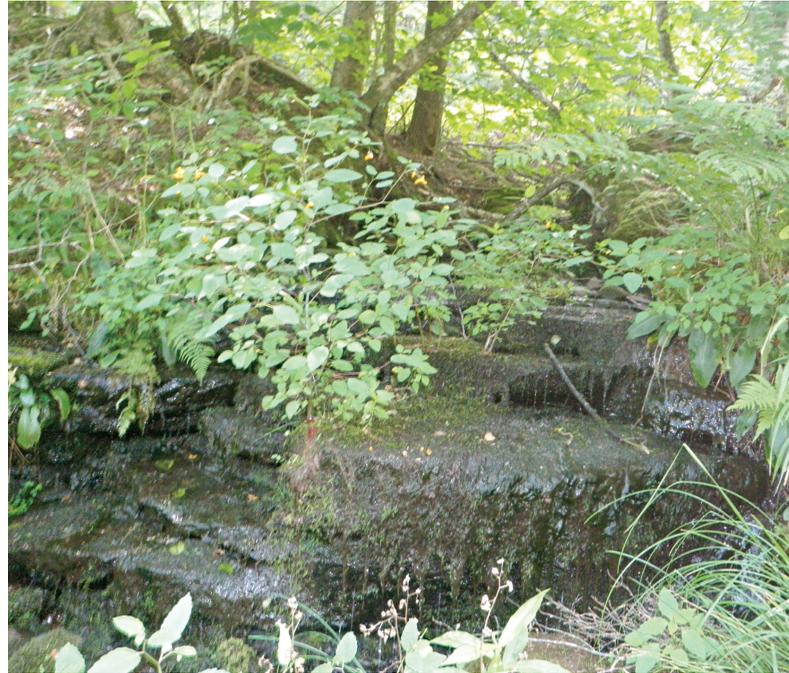
*Intermittent seep flowing over bedrock (P7290172)*
