Final Report

for Fish Passage Improvement

> on Town Brook

Town of Stamford

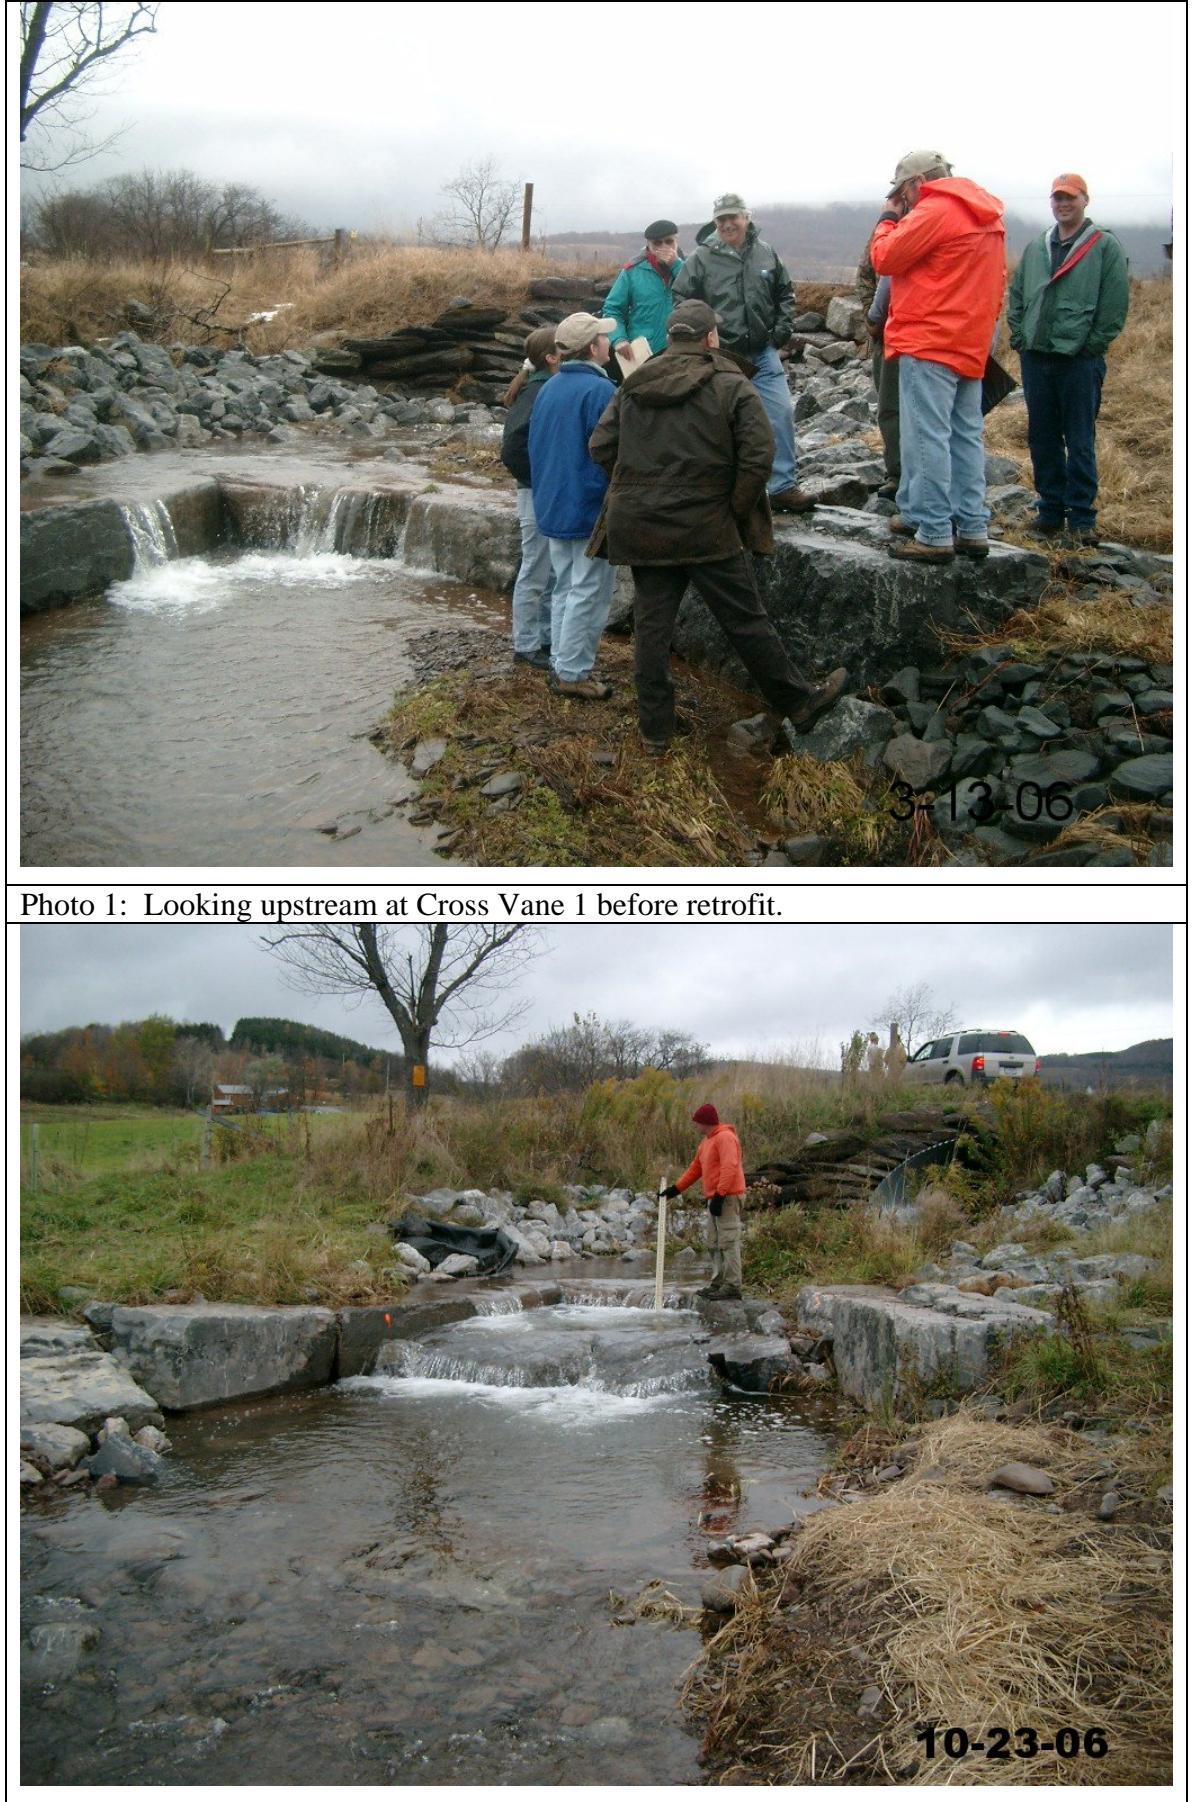
Photo 2: Looking upstream at Cross Vane 1 after retrofit. H:\Working Data\WestBranch SCMP\Projects\Town Brook\Dave Post\2006_Fish Passage Refit\Photos\2006\Post_Before_After_v2.doc

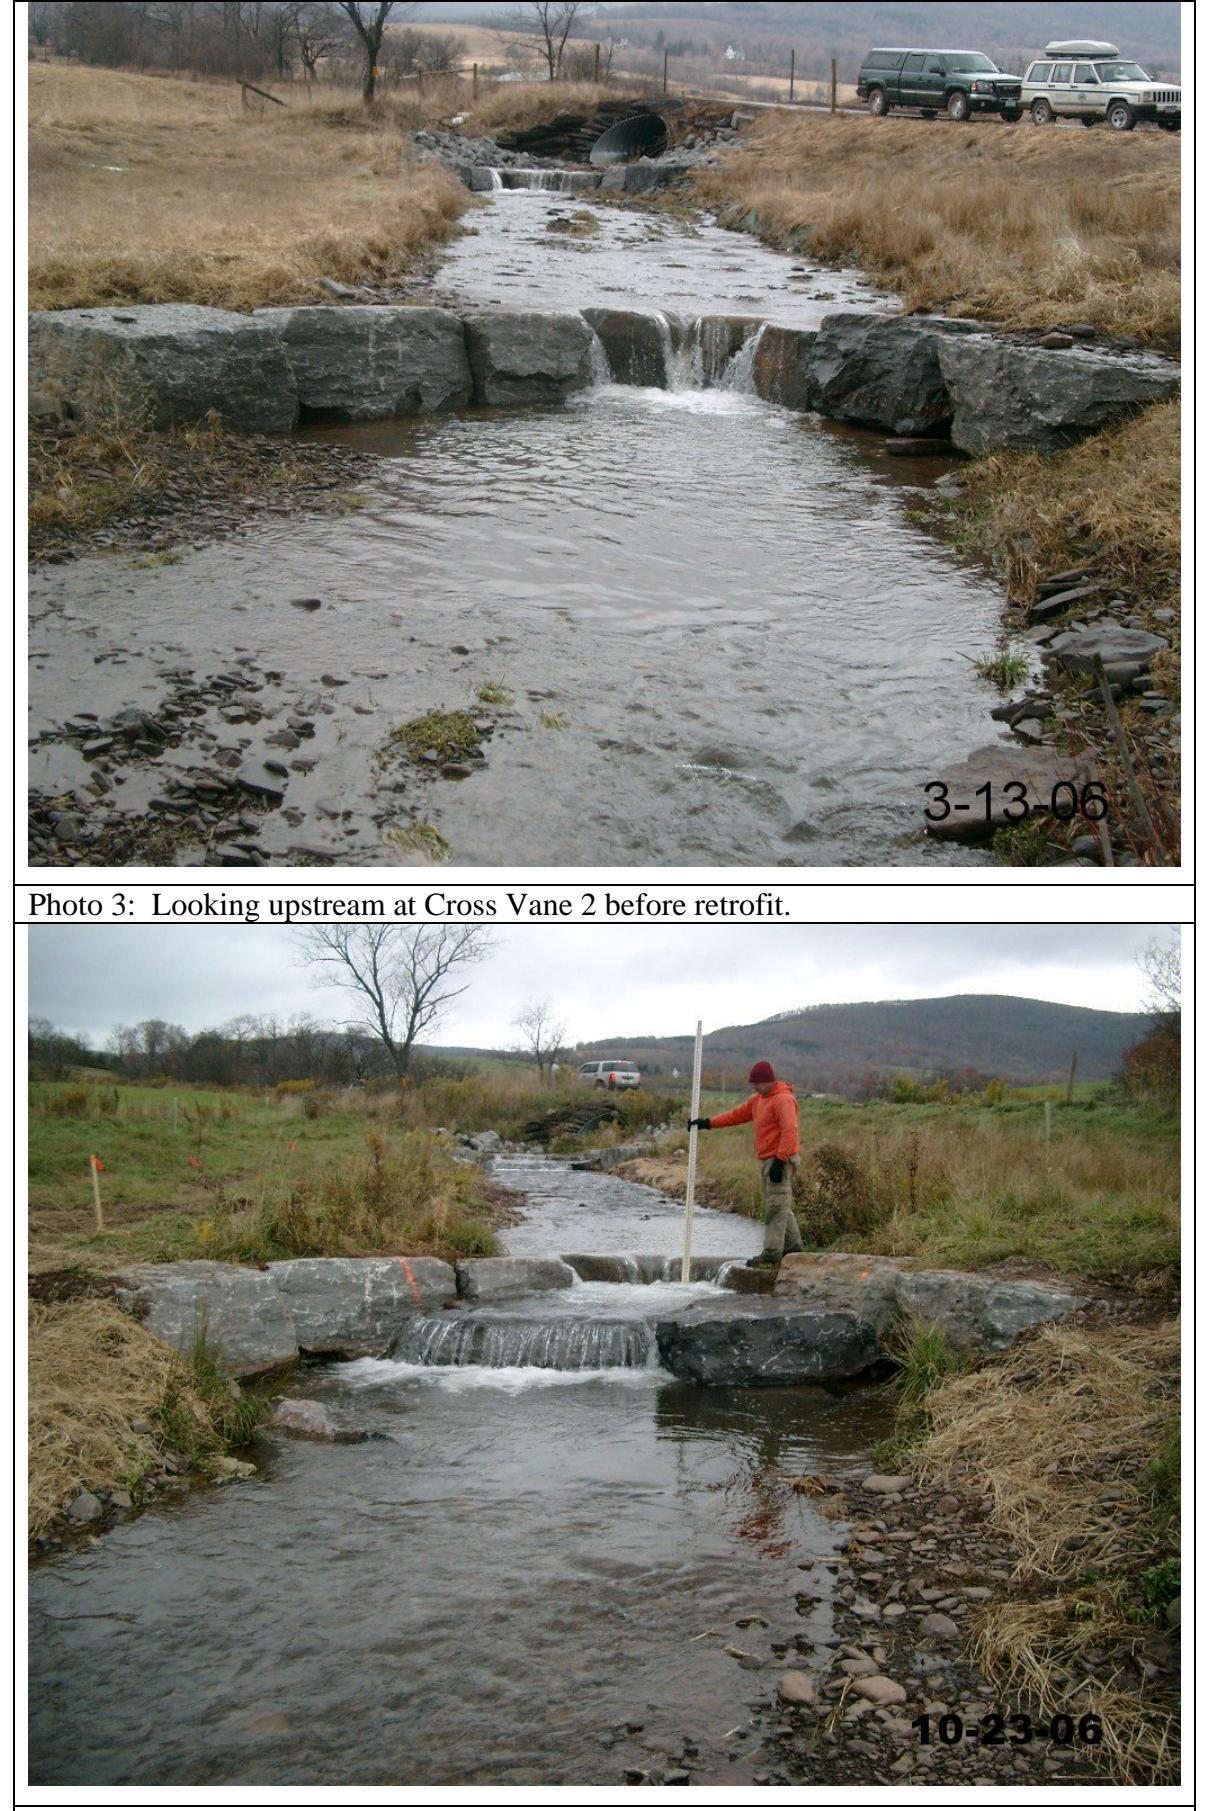
Photo 4: Looking upstream at Cross Vane 2 after retrofit. H:\Working Data\WestBranch SCMP\Projects\Town Brook\Dave Post\2006_Fish Passage Refit\Photos\2006\Post_Before_After_v2.doc

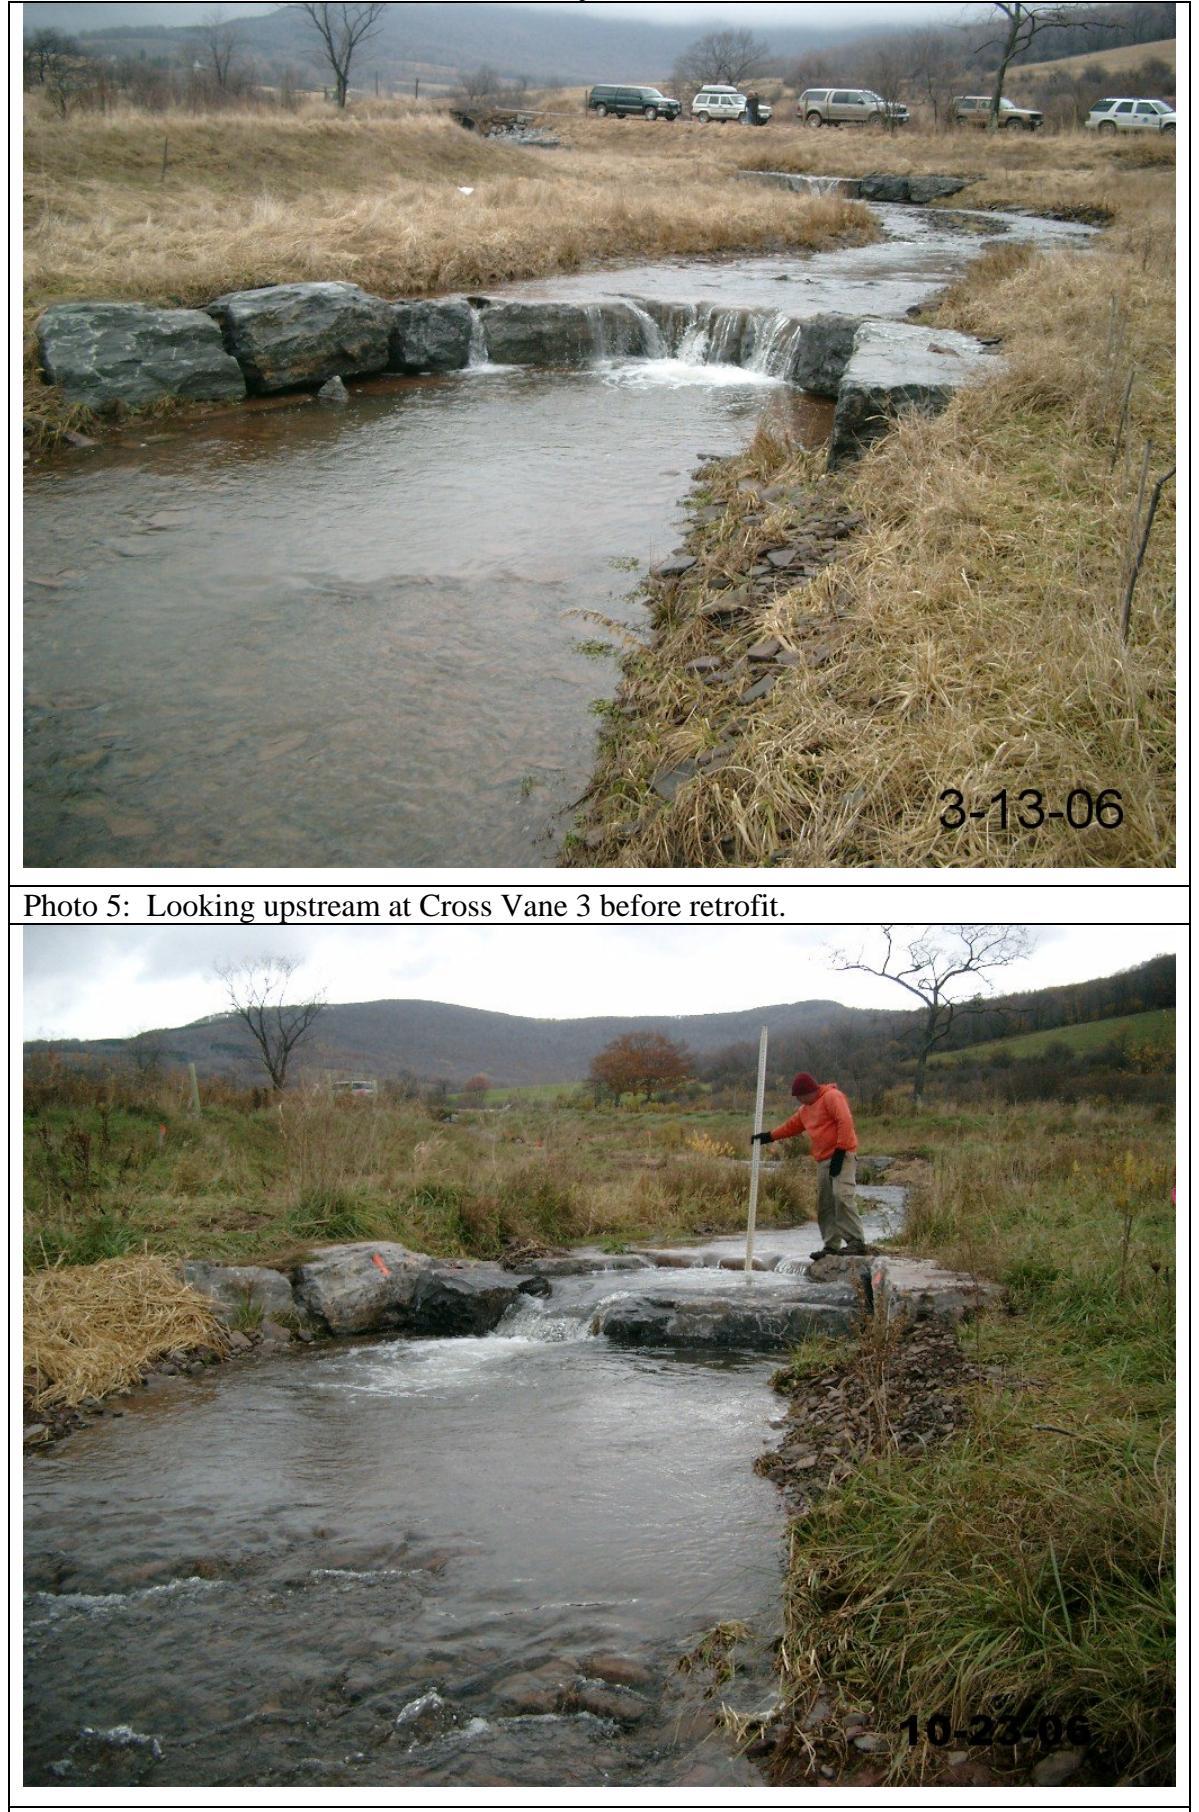
Photo 6: Looking upstream at Cross Vane 3 after retrofit. H:\Working Data\WestBranch SCMP\Projects\Town Brook\Dave Post\2006_Fish Passage Refit\Photos\2006\Post_Before_After_v2.doc

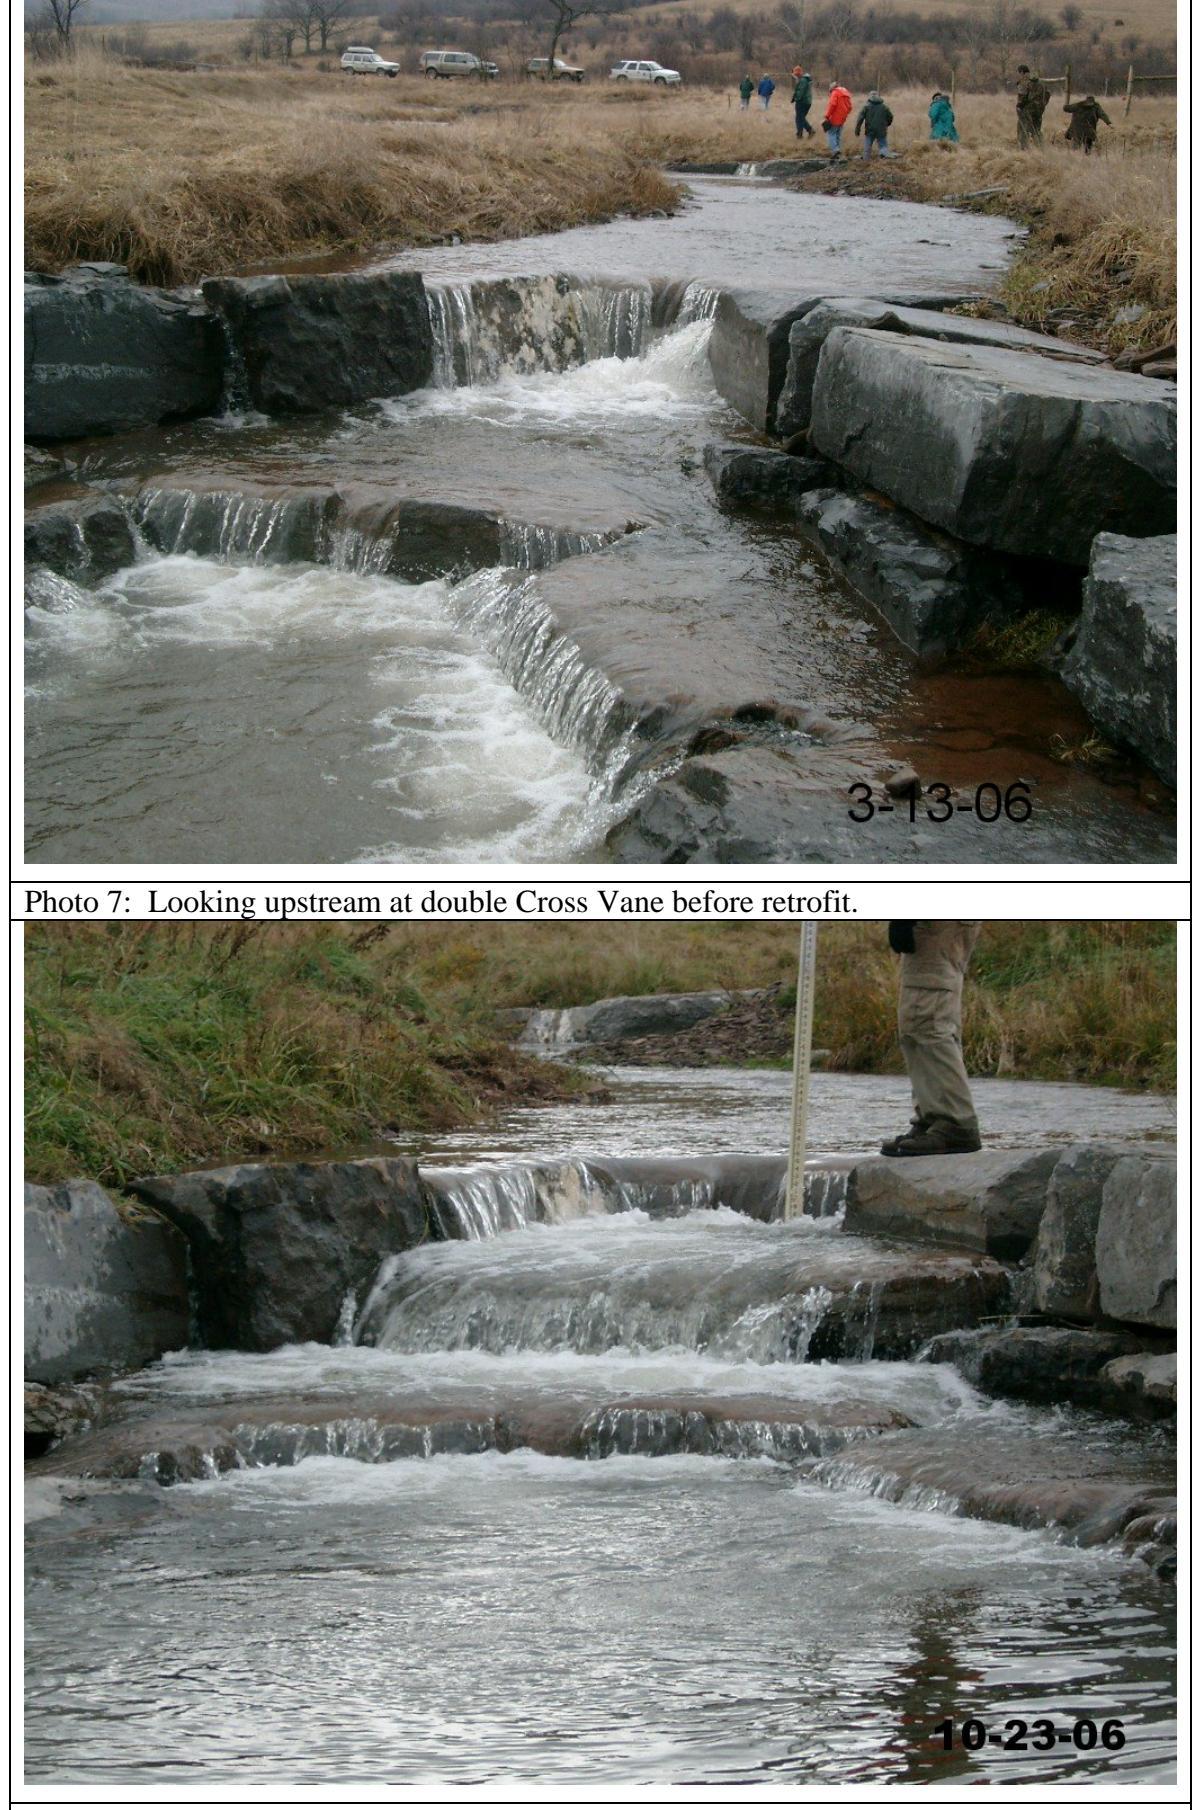
Photo 8: Looking upstream at double Cross Vane after retrofit. H:\Working Data\WestBranch SCMP\Projects\Town Brook\Dave Post\2006_Fish Passage Refit\Photos\2006\Post_Before_After_v2.doc

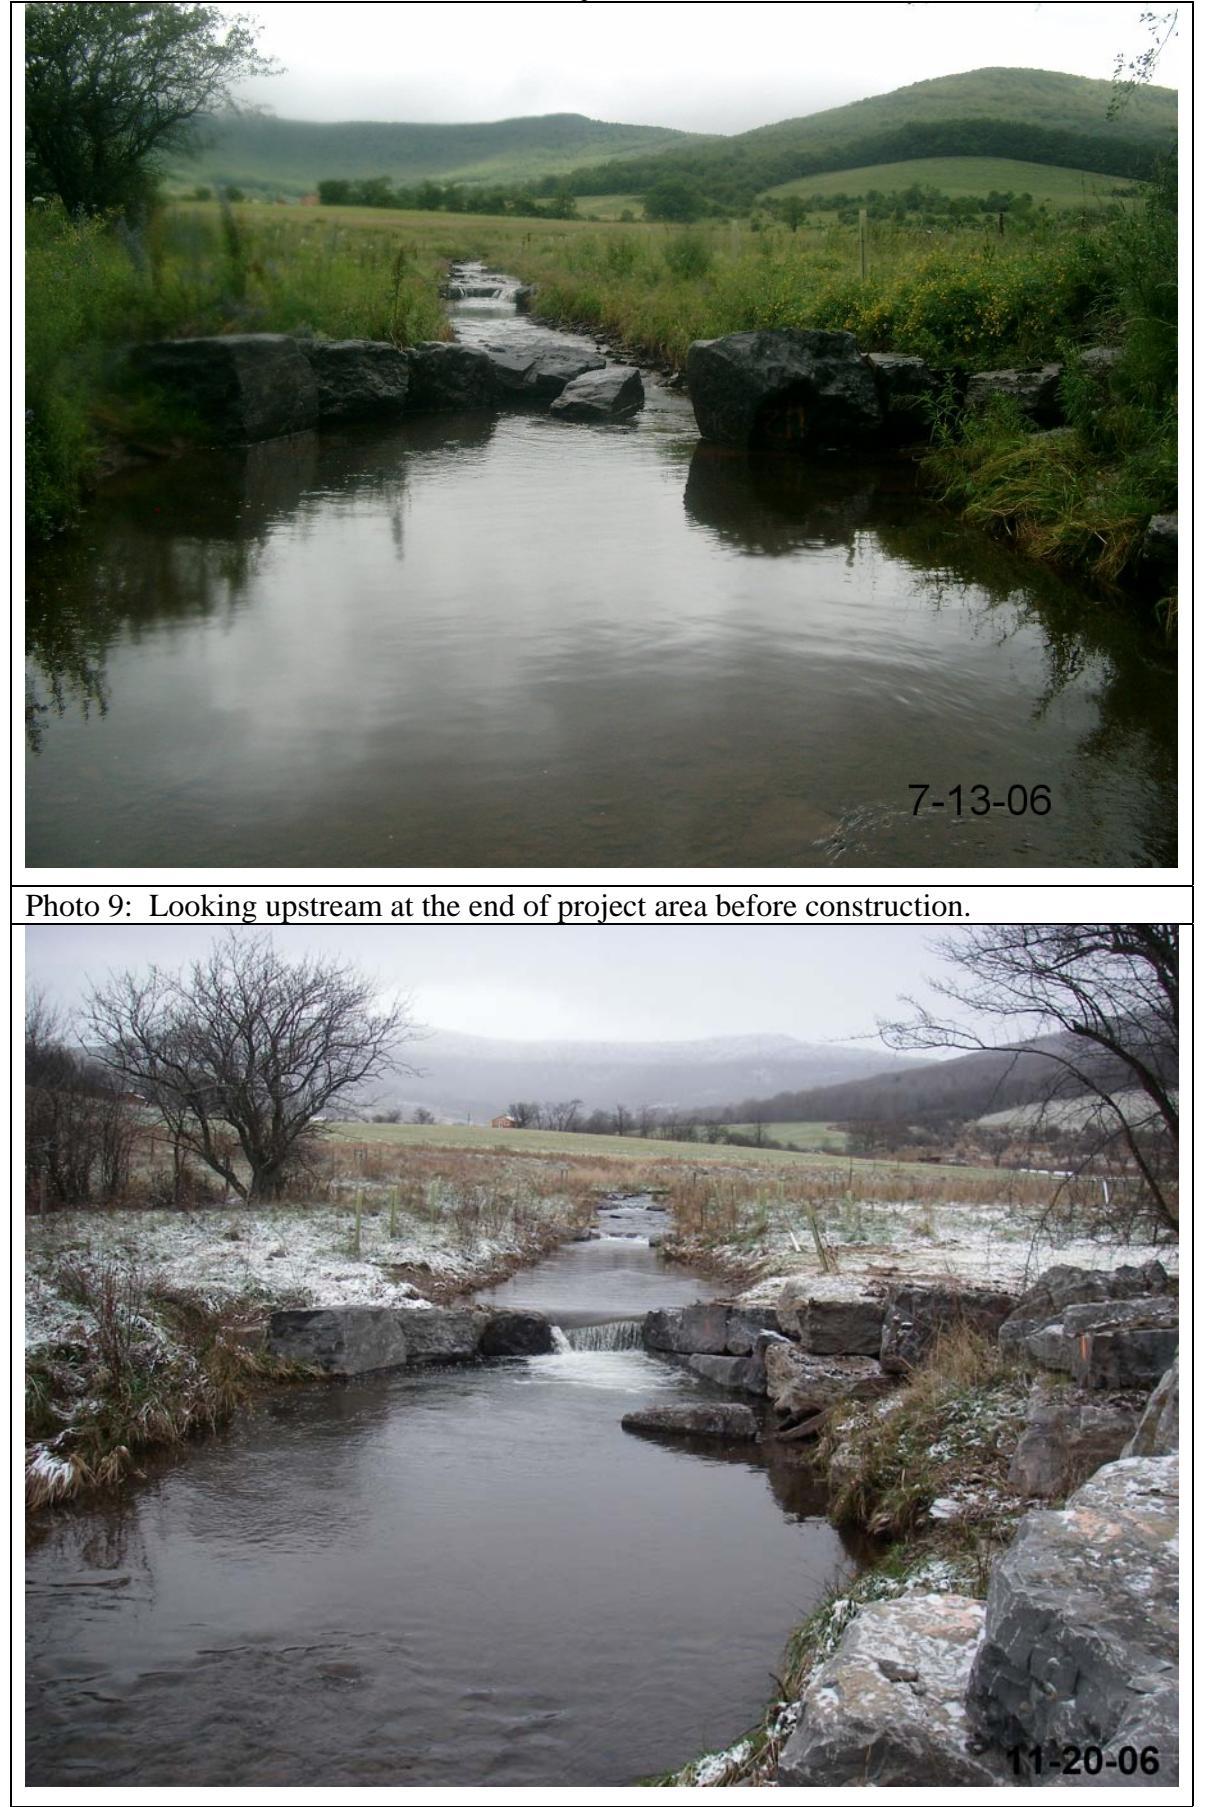
Photo 10: Looking upstream at the end of the project area after construction. H:\Working Data\WestBranch SCMP\Projects\Town Brook\Dave Post\2006_Fish Passage Refit\Photos\2006\Post_Before_After_v2.doc

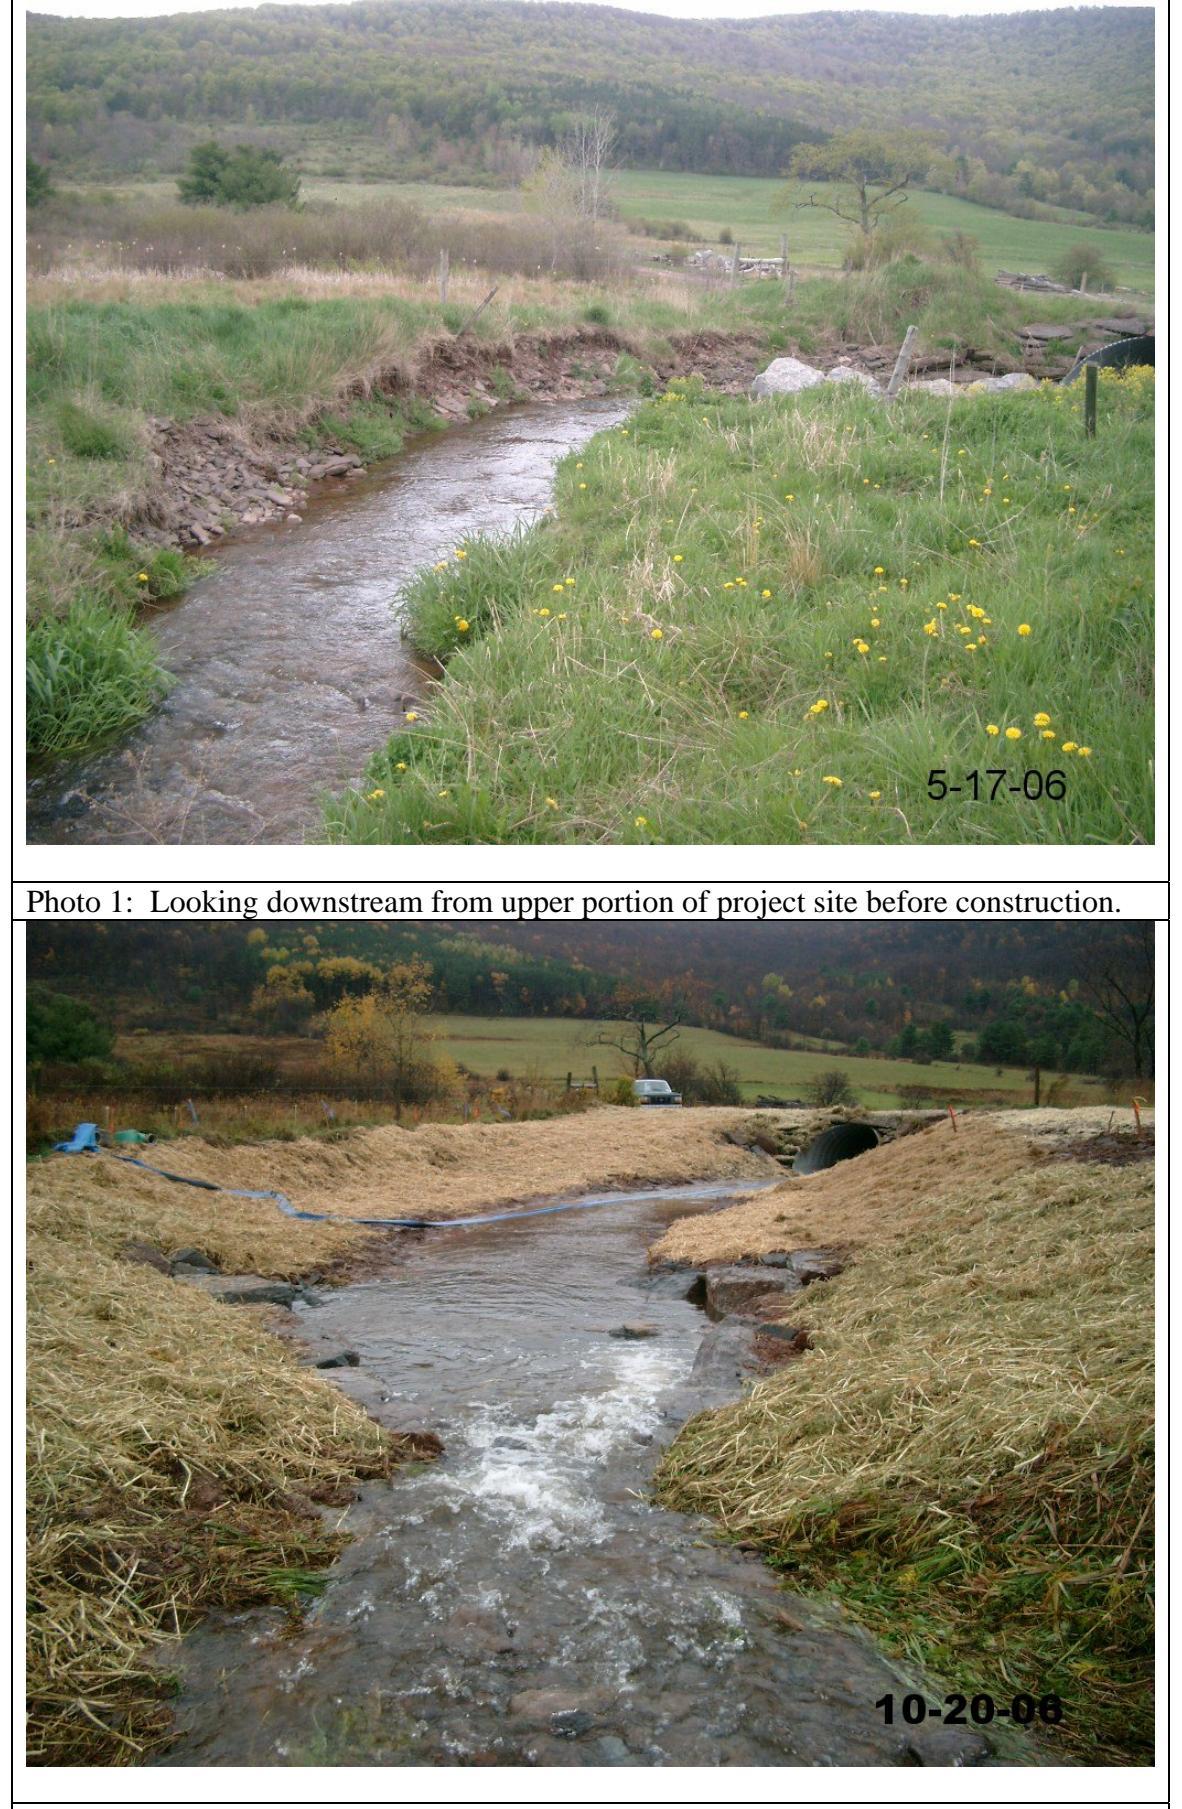
Photo 2: Looking downstream from upper portion of project site after construction. H:\Working Data\WestBranch SCMP\Projects\Town Brook\Palmatier\Photos\Palmatier_before_after.doc

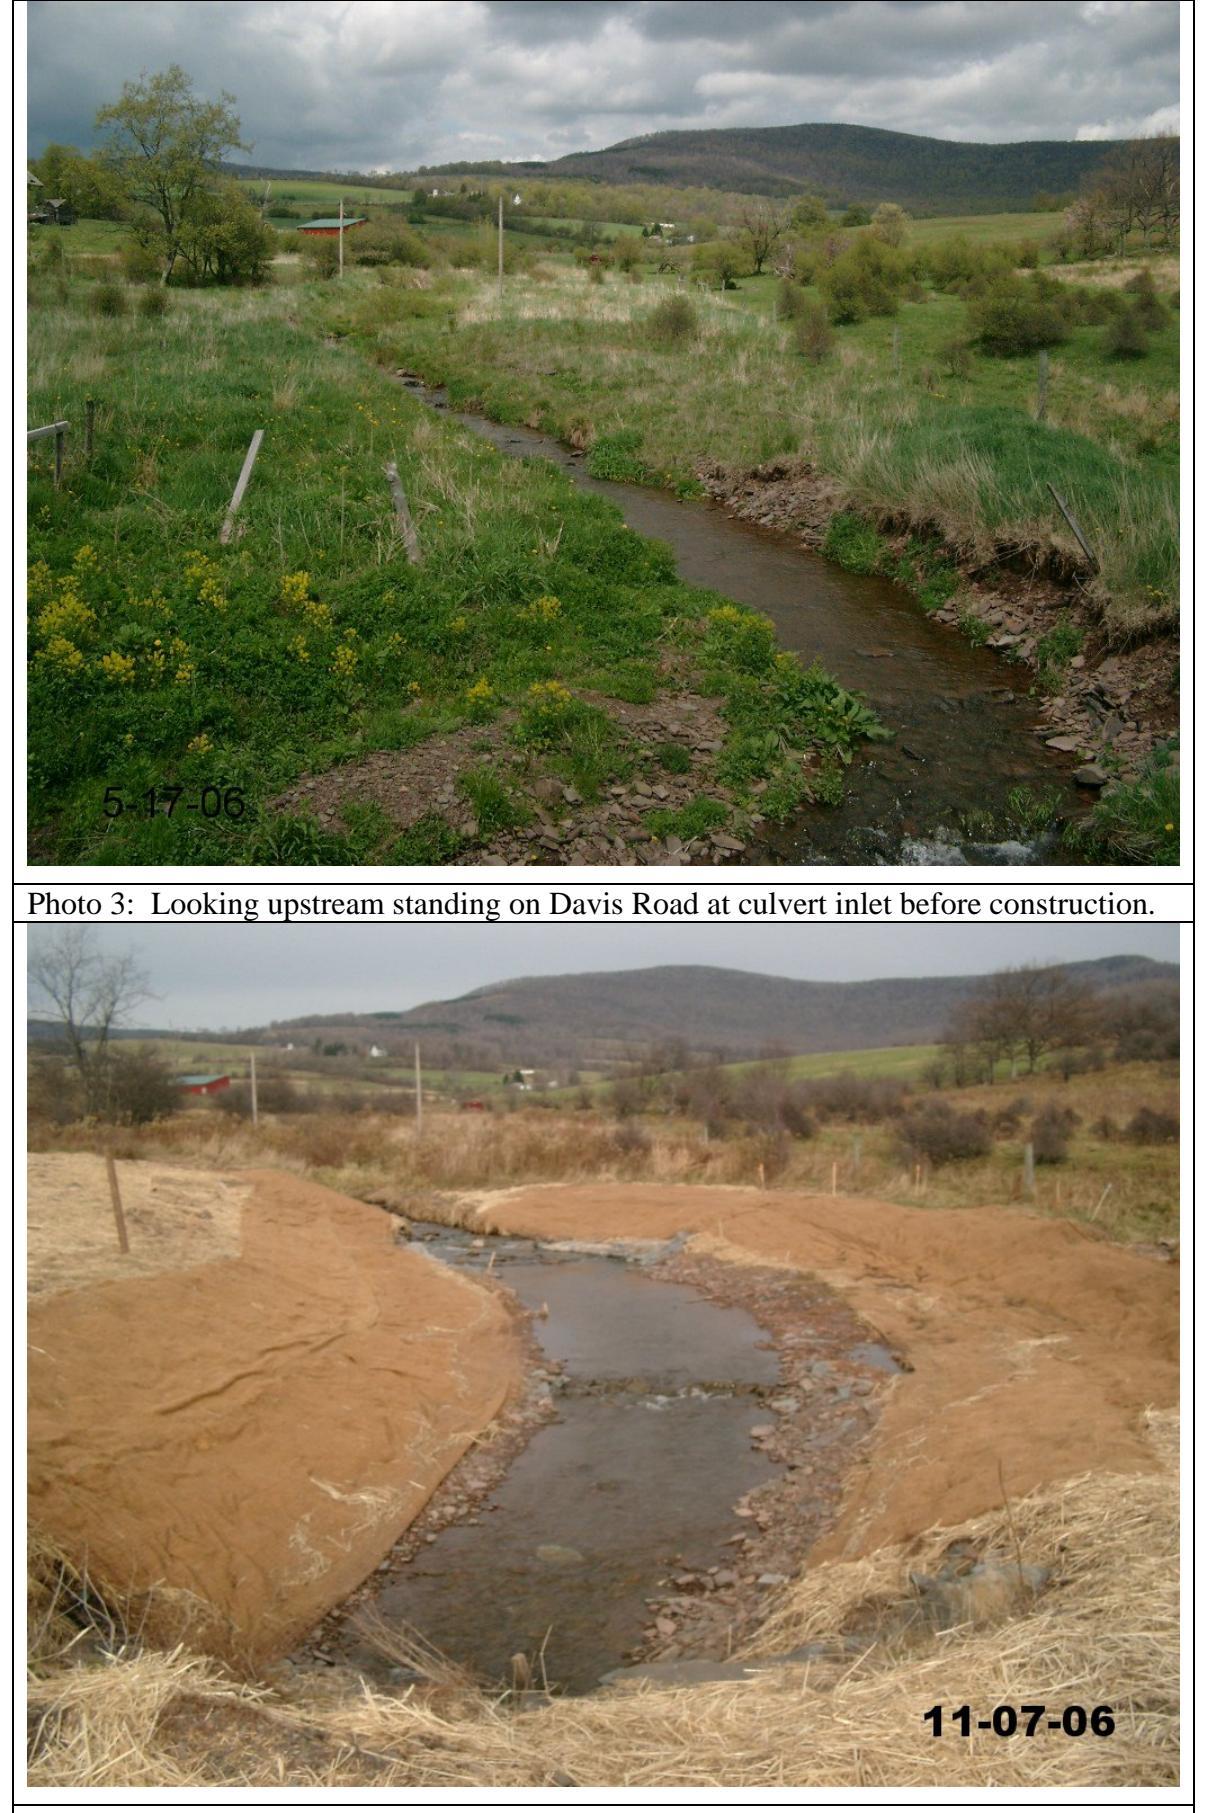
Photo 4: Looking upstream from Davis Road after construction. H:\Working Data\WestBranch SCMP\Projects\Town Brook\Palmatier\Photos\Palmatier_before_after.doc
