## Management Unit 13

Ulster County - Town of Shandaken  
Between Cross Section 149 & 150 to Cross Section 153

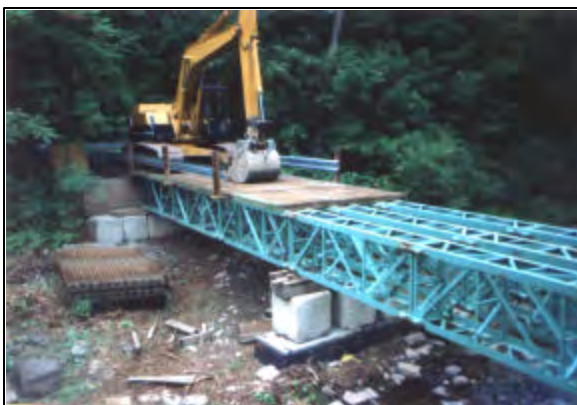
Figure 4 Bridge at Stony Clove Lane under construction, September 16, 1993

After the 1996 flood, an emergency permit was issued to Stuart Felberg to install rip-rap and remove wood debris and gravel from the flood event (Inset C). In 1999, another permit was issued to Stuart Felberg and Ellen Lerner, to install 110 ft. of rip-rap on the right stream bank. In 1993, the Ulster County Department of Public Works (DPW) was issued a permit to replace the bridge at Stony Clove Lane (Fig. 4 & Inset F). This project required of the removal of the existing deteriorated

superstructure and left abutment, which at the time consisted of deteriorating laid-up timber cribbing. A new reinforced concrete abutment on the left bank, new multi-stringer superstructure and a laminated timber deck were installed. In 1994, the Ulster County DPW was issued another permit to perform minor excavation at the base of the stream embankments at either end of the left abutment in order to provide a level area to install a laid-up stone wall for the stabilization of the failing stream bank. This failure was threatening to undermine Stony Clove Lane. In 1996, the Ulster County DPW was issued a permit, in response to stream bank failure on the left stream bank downstream from the Stony Clove Lane Bridge, to install 15 ft. of steel sheet piling extending downstream from the left bridge abutment, backfill and grade the failed bank to the existing top of bank. Directly downstream from this bridge, in 1996, another permit was issued to Karen Selig to install 75 ft. of rip-rap and skim gravel to be used as backfill along the left stream bank. After the 1996 flood an emergency permit was issued to David Goldberg to install timber cribbing or rip-rap along 250 ft near the end of the management unit. There is currently no rip-rap or log cribbing found along this bank, indicating that the project was either never completed or that the revetment has been washed away.

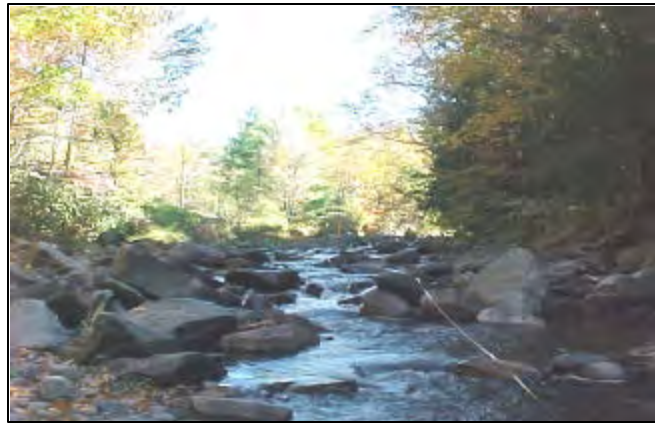
**Figure 6 Cross-section 150  
Stream Type B3 Looking Upstream**

Management unit #13 begins with a 320 ft. reach of B3 stream type (Fig. 6). This stream reach is moderately *entrenched*, or confined within the stream banks during high flow events. Stream channel slope is 2.1% and the dominant bed material is cobble.

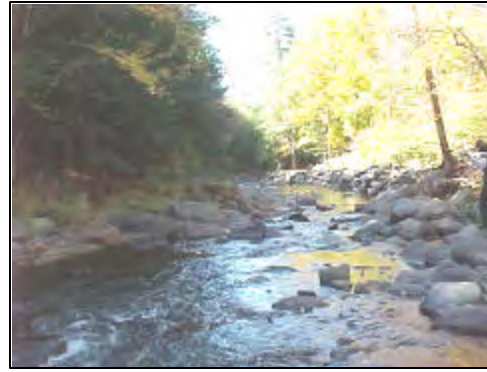
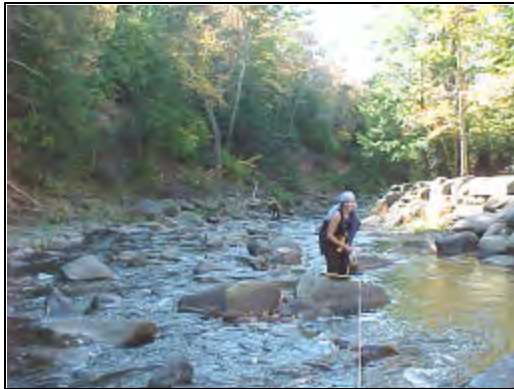
Continuing downstream, the channel *meanders* to the left, becomes disconnected from its floodplain and widens, changing stream type to F3 for the next 728 feet (Fig. 7 & 8). Channel slope of this reach decreases to 1.3%.

Rip-rap has been installed along approximately 387 ft. of the right stream bank, which begins on the outside of the meander bend and continues through the next bend, ending on the inside of the meander (Inset C). Stream bank erosion often occurs on the outside bank of bends, where the stream velocity is greatest during high flows. At the top of this bank are two private residences with grass lawns extending to the stream bank edge.

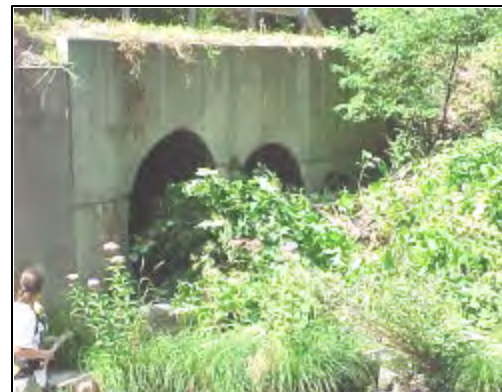
**Figure 9 Floodplain Culverts**

The stream channel widens further as it approaches the Stony Clove Lane Bridge (Inset B). This bridge (BIN #3347250) is maintained by Ulster County and was last replaced in 1993. Three large floodplain culverts were installed through the right bridge abutment, to help reduce the obstruction to flood flows caused by the bridge approach (Fig. 9). Bridges often cause stream instability because they constrict stream flow through a small opening. These floodplain culverts protect the bridge abutment by allowing floodwaters to pass, reducing flood stages upstream and enhancing sediment transport continuity. As a result of the floodplain drainage provided by these culverts, the *aggradation* typically found upstream of bridges is not evident here.

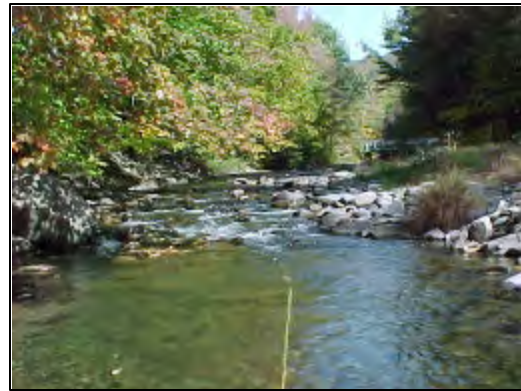
**Figure 10 Cross-section 151  
Stream Type B3c Looking Upstream**

As the stream emerges from under the bridge, it transitions to a B3c stream type for the remaining 384 ft. of this management unit (Fig. 10). This reach is overwide and shallow, probably due to channel grading associated with bridge and abutment maintenance, and the deposition of *bedload* due to the abrupt change in floodplain access and width. Deposition of bed materials is common in overwide channels because they lose their ability to transport the stream's bedload. In this situation streams often *aggrade*, or rise in stream bed elevation due to excessive deposition. Overwide channels also provide poor fish habitat due to the filling of pools and warmer water temperatures.

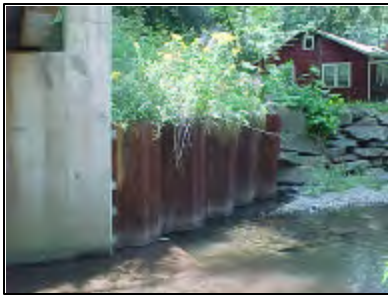
**Figure 11 Sheet Piling**

In response to repeated erosion which threatened Stony Clove Lane, the Ulster County DPW installed 13 ft. of sheet piling along the left stream bank downstream from the bridge. Immediately downstream of the sheet piling, the landowner has installed a 63 ft. stacked rock wall (Inset E) and 55 ft. of log cribbing (Inset A) to protect the left stream bank from erosion. At the top of this bank is a grass lawn extending to the stream bank edge.

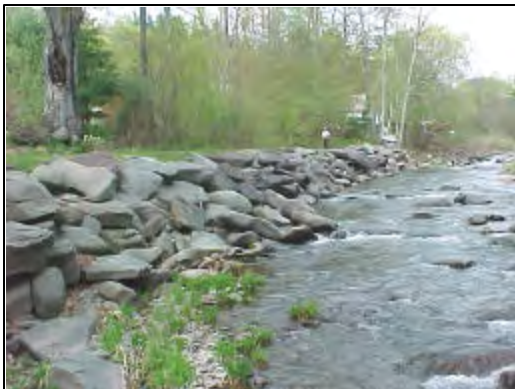
Figure 14 Planting Site #39 looking upstream

Planting site #39 is located on two residential properties along rip-rap on the right stream bank upstream from the Stony Clove Lane Bridge (Fig. 14). This stream bank is heavily armored with rip-rap, with grass lawn mown to the edge of the stream bank (Inset C).

Recommendations for this site include *joint planting* the existing rip-rap, by inserting plantings into the soil between the rip-rap rocks. Joint planting will strengthen and increase the longevity of this rip-rap. These plantings will also improve the aquatic habitat

by providing shade, which maintains cooler water temperatures. Upland plantings of native trees and shrubs in the mown areas will also improve the long-term stability of this bank and increase the buffer functionality.

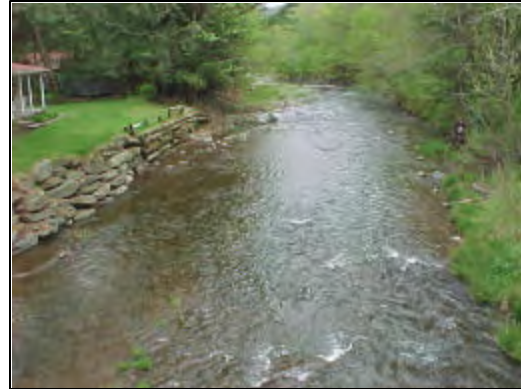
**Figure 15** Planting Site #41 looking downstream

Planting site #41 is located on three properties on the left and right stream bank, downstream from the Stony Clove Lane Bridge (Fig. 15). The left stream bank is stabilized with rip-rap and log cribbing (Inset E & A). The right stream bank has a low bench with disturbed vegetation, with herbaceous upland areas. Recommendations for this site include *joint planting* the existing rip-rap, by inserting plantings into the soil between the rip-rap rocks. Joint planting may be difficult at this site due to the steep slope of the stream bank. To increase bank stability willow *fascines* could be planted at the toe of this bank.

Upland plantings of native trees and shrubs in the grass areas would also improve the stability of this bank and increase the buffer functionality. On the right stream bank, willows and other native shrubs should be planted on the low bench. Upland planting of herbaceous areas would improve buffer functionality at this site.
