Local Flood Analysis

Village of Tannersville Greene County, New York February 2018

MMI #2884-10-06

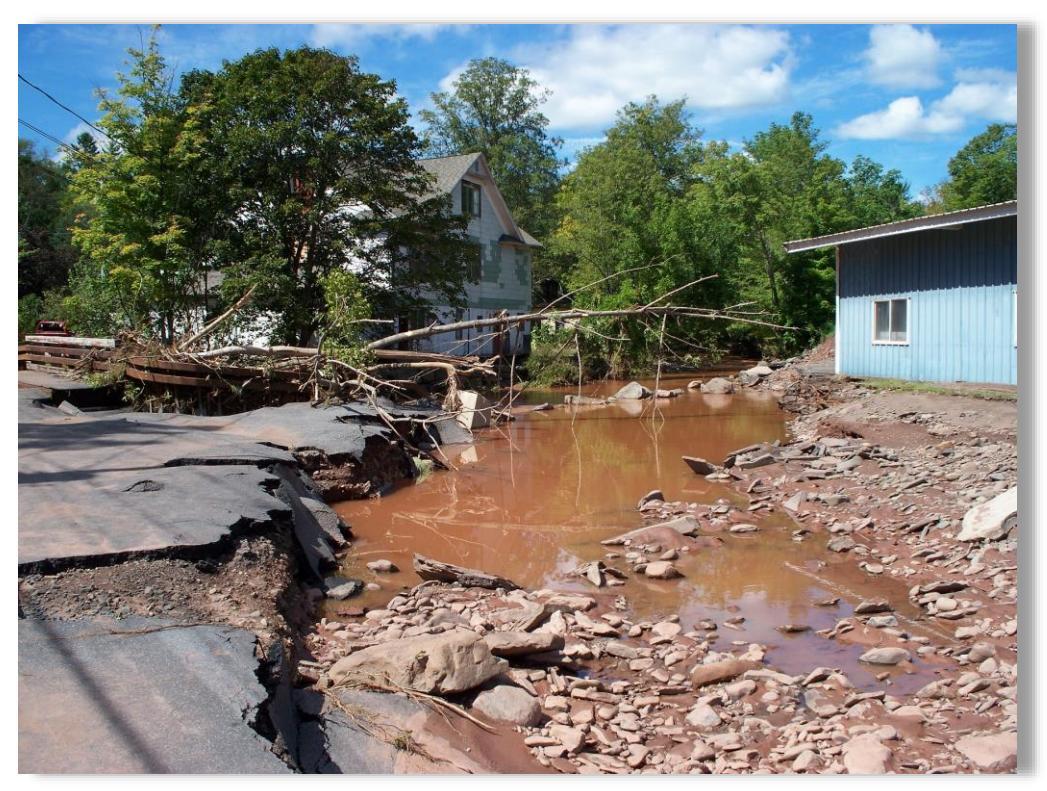
Figure 3-4 View of the Railroad Avenue bridge on the left and the DPW garage on the right the day after the flood

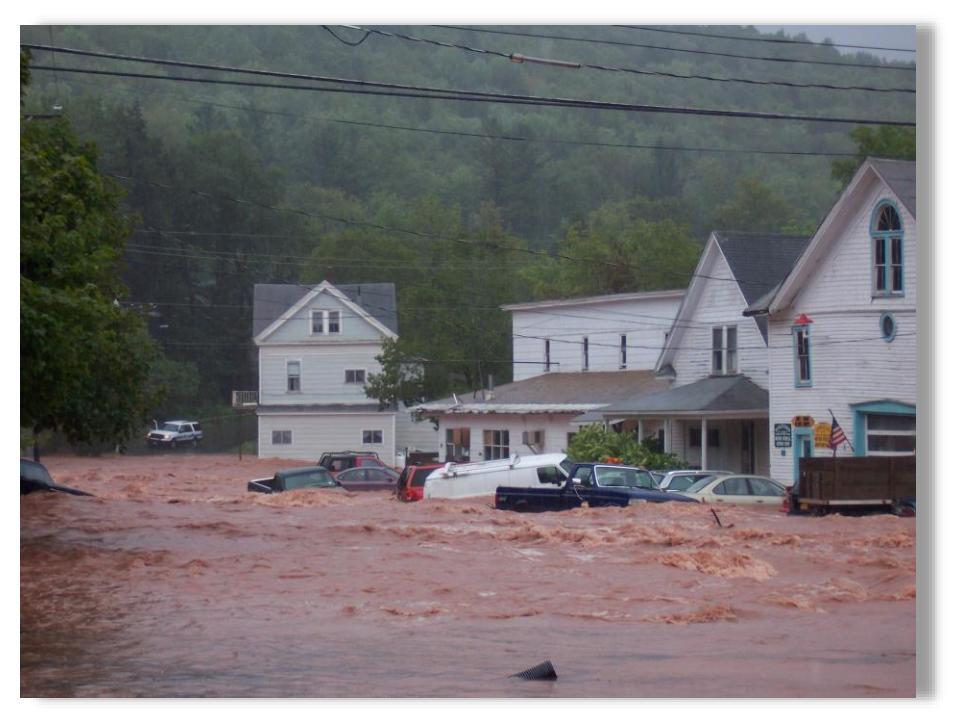
Figure 3-5 View of Railroad Avenue and Legg's Garage during the flood

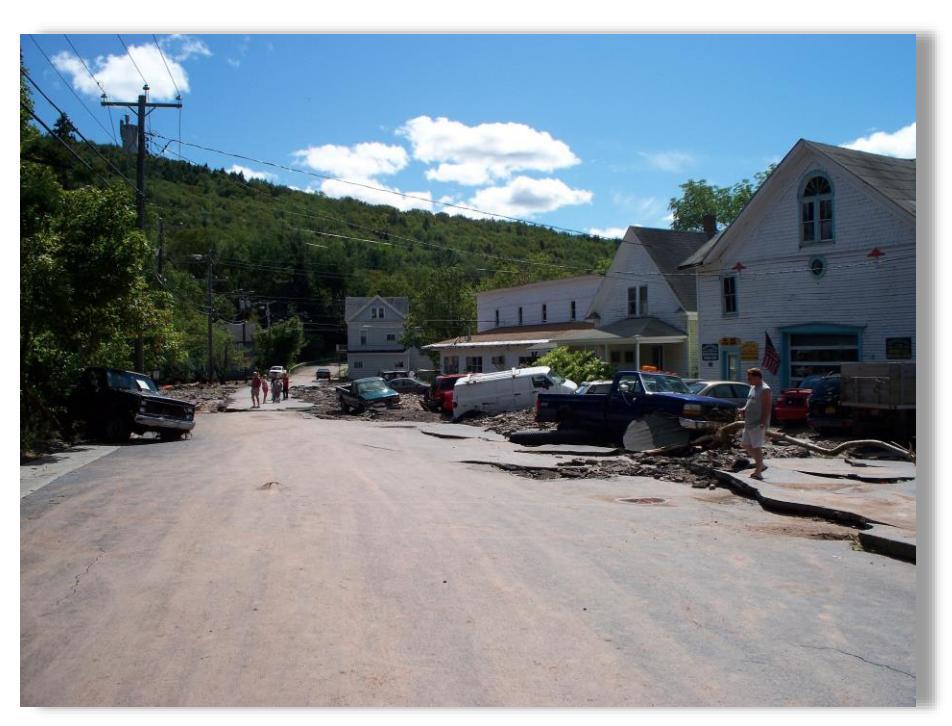
Figure 3-6 View of Railroad Avenue and Legg's Garage the day after the flood

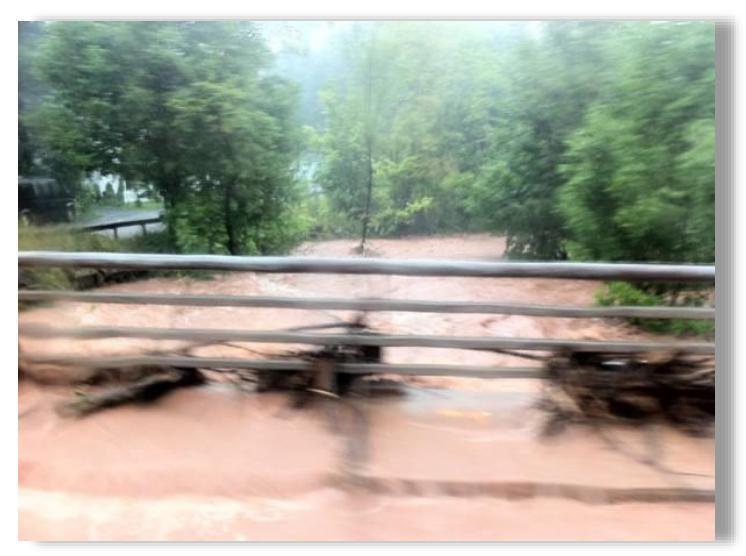
Under current conditions, the bridge is able to pass the 10-year discharge. In contrast to the 10-year discharge, the 50-, 100-, and 500-year events all overtop the bridge. The bridge was overtopped during the Tropical Storm Irene flood in August 2011 (Figure 4-3).

Figure 4-3 Main Street Bridge over Sawmill Creek overtopping in Tropical Storm Irene

- The Railroad Avenue bridge over Sawmill Creek is capable of passing the 10-year flood event but overtops in the 50-year flood event. When the bridge is scheduled for replacement, it is recommended that a full hydraulic assessment be conducted to ensure that the bridge opening is adequately sized and that the new bridge spans the channel and floodplain.

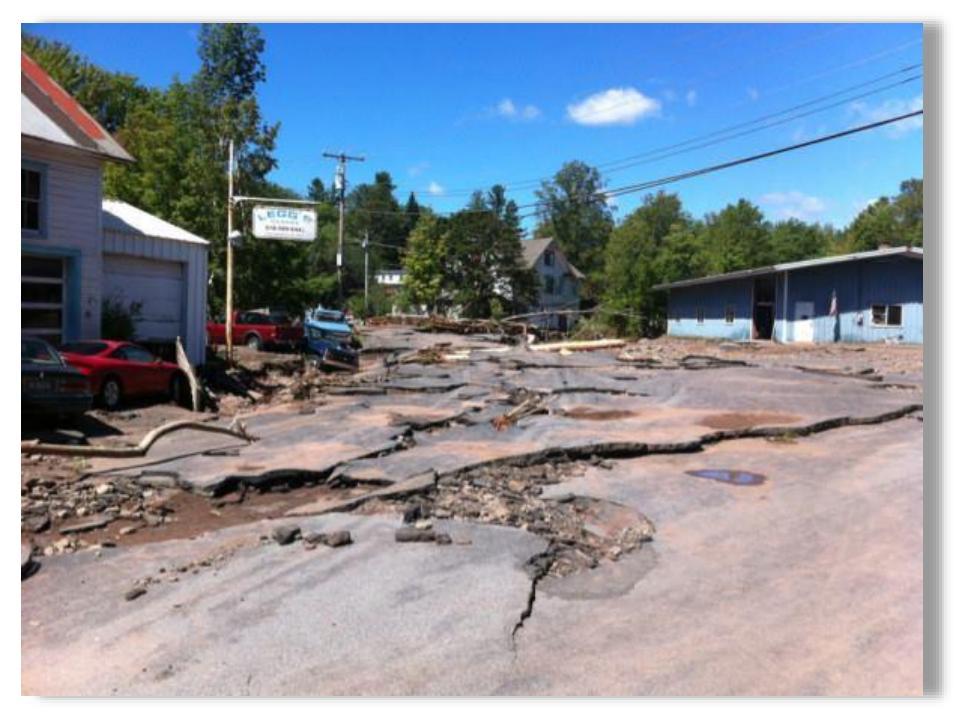
Figure 4-25 Tannersville Highway Department Garage following Tropical Storm Irene

- The relocation of the Village of Tannersville Highway Department garage out of the Special Flood Hazard Area (SFHA) (commonly referred to as the 100-year floodplain) is recommended. The facility is located within the SFHA and was flooded in Tropical Storm Irene with substantial damage to the structure. In addition to eliminating flood risks at the facility, the relocation would also result in benefits to water quality by removing potential pollutants from floodprone areas.
- The Main Street bridge over Sawmill Creek was found to be undersized, and it overtops during the 50-year flood event. When the bridge is scheduled for replacement, it is recommended that

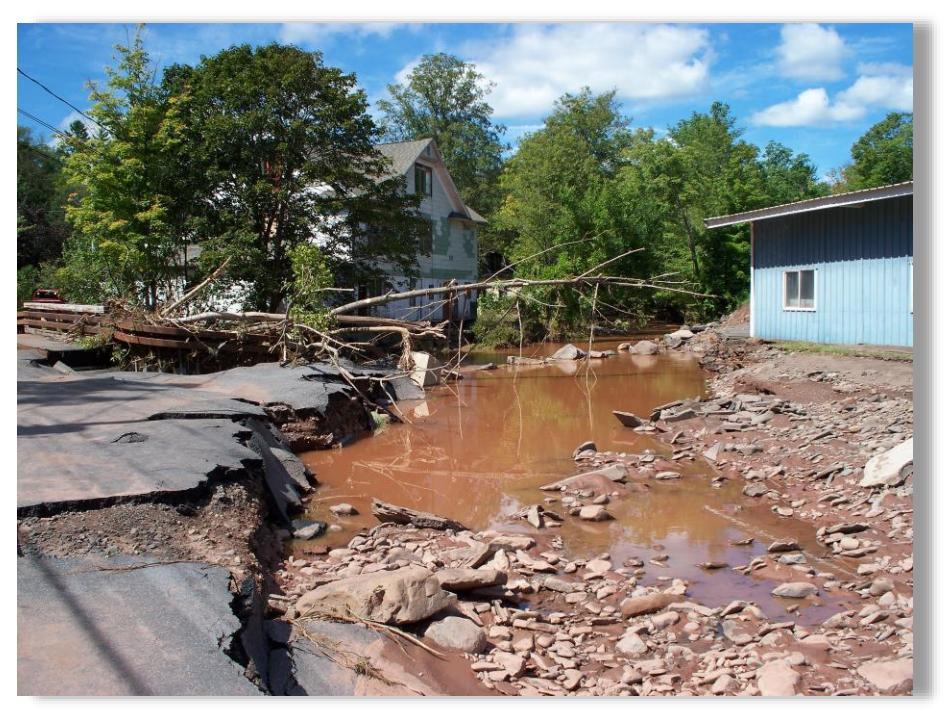
Figure 4-26 Tannersville Highway Department Garage following Tropical Storm Irene

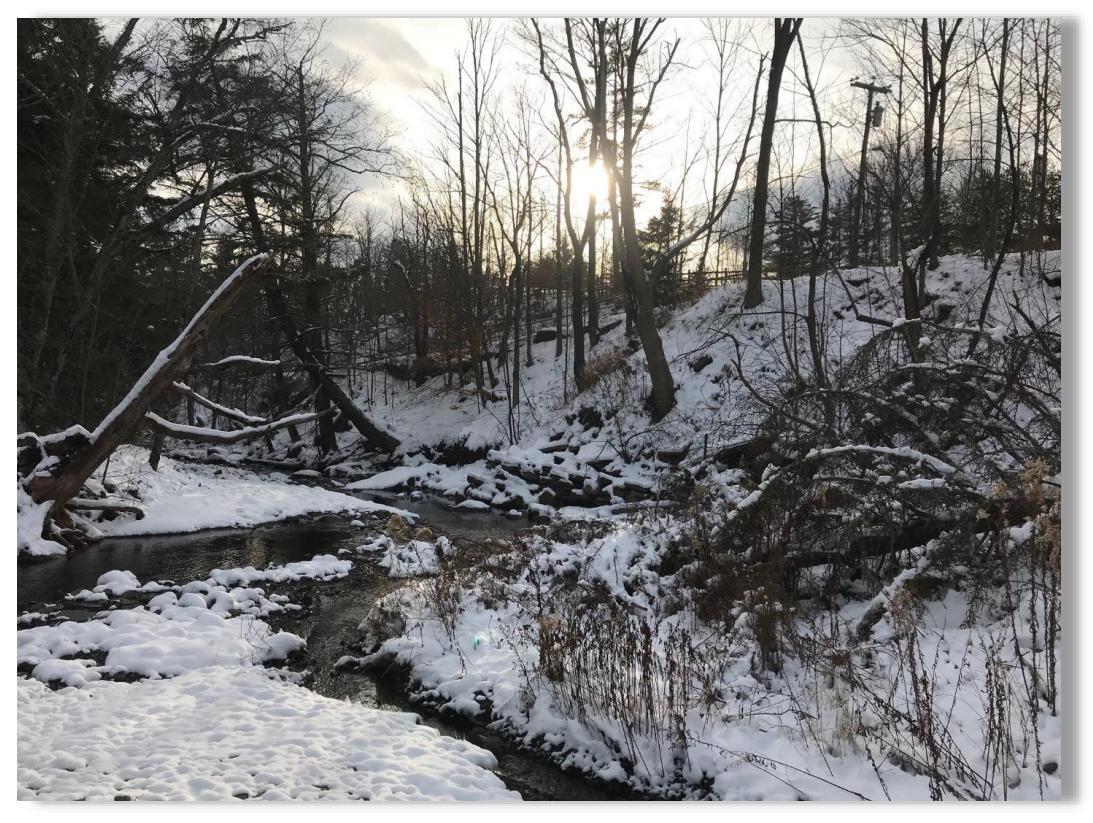
Figure 6-1 Eroded Hillslope along Railroad Avenue, Viewed from GCSWCD Building

• An engineering analysis of the embankment and implementation of bank stabilization measures is recommended.

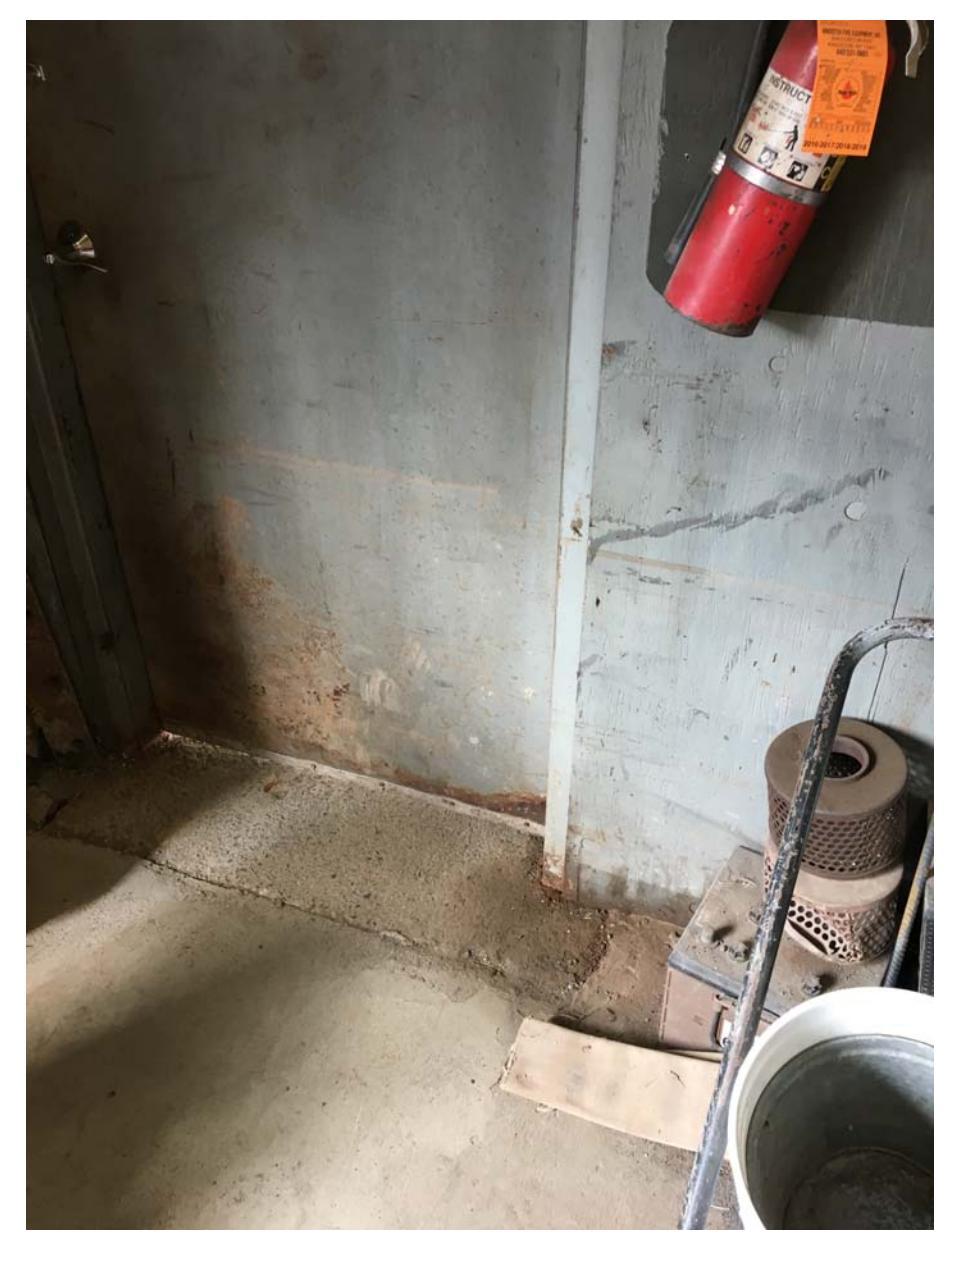
Photo #1 – Typical Water Mark on Interior of Building

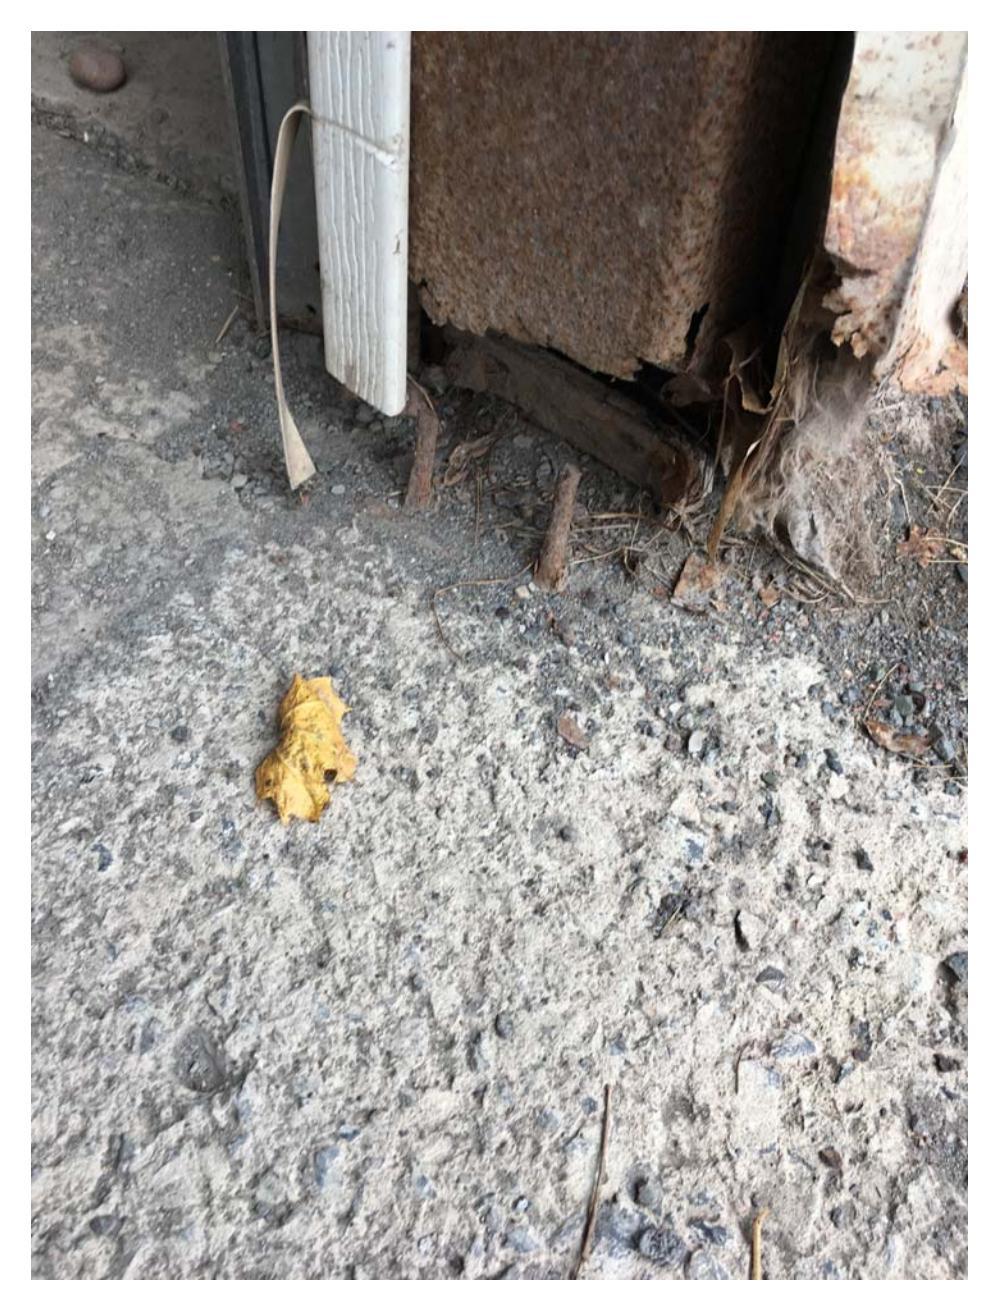
Photo #2 – Typical Example of Rusted Baseplate
Village of Tannersville Highway Garage Evaluation EXHIBIT A

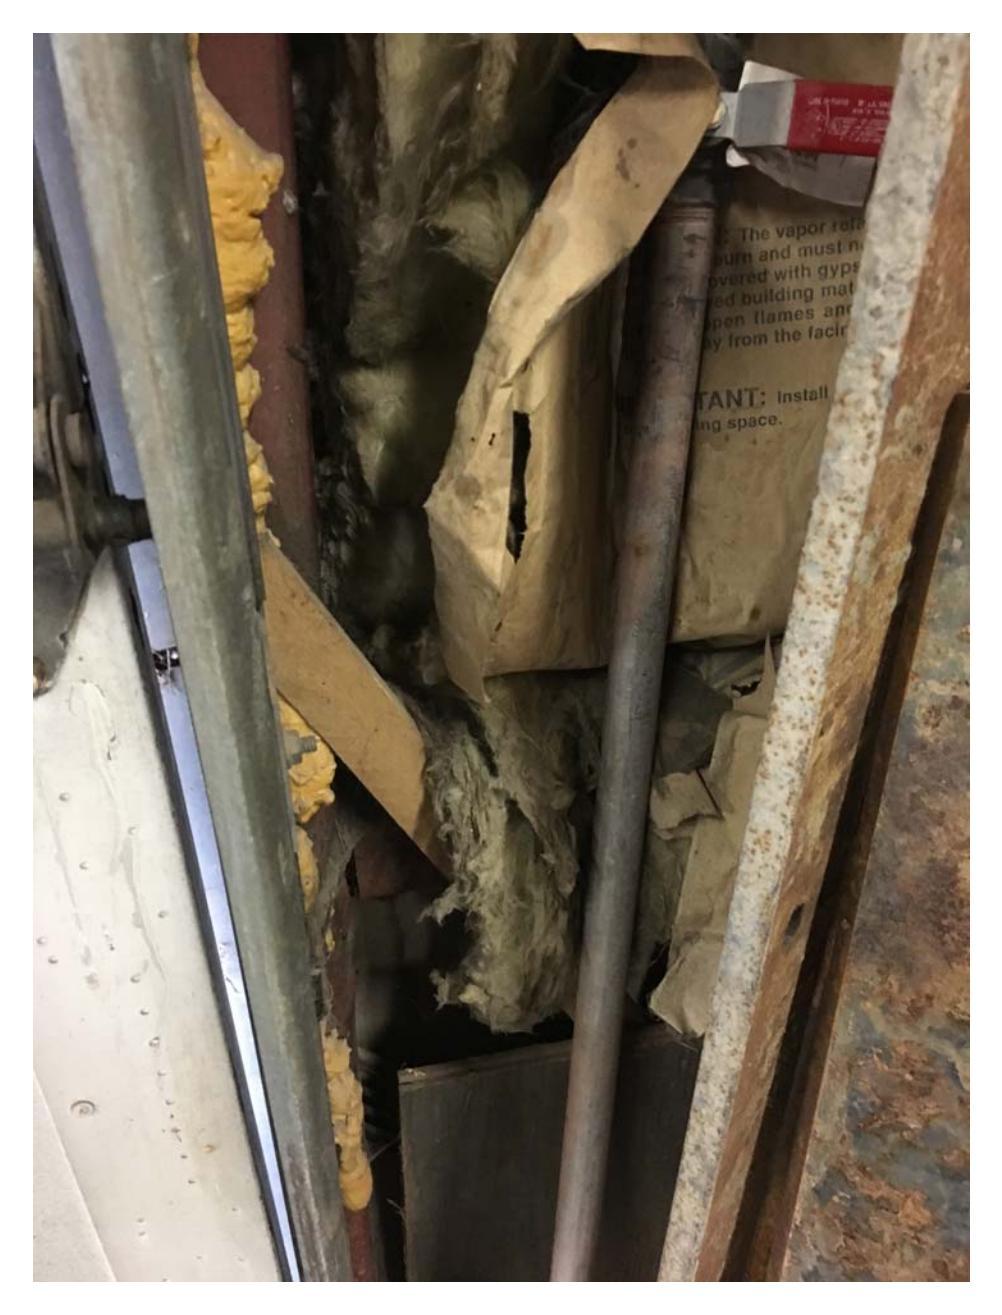
Photo #2 – Typical Damaged Insulation
