Reach 1a (Source to Maplecrest Gage Station)

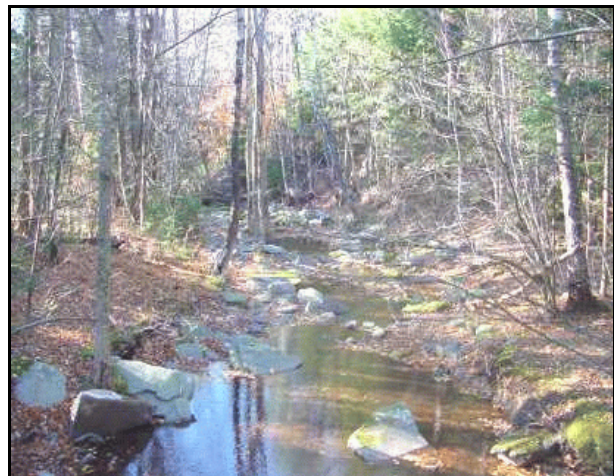
Figure VI-1: Headwater segments in 1a are characterized by a healthy riparian forest and a course streambed of boulders and cobble.

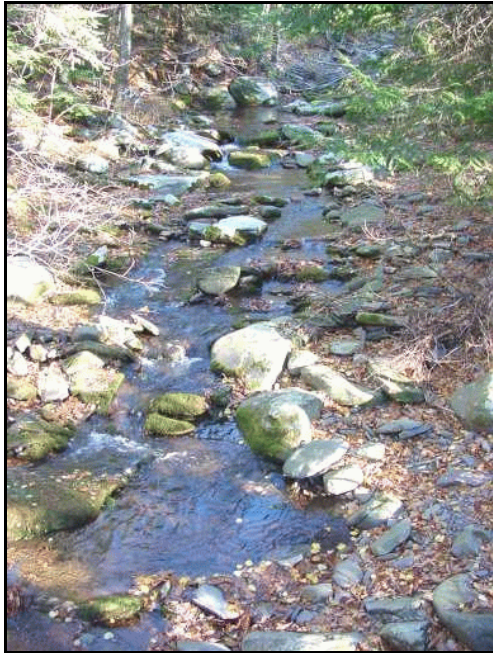
Figure VI-2: Heavy moss growth and imbrication of boulders and cobbles are characteristic of a stable stream profile.

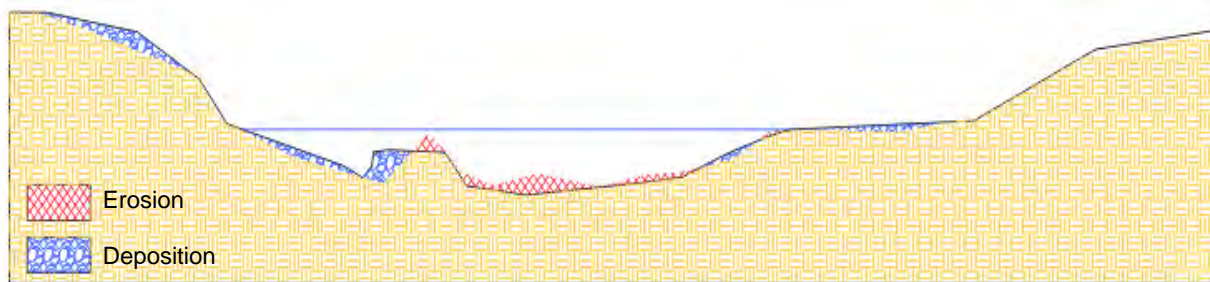
The stream channel approaching cross section #2 transitions from an entrenched A stream type into a moderately entrenched channel with the introduction of a narrow, defined floodplain. Stream type changes to B3, with channel material remaining fairly constant from cross section #1. Cobble is the predominant particle size, although bedrock and medium boulders are also frequently seen throughout the entire reach. Cross section #2 has exhibited a consistent and stable channel morphology throughout the monitoring period, with no appreciable lateral erosion observed. Measurements of width/depth ratio, entrenchment ratio, and cross sectional area have remained essentially unchanged (**Figure VI-3**).

Figure VI-3: Overlay of 1999 and 2000 monitoring surveys for Headwaters #2 cross section, depicting minimal erosion or aggradation.
