## **Reach 4a** (CR 12 South Street to CR 19 Tuttle Farm)

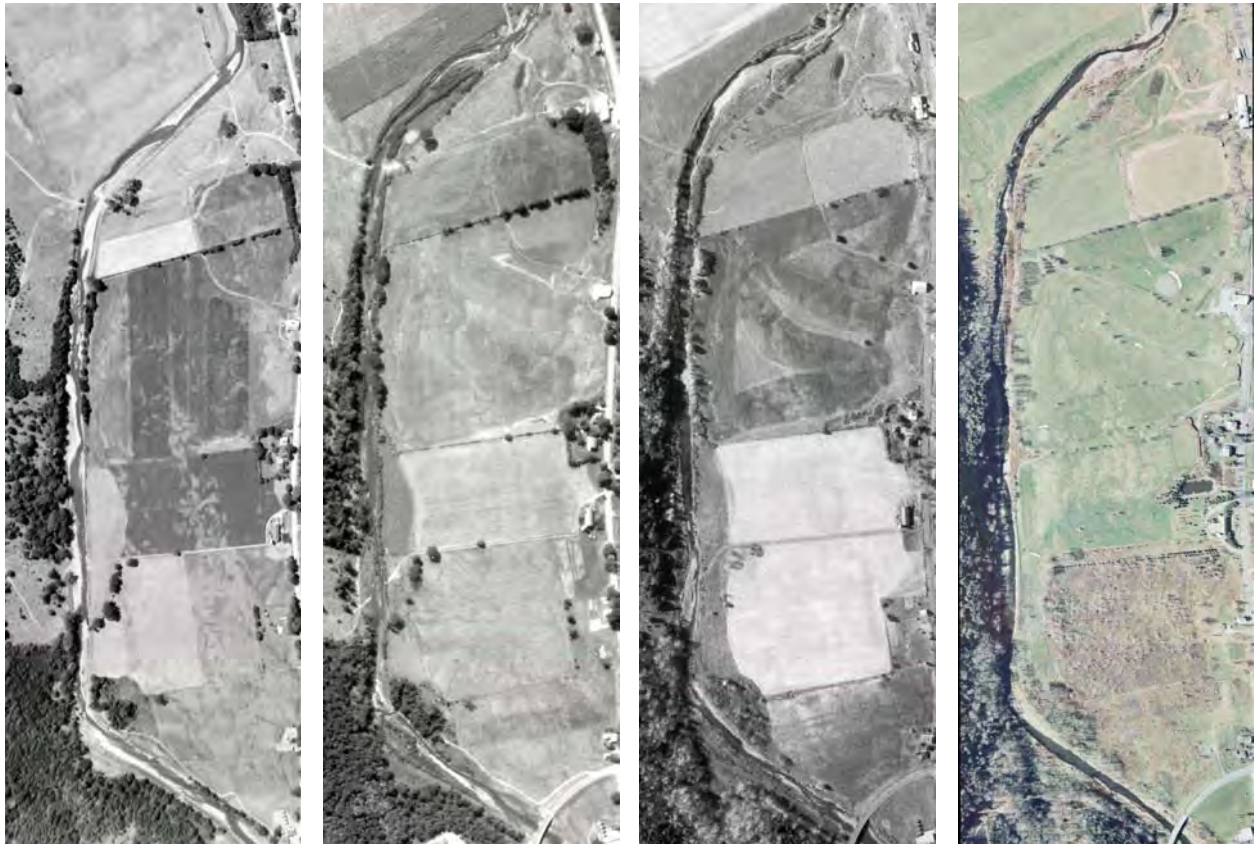
**Figure VI-38:** Aerial photograph progression of reach 4a, left to right 1959, 1967, 1980, 2000.

Streambank hardening with rip rap or other methods reduces or eliminates natural channel adjustments and restricts the channel to an unnaturally low sinuosity. A review of aerial photographs from 1959 to 2000 (**Figure VI-38**) reveals that channel planform has remained essentially unchanged for over 40 years . While some minor adjustments have been noted on the Tuttle Farm, for the most part the channel has not moved during this period.

Several sections of streambank in reach 4a have been hardened for stabilization by rock rip-rap (**Figure VI-43 photo B**). In the past, flood-related streambank damage has occurred behind Christman's Golf Course, as well as at Valley View Farm on numerous occasions. In the 1959 aerial photo (**Figure VI-38, left photo**) an irregular shaped (lighter) area on the

right streambank appears to indicate a fairly recent streambank avulsion that has been returned to its prior condition. It is likely that this occurred in the August 1955 flood event which caused extensive damage in the Batavia Kill valley.

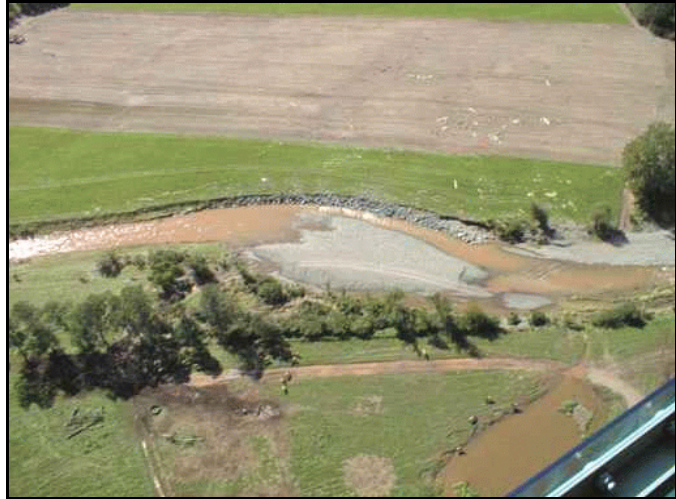
**Figure VI-41:** View of eroding bank on Valley View Farms where channel is over widened.

As the stream channel enters the meander bend just above the eroded bank on the Valley View Farm, the channel width to depth ratio is 18.2 (**Figure VI-39**), and basically appropriate for the valley setting and stream type. As the stream channel continues downstream and reaches a second eroded bank, the width to depth ratio jumps to 63.2 (**Figure VI-40**). This width to depth ratio is high, and is primarily the result of active mining of stream sediments from a point bar in this area. Mining of the streambed for gravel results in an over widened channel and the loss of sediment transport capacity (**Figure VI-43 photo A,B**). The stream's cross-sectional area above and below the proposed project location average 250 ft<sup>2</sup>, while the landowner maintains channel at the project reach location such that the cross sectional area is approximately 530 ft<sup>2</sup>. This change in width to depth ratio is primarily associated with recurring mining of stream gravel from the Batavia Kill in this area. The stream is unable to reestablish the channel dimensions that would enable it to transport its sediment load effectively and preclude any need for channel maintenance. (**Figure VI-41**).

A 1966 newspaper account shows repairs being made to a large channel avulsion that occurred in 1965 on the Valley View Farm. As recently as 1998, the same streambank at the bottom of the reach was still actively migrating (**Figure VI-41, Figure VI-43 photo B**). A restoration project was designed for the Valley View Farm by the GCSWCD following the January 1996 flood event. The project initially focused on re-shaping the streambank in its existing location, and installing 400 feet of rip rap along the left streambank. The rip rap was to be installed to the top of the bank.

After further evaluation, including a Phase III assessment, the project design was modified to include two rock vanes and one cross vane. The structures were incorporated in order to reduce the amount of rock material necessary to stabilize the bank. The height of the rip-rap was reduced to the bankfull stage with bioengineering designed to protect the upper bank zone. The project was modified a second time in July of 1997 to account for suggestions by the permitting agencies to use geomorphic stabilization techniques. Included within the final design were six rock vanes and one cross vane as substitutes for the rip-rap stabilization, and the construction of a low-maintenance farm crossing for access to the adjacent fields. While the project reached the final design and permitting stage, construction was cancelled in 1998. Since that time, the landowner has placed rock rip-rap along the streambank.

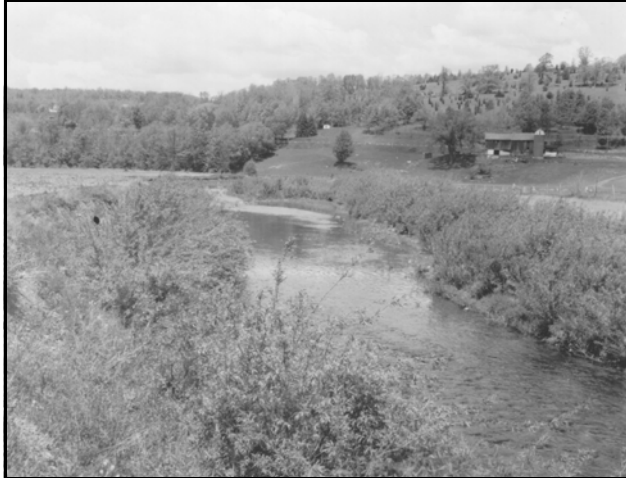
**Figure VI-42:** June 1966 photograph of willows in Reach 4a. Valley View Farm barns are seen in the background.

Reach 4a exhibits signs of increasing colonization by Japanese knotweed. As discussed in other sections of this SMP, knotweed is an aggressive invasive species, which quickly out-competes the more beneficial native plant communities (**Figure VI-43 photo D,E,F,H**). Historically, many sections of the reach were dominated by thick stands of willow that provided much more effective bank stabilization. Evident in a June 1966 photograph (**Figure VI-42**), is an extensive willow dominated plant community along both streambanks as the stream approaches the area of Valley View Farm. While the buffer in 1966 did not indicate the presence of taller woody

vegetation (trees), which is better for shading, the willows were superior to plant communities found at the reach today. While some willow does currently exist in the reach, dense stands are infrequent.
