The Chestnut Creek Stream Management Plan

Volume I of II

Background, History and Watershed Description

March 2004

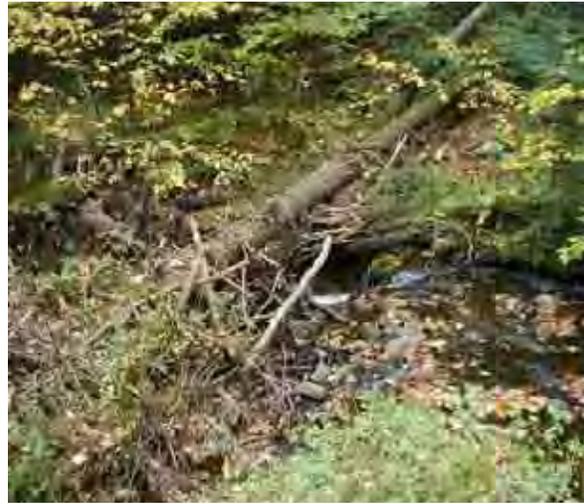
Photo 2. View showing channel wide debris jam.

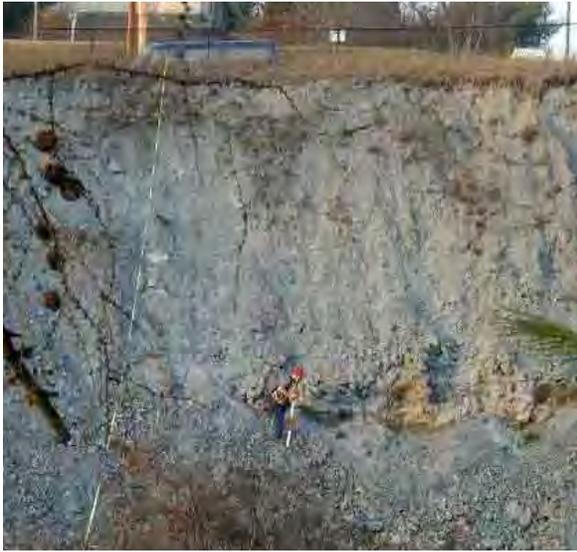
Photo 4. View of eroded left bank on DEP property. Material undercut and slumping.

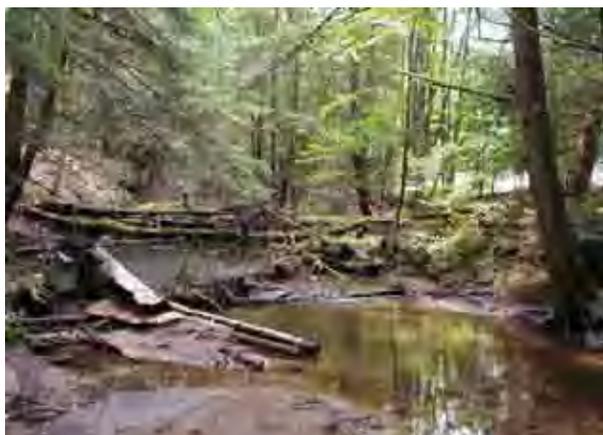
Photo 8. View looking upstream from below XS-47. Sediment has accumulated due the debris jam shown above.

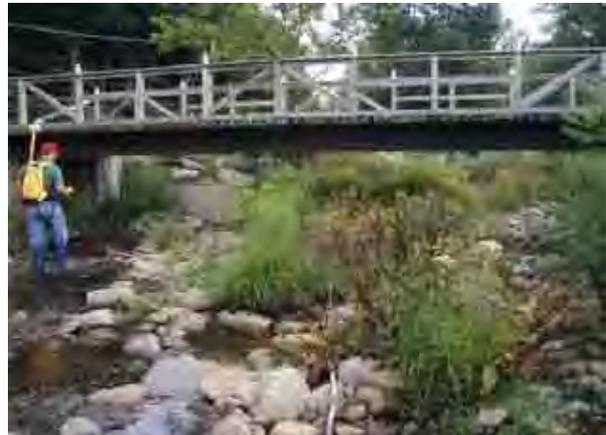
Photo 10. View looking downstream at private crossing below Slater Rd. Channel is split with a center island. The banks and island are well-vegetated with willows, but stream seems to be choked into the right bank.

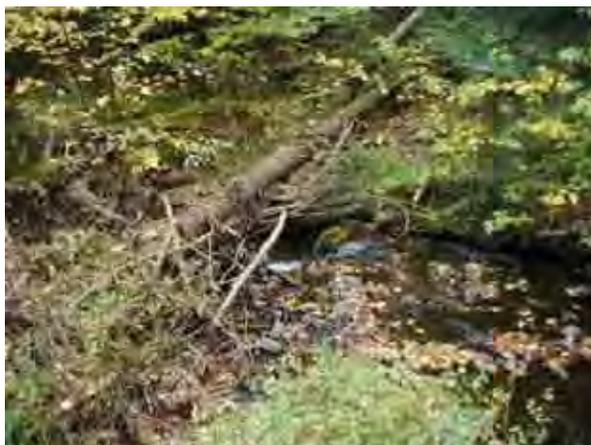
Photo 15. Debris jam and *head cut* behind Grey's Woodworking just upstream of XS180.

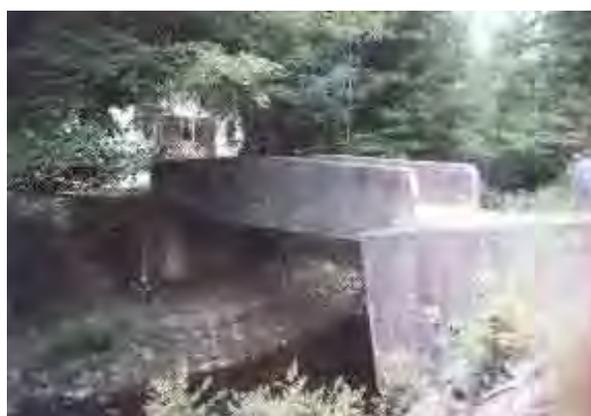
Photo 6. Failing left abutment (on photo right) attached to concrete wall at Mohr's Bridge, stream flow from right to left.

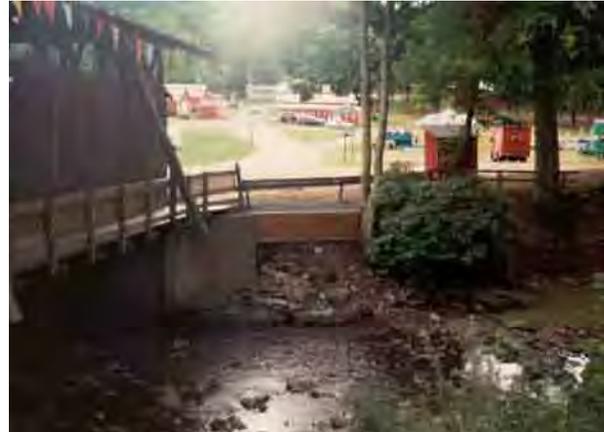
Photo 9. Looking upstream right bank Covered Bridge and Fairgrounds. Archive photo obtained from NYS DEC of repair work conducted on wingwall scour in 1991.

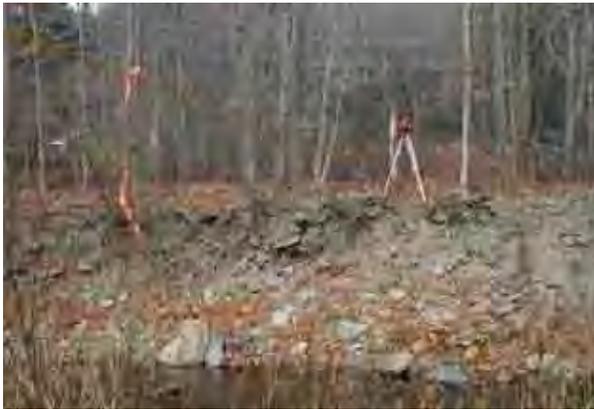
Photo 19. Monitoring cross section 4 at eroded left bank view from right opposite tennis courts at Fair-ground.

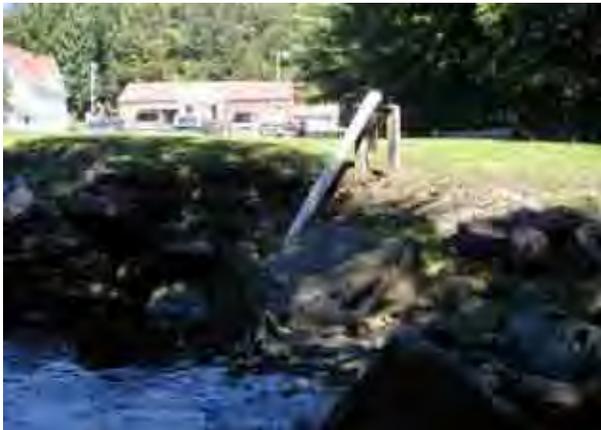
Photo 13. Dry hydrant (out of order, removed) and eroded bank behind Town Hall parking lot-view looking toward left bank & Town Hall from center of stream. (flow left to right)

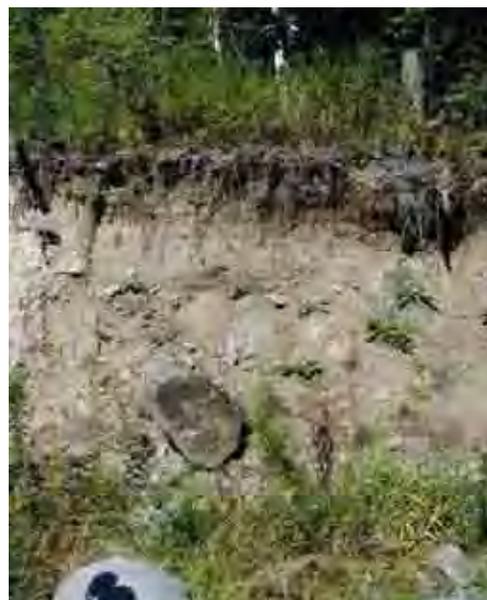
Photo 12. Monitoring cross section, DEP 2, eroded left bank.

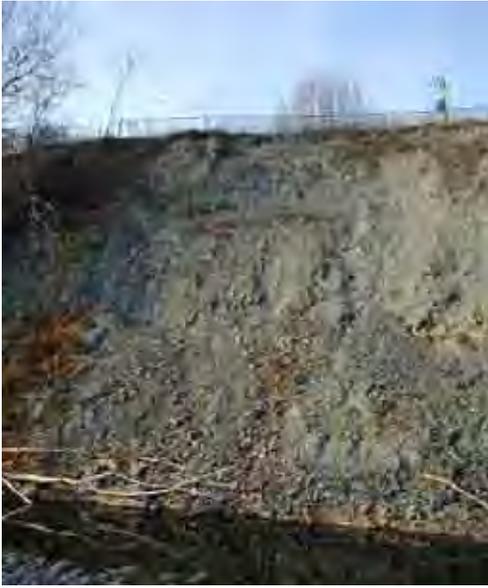
Photo 13. Monitoring cross section, DEP 1, left toe of eroding bank close up of Photo 9, stream flow left to right.

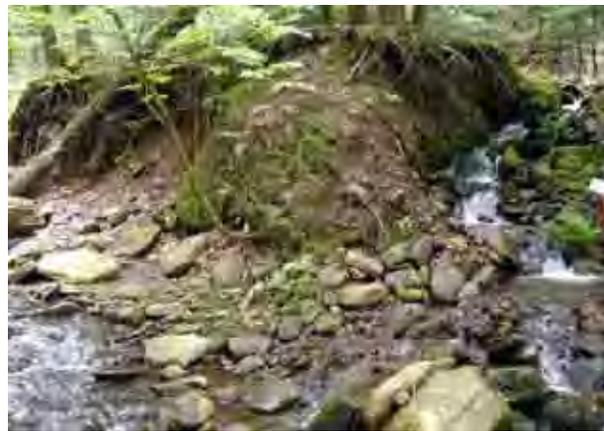
Photo 3. View looking upstream at left bank and confluence with another tributary downstream of Photo 2 (on right side of the photo) that flows under Camp Road. Significant erosion.

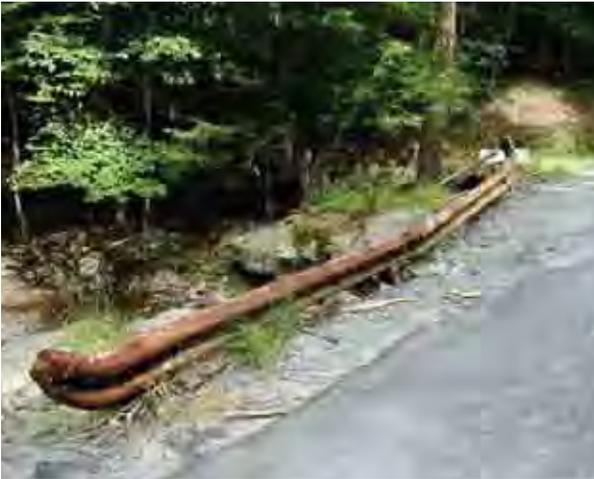
Photo 4. Recent storms have overtopped the road at this culvert, causing damage to the road. FEMA funding replaced guardrail seen in photo, 2002.

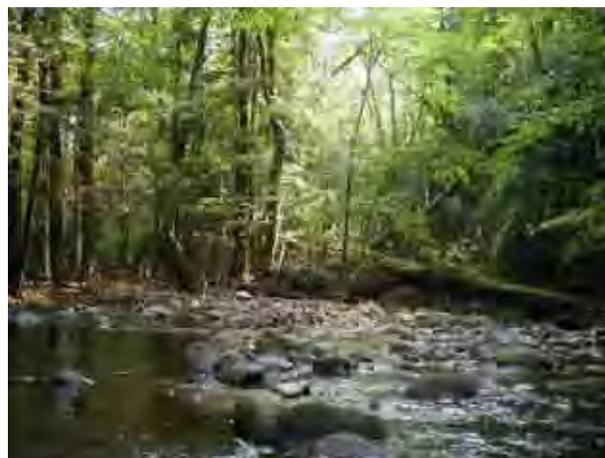
Photo 12. View looking downstream at aggradation.

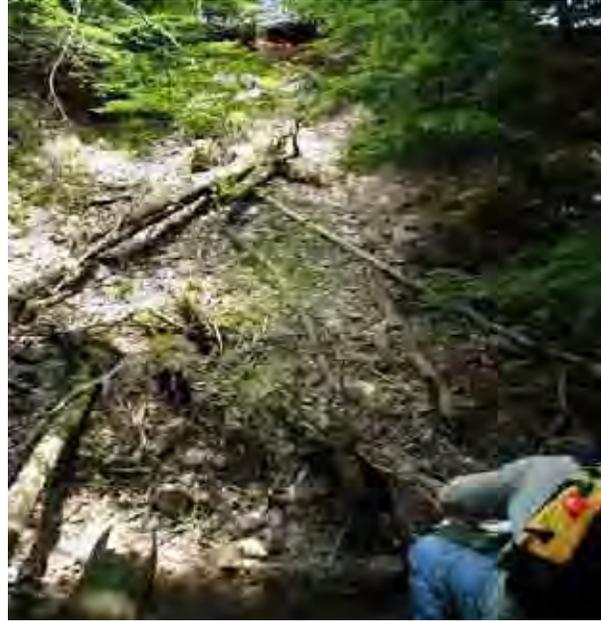
Photo 16. Shows very steep eroding right bank along the upper reaches of Pepacton Hollow along Camp Road.

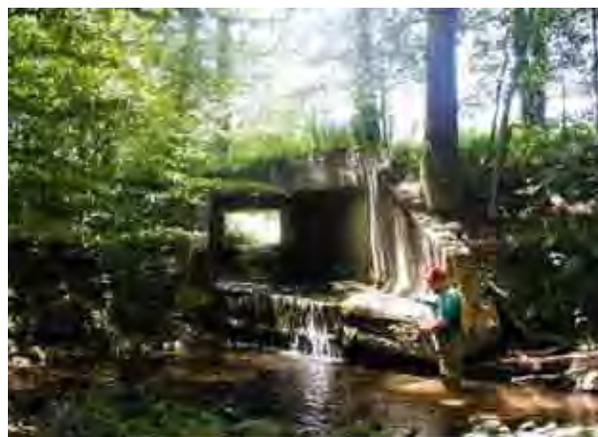
Photo 7. View from mid channel looking upstream. Scour pool at outlet of Route 42 box culvert. Eroding right bank 10' high.

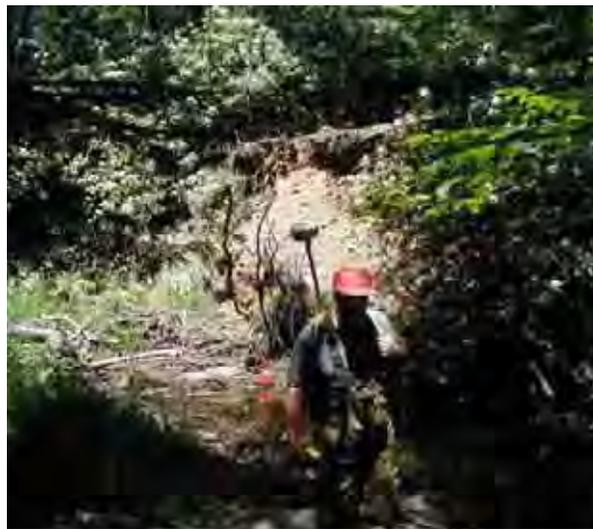
Photo 9. View looking at 30'-60' eroded right bank. Lack of vegetation on top of cobble/gravel/sand. Fallen trees at base of bank.

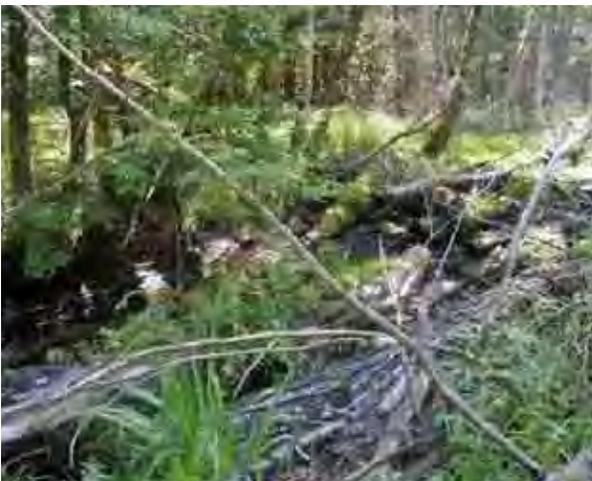
Photo 11. View looking upstream at river wide log jam on Red Brook, can cause stream instability.

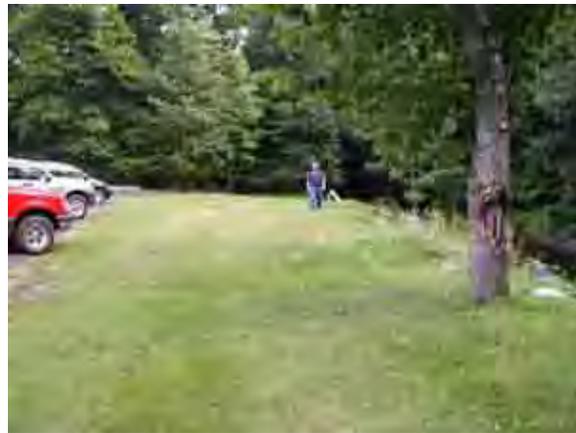
Photo 2. Top of bank before construction. Damaged Black Cherry on right, dry hydrant shown in the distance; both were removed.
