# Rondout Creek Management Unit 1

Management Unit 1  
Between Station 1100 and Station 100

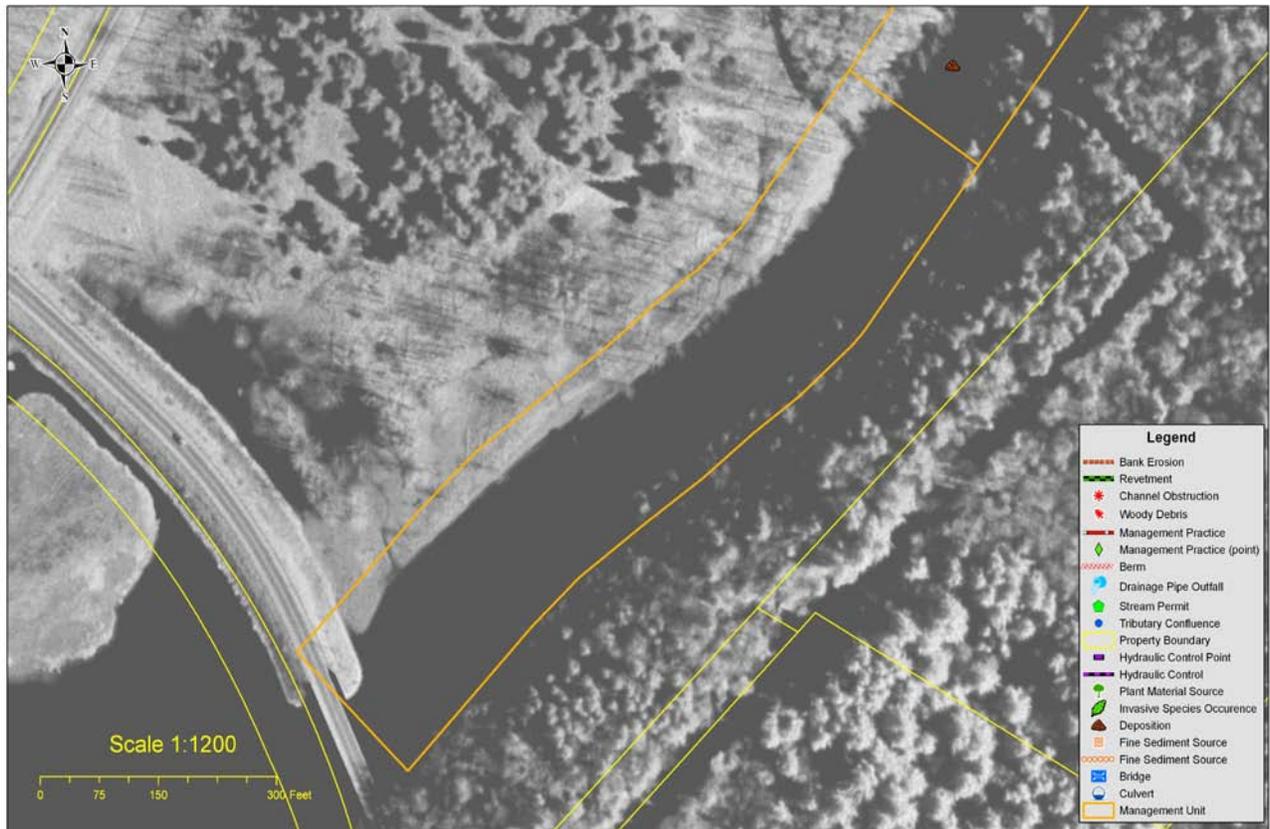
Figure 1 Stream feature inventory MUI

The 2009 stream feature inventory revealed that 0% (0 ft.) of the stream length exhibited signs of active erosion along 1,017 ft. of total channel length (Fig.1). No revetment or berms were identified in this management unit at the time of the stream feature inventory.

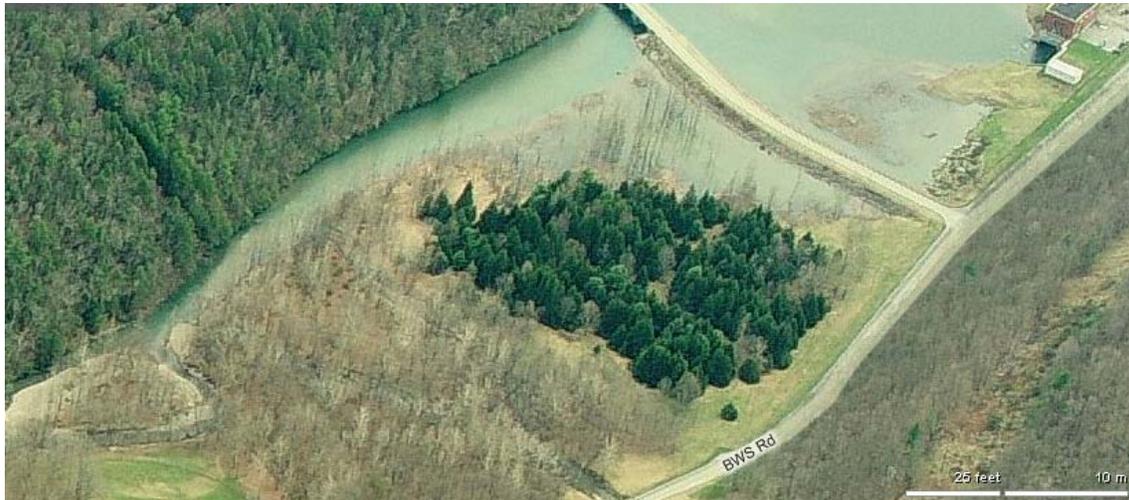
*Figure 3 Management Unit 1*

With the confluence from the right of Sugarloaf Brook, a major tributary (8 mi.<sup>2</sup>) comprising 20% of the total Rondout Creek contribution to the reservoir, the mainstem in Management Unit 1 broadens. Sandy soils here give evidence of frequent floodplain inundation, as illustrated in Fig. 3 above. The left bank is controlled by bedrock ledge; the floodplain on the right is well-connected with the channel; the channel gradient is nearly unmeasurable in this reach at base flow when the reservoir is at near capacity (<0.01%). As a result, channel morphology is in seasonal flux through this short unit; bed aggradation results from backwatering when reservoir levels are high, which is rescoured when larger flow events occur when reservoir levels are lower. No recommendations are given for this management unit.

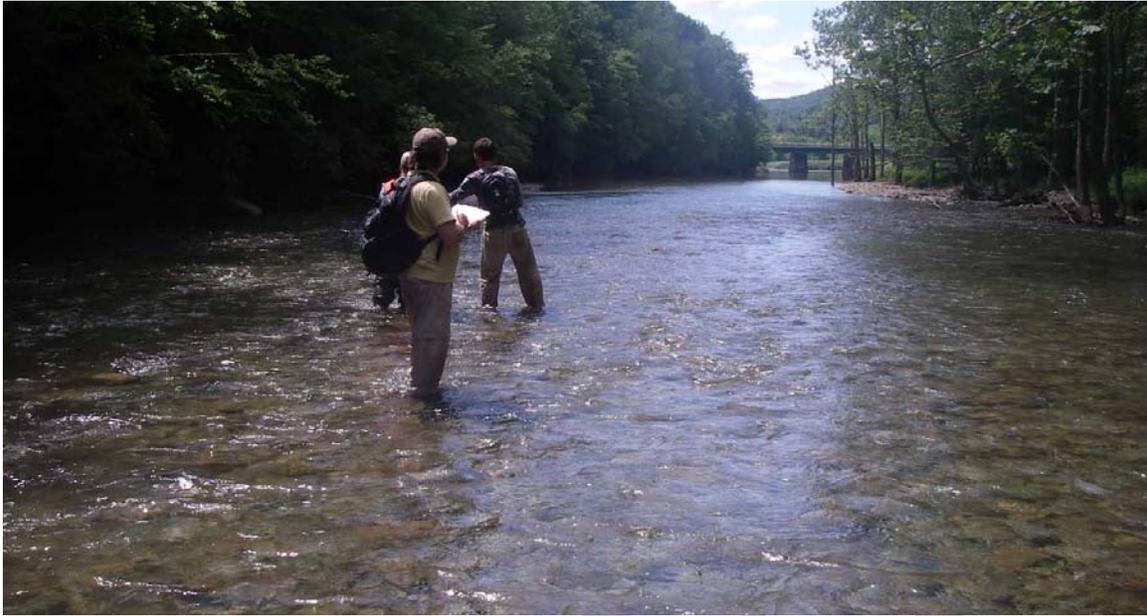
*Figure 4 Aggradation due to backwatering from the reservoir*

As stated above, sediment transport is largely controlled by reservoir levels in this Management Unit.
