Schoharie Creek Management Unit 13

Town of Lexington – Station 48154 to Mosquito Point Bridge (Station 41722)

Figure 4.13.1 Management Unit 13 - 2006 aerial photography with stream feature inventory

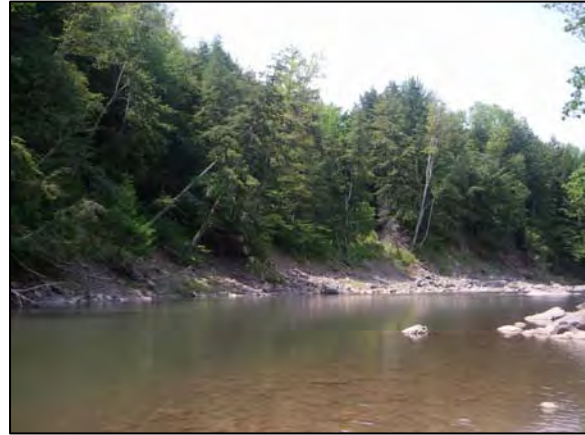
As the bedrock protecting the left streambank ended, erosion began (Station 46750). Along the outside meander of this bend the *thalweg*, or deepest part of the stream channel, flowed up against the left streambank causing significant bank erosion. Streambank erosion often occurs on the outside of meander bends where the stream velocity is greatest during high flows. Many mature trees had fallen from the top of the bank and a 24,063ft² area of streambank had been left unvegetated. This site may stabilize on its own over time. It appeared a low bench had begun to develop at the toe of the eroding bank which may act to reduce flood water velocities near the bank. As the bank stabilizes native vegetation should reestablish.

Bank erosion at Station 46750

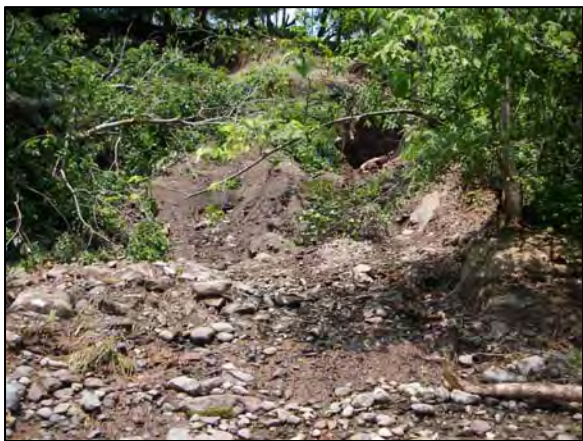
Bank erosion at Station 45560

Downstream, the hillslope on the right streambank was undermined by toe erosion, resulting in the mass wasting of the bank (Station 45560). This erosion had resulted in a loss of vegetation on a 4,287 ft² area of streambank. The exposed soil has a high silt and clay content, contributing sediment through *wet ravel* and may yield a significant suspended sediment load during rainfall events. An entrenched tributary flowing over

the bank and many seeps have exacerbated this erosion.

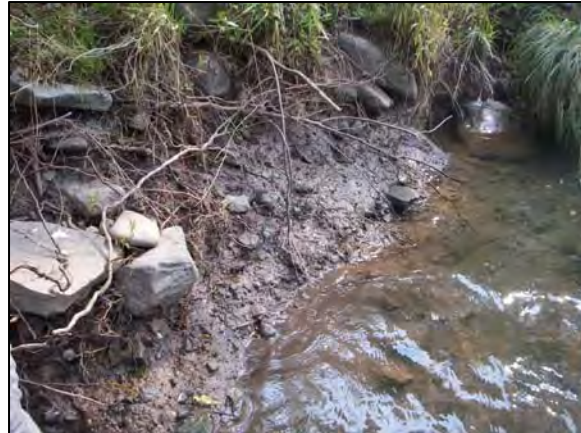
Clay exposure at Station 43800

As the stream flowed up against the County Route 23A embankment much of the right streambank had been hardened. Rip-rap had been installed along 778 ft of this embankment (Inset B, Station 44640 & Station 44050). While rip-rap and other hard controls may provide temporary relief from erosion, they are expensive to install, degrade habitat, and require ongoing maintenance or may transfer erosion problems to upstream or downstream areas. Alternate stabilization techniques should be explored for streambanks whenever possible. Along this rip-rap, the streambank toe had scoured exposing a 15 ft long section of clay and silt (Station 43800). Native shrub and sedge species should be interplanted through the rip-rap and along the toe of this streambank to help strengthen the revetment and enhance aquatic habitat.

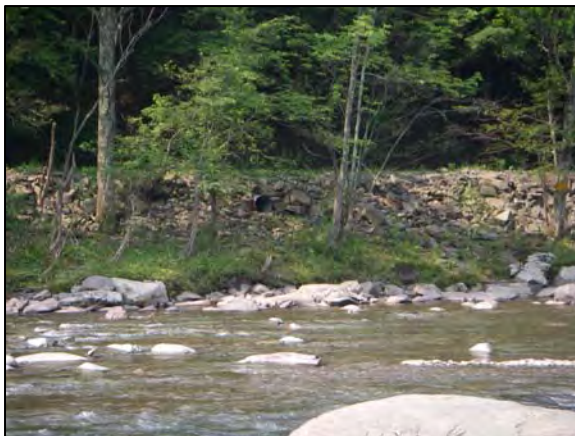
Rip-rap at Station 42050

Approximately 298 ft of rip-rap had been installed along the Fuller Road embankment on the left streambank (Station 42050). High flows have started to scour this bank. Native shrub and sedge species should be interplanted along the toe of this streambank to help strengthen the revetment, while enhancing aquatic habitat. A combination of trees and shrubs should also be

planted along the streambank to increase bank stability and protect the road embankment.

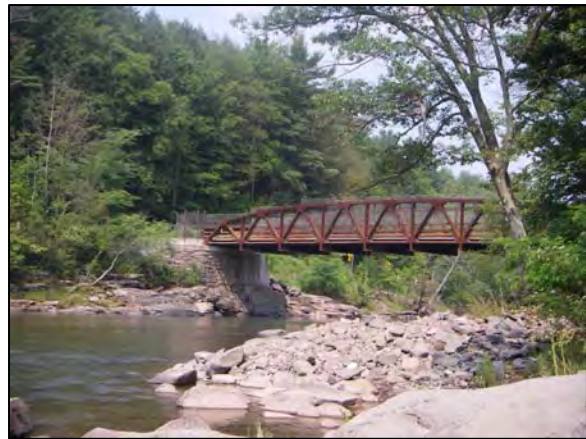
At the downstream end of this management unit the stream passed under the Mosquito Point bridge (Station 41722, BIN 3302930). This bridge may constrict the floodplain at very high flows, but appeared to pass most flows effectively. Flood damage to bridges is typically caused by inadequate hydraulic capacity of the bridge, misaligned piers and/or abutments, or accumulation of debris. As bridges are replaced over time, these issues should be evaluated and adjusted if necessary to lessen the probability of flood damage by providing a more effective conveyance channel that promotes water and sediment flow through the bridge opening.

Mosquito Point bridge at Station 41722
