Schoharie Creek Management Unit 14

Town of Lexington – Mosquito Point Bridge (Station 41722) to Station 34336

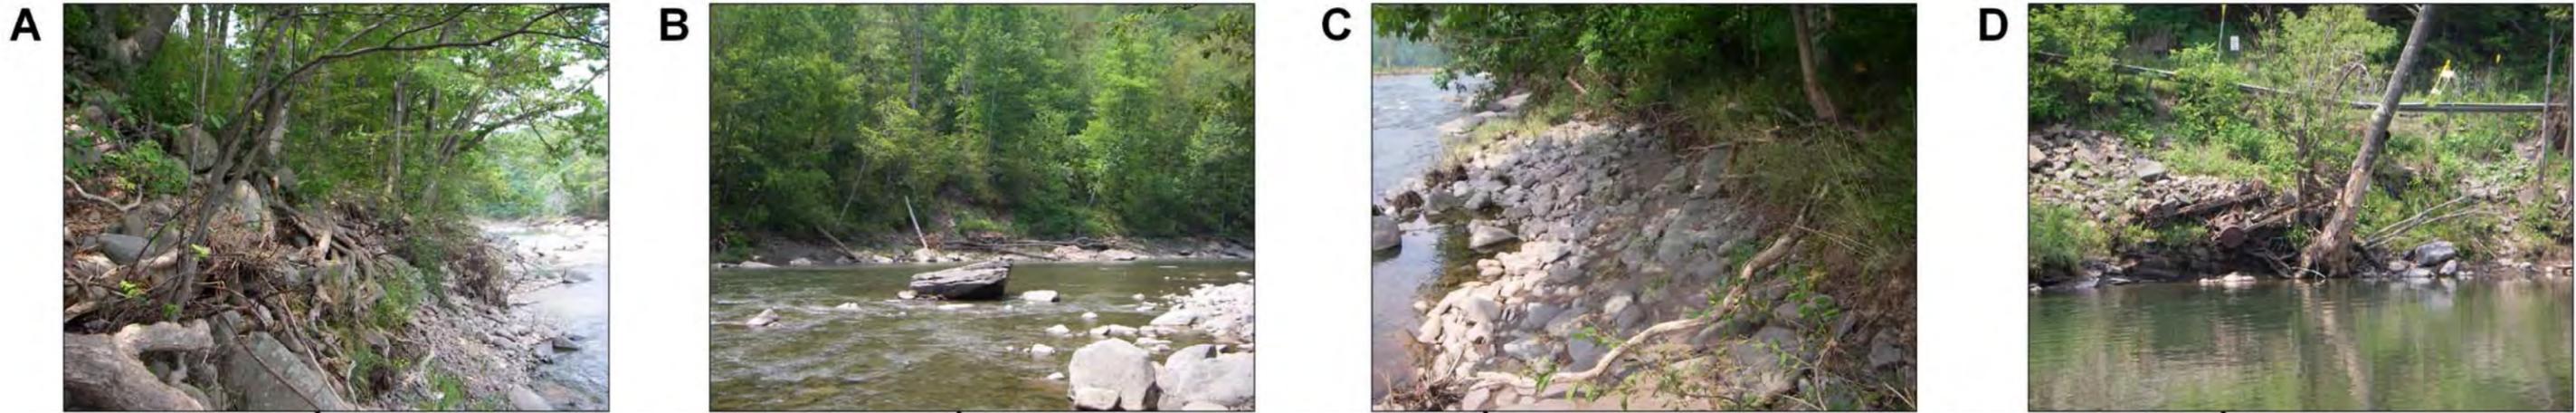
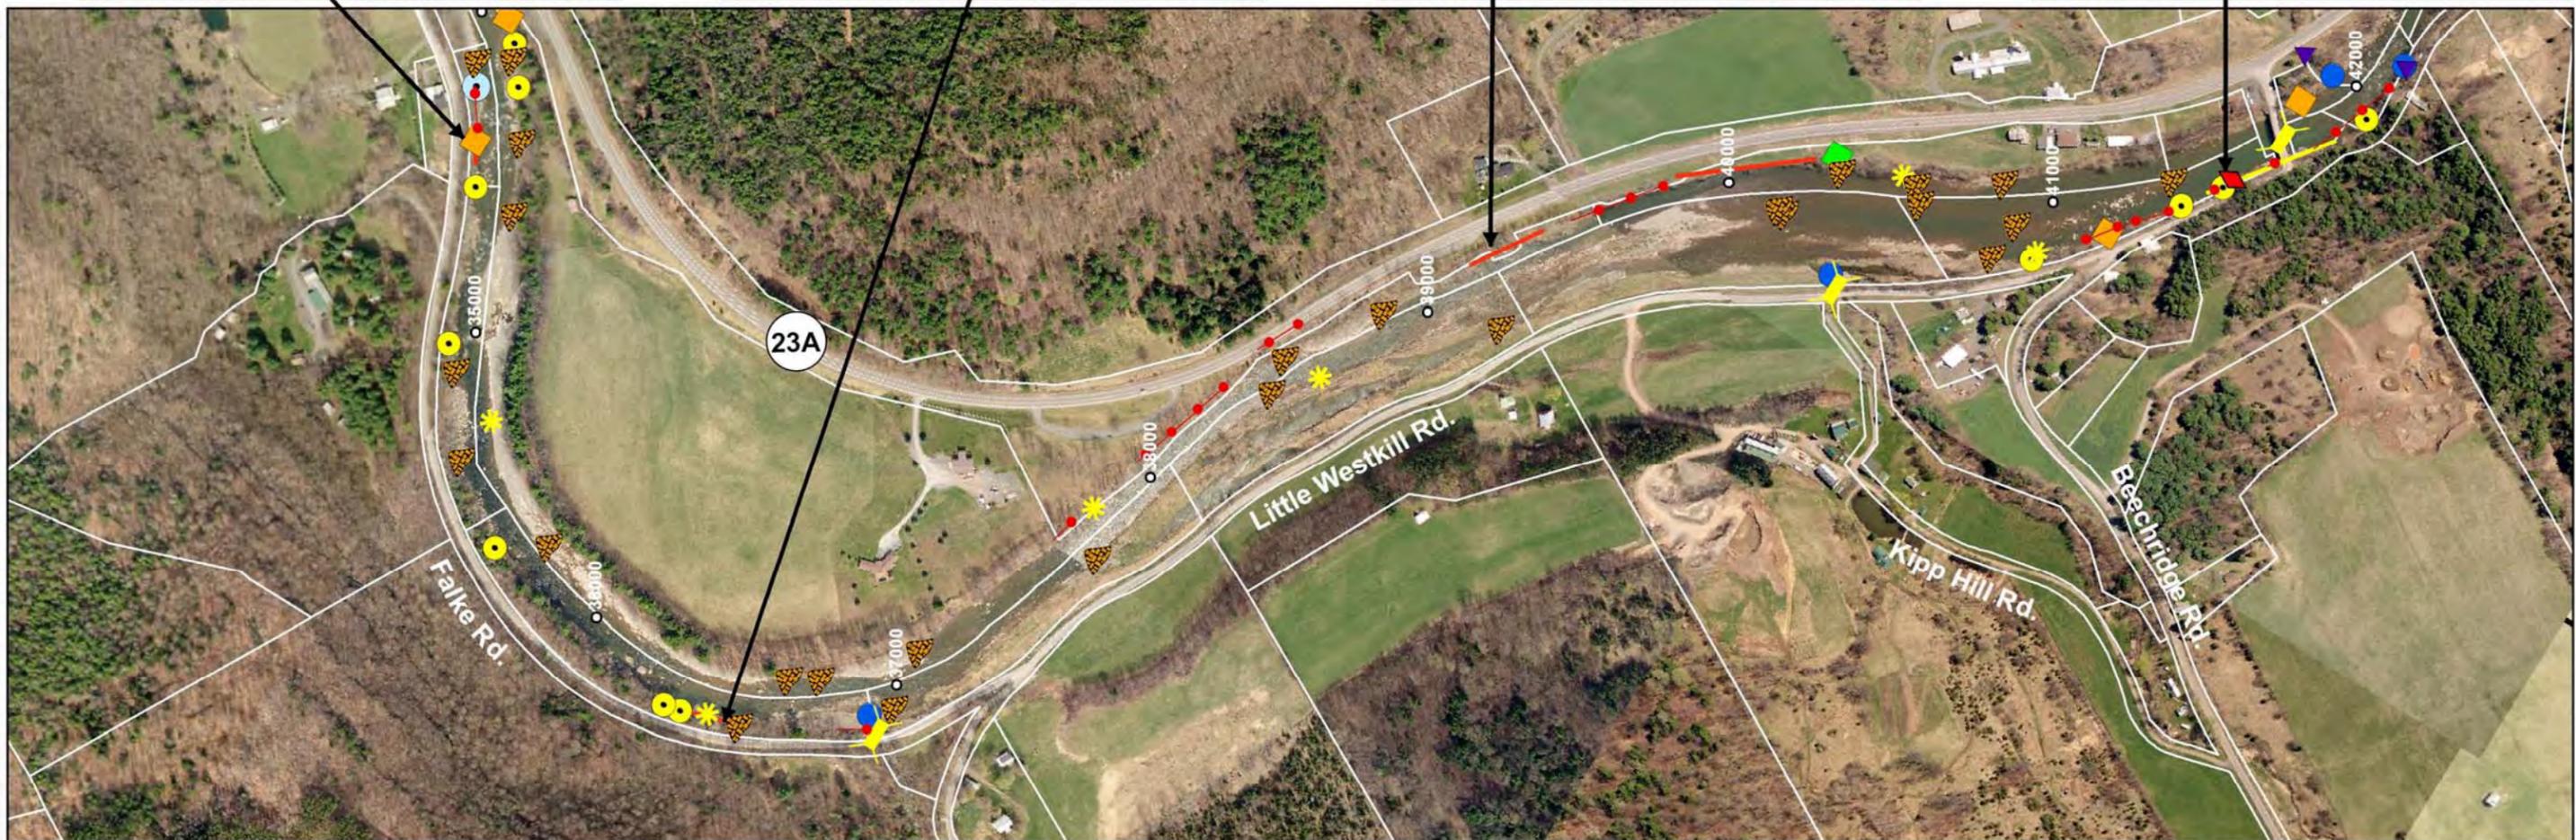
Figure 4.14.1 Management Unit 14 - 2006 aerial photography with stream feature inventory

The 2006 stream feature inventory revealed that 6.9% (1,019 ft) of the streambanks exhibited signs of active erosion along the 14,772 ft of total channel length in the unit (Figure 4.14.1). The total surface area of active erosion totaled approximately 15,044 ft². *Revetment* had been installed on 8.8% (1,294 ft) of the streambanks. No *berms* were identified in this management unit at the time of the stream feature inventory.

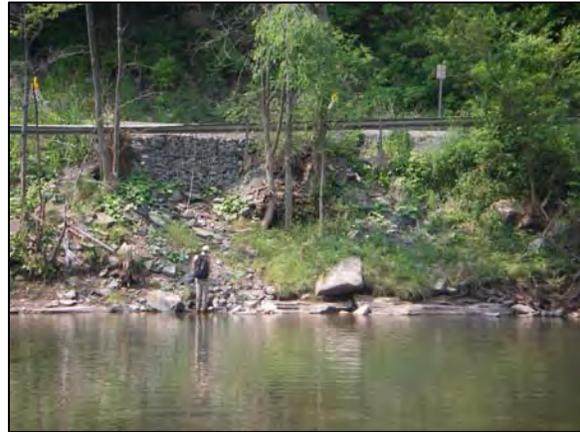
Starting at the Mosquito Point bridge, Little West Kill road runs parallel to the stream along the left streambank for approximately 4,822 ft (Station 41722-36900). This embankment has suffered repetitive flood damage due to its location within the 100-year floodplain. Elevating and relocating portions of this roadway is recommended to address flooding issues.

Little West Kill Road embankment

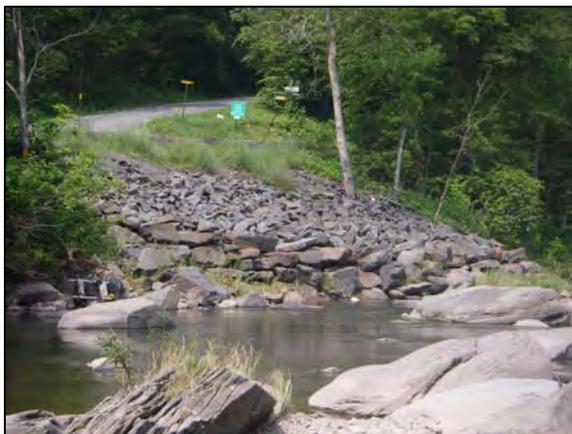
Rip-rap at Station 41200

Due to damage from high flow events and stormwater runoff, rip-rap had been installed along 114 ft of the left stream embankment (Station 41200). While rip-rap and other hard controls may provide temporary relief from erosion, they are expensive to install, degrade habitat, and require ongoing maintenance or may transfer erosion problems to upstream or downstream areas. Alternate stabilization techniques

inserting native tree and shrub plantings into the soil between the rocks, would strengthen and increase its longevity. These plantings would also improve the aquatic habitat by providing shade, resulting in cooler water temperatures. A 60 ft² *lacustrine* clay exposure was documented at the toe of this revetment (Station 41150). Fine sediment inputs into a stream increase *turbidity* and can act as a transport mechanism for other pollutants and pathogens. To provide protection against toe erosion, sedges or willows could be planted along the toe of the streambank.

should be explored for streambanks whenever possible. Interplanting of this rip-rap, by

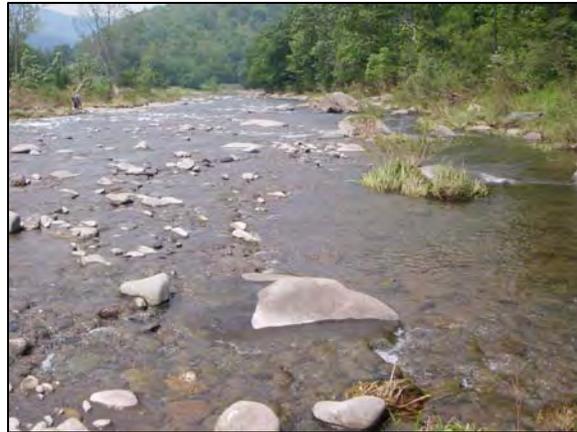
Downstream the stream channel became overwide and shallow causing a significant amount of *aggradation* (Station 40900-37700). Deposition of bed materials is common in

overwide channels because flow velocities are slower and they lose their ability to transport the stream's *bedload*. Resulting gravel bars may help maintain channel stability during flood events. In stable streams, the bars will erode away while the channel is in flood stage. The bars are then rebuilt as flow decreases, helping the stream maintain its stability by reestablishing its pools and riffles. If

Aggrading stream reach (Station 40900-37700)

gravel bars are removed, these processes do not occur and instead, the flood water often dissipates its energy by eroding banks and scouring the stream bed. Dredging of gravel alters the shape and slope of the channel and may disconnect the stream from its floodplain, destroying the features that naturally dissipated the stream's energy. This frequently results in erosion problems and additional buildup of eroded sediment within the channel. Approximately 5,000 yd³ of gravel was removed from this reach after the 1996 flood event.

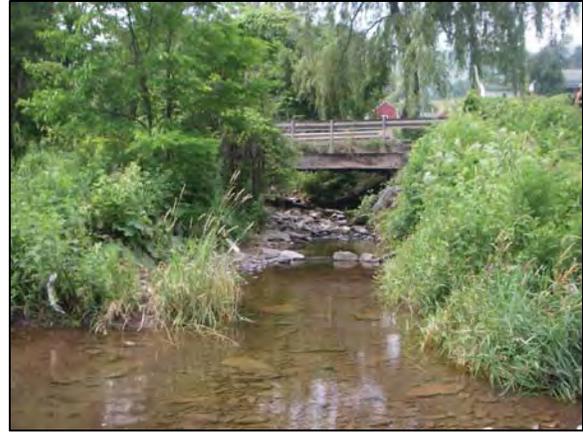
An unnamed tributary entered the Schoharie Creek from the left streambank (Station 40300). This tributary drained the steep slopes of Vly Mountain, before it reached the flatter topography of the valley floor where it entered the Schoharie Creek As a result of this stream

slope change, the tributary lost its ability to transport sediment gathered from the mountain slopes, and began to deposit sediment at its mouth and into the more gently sloped Schoharie Creek. This is a common feature of confluence areas, which often contain extensive sediment bars, function as important sediment storage areas, and are typically among the most dynamic and changeable areas in the stream system. This tributary was classified C by the NYSDEC (NYSDEC, 1994).

Tributary at Station 40300 - looking upstream

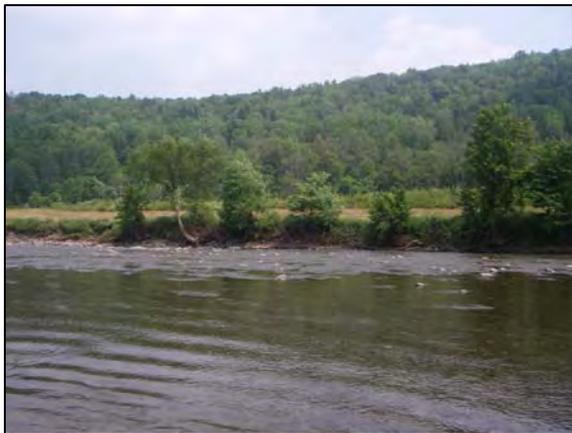
On the opposite bank, 433 ft of the County Route 23A embankment had suffered minor erosion during high flow events (Station 40300). The terrace at the top of the embankment had herbaceous vegetation in the riparian zone. Mown lawn or pasture does not

Bank erosion and planting site at Station 40300

provide as much resistance to streambank erosion as the deep and dense root structure found in streamside forest. The complex root systems of trees may also act to filter nutrients and pollutants, if any, from stormwater runoff. Areas where the riparian zone has been maintained in pasture or lawn present opportunities to improve the streamside buffer with tree plantings in order to promote a more mature vegetative community along the streambank and in the floodplain. The

stability of this streambank could be improved with plantings of willow *fascines* and sedges along the toe of the bank coupled with trees and shrubs along the bank and upland area.

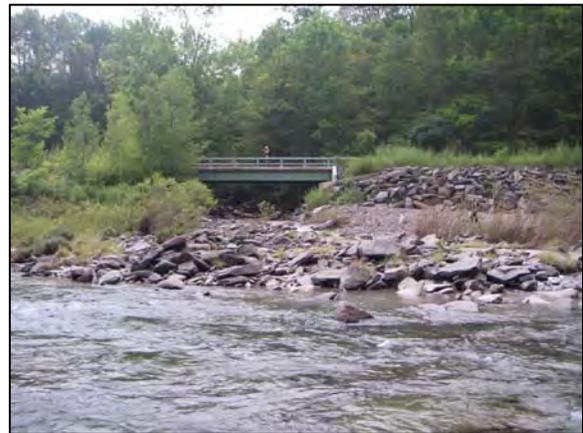
Proceeding downstream, the stream channel began to narrow. The Little West Kill entered the Schoharie Creek from the left streambank (Station 36900). The Little West Kill mainstem flows approximately 3 miles from its headwaters on Roundtop Mountain, roughly following Little West Kill Road, to its confluence with the Schoharie Creek. The Little Westkill mainstem is classified as C(ts) by NYSDEC, indicating that the best uses for this stream are the support of fisheries, including trout spawning and other non-contact activities (NYSDEC, 1994). Approximately 1.8 miles of its tributaries are classified as C(t), and 6.5 miles were classified as C by the NYSDEC.

Little West Kill tributary at Station 36900

The Little West Kill watershed drains approximately 8.2mi² and is closely surrounded by Roundtop, Bearpen, and Vly Mountains. As evidenced by the large amount of deposition upstream and downstream of the confluence, the Little West Kill delivers a significant amount of sediment to the Schoharie Creek. A stream feature inventory to identify sediment sources from this tributary is recommended. At the confluence, rip-rap had been installed on 97 ft of the left streambank (Station 36900). Interplanting of this rip-rap, by inserting native tree and shrub plantings into the soil between the rocks, would strengthen and increase its longevity.
