Neversink River East Branch

MANAGEMENT UNIT 1

EAST BRANCH MANAGEMENT UNIT 1
BETWEEN STATION 1450 AND STATION 0

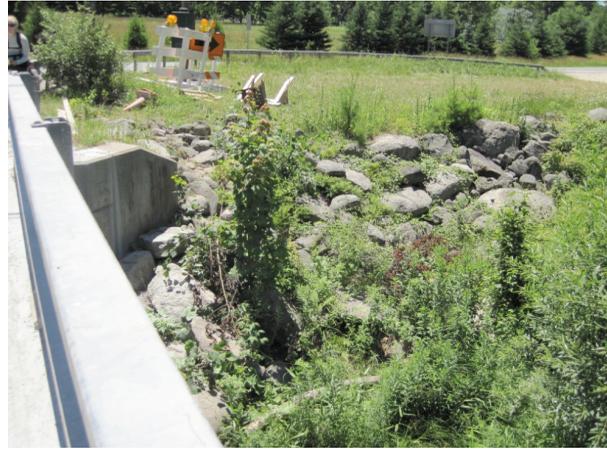
EBMU1 begins at the downstream end of the bridge crossing of West Branch Road. The stacked boulder revetments that began on the upstream side of the bridge in EBMU2 continue into this management unit. The revetment along the right bank continues for approximately 60-feet until Station 1390. The left bank is revetted for a length of 40-feet to Station 1410. (*A515*) Continuing downstream past the

Left bank revetment at bridge abutment (A515)

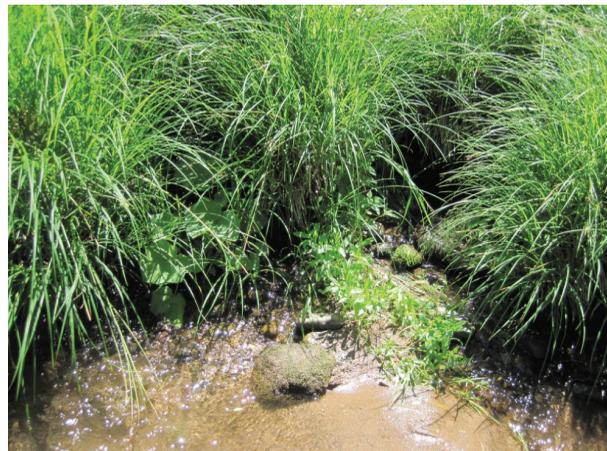
A small unnamed tributary enters the main channel from the left bank at Station 1300. This tributary appears to be drainage from the retention pond that was documented approximately 600-feet upstream in EBMU2. (A517) This management unit can be largely classified as a sediment storage reach as evidenced by significant deposition of sediment throughout the channel. The likely cause of most of this aggradation is a backwatering effect brought about by the confluence downstream. The first instance of aggradation was documented at Station 1190, where sediment deposition has raised the elevation of the stream bed across the entire channel. This aggradation continues downstream for approximately 280-feet until Station 910. (B404)

Drainage from retention pond entering stream (A517)

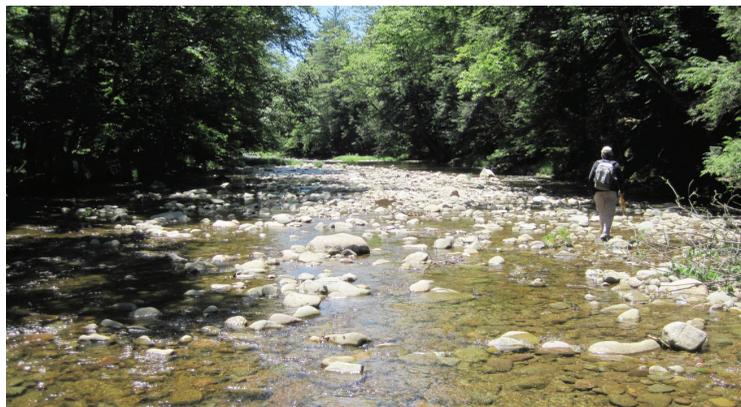
Full channel aggradation (B404)

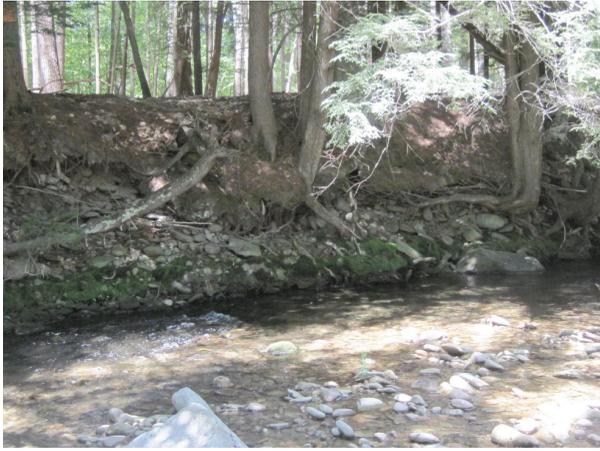
The right bank is experiencing erosion beginning at Station 1140 and continuing for approximately 90-feet until Station 1050 (BEMS ID# NEB1_1000). (B407) Moderate hydraulic scour of this 8-foot high bank has exposed cobble sized alluvial materials as well as the root structure of several trees. The rate of erosion at this site does not appear to be severe enough to warrant intervention. However, recommendations for this site minimally include monitoring for future changes in condition (passive restoration).

Erosion along right bank (B407)

BANK EROSION The right bank is experiencing erosion beginning at Station 1140 and continuing for approximately 90-feet until Station 1050 (BEMS ID# NEB1_1000). The rate of erosion at this site does not appear to be severe enough to warrant intervention. However, recommendations for this site minimally include monitoring for future changes in condition (*passive restoration*).

Intervention Level	Passive Restoration of the bank erosion site between Station 1140 and Station 1050 (BEMS ID # NEB1_1000).
Stream Morphology	Excessive sediment deposition caused by backwatering at confluence of East and West Branches. Conduct baseline survey of channel morphology, including channel migration at confluence of East and West Branches.
Riparian Vegetation	Investigate occurrence of Japanese Barberry at Station 380.
Infrastructure	Investigate flood threats to Denning Road in left floodplain.
Aquatic Habitat	Fish population and habitat survey.
Flood Related Threats	Assess threats to building structures in 100-year floodplain.
Water Quality	None.
Further Assessment	Long-term monitoring of erosion sites.

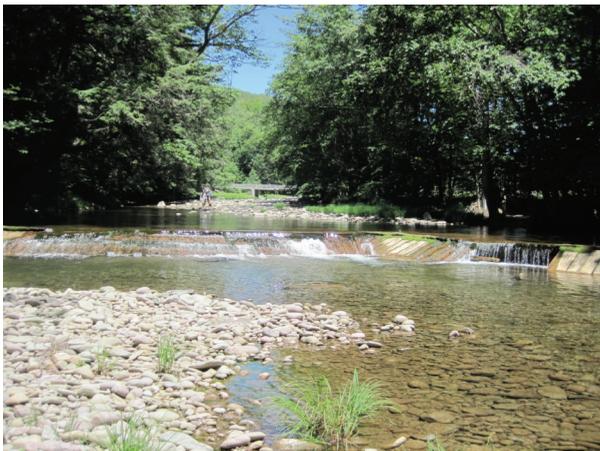
Timber dam spanning channel width (A522)

At Station 850 there is a v-shaped timber dam that spans the entire width of the stream channel. (A522) This structure appears to have been placed to provide habitat for trout. The water faces an abrupt vertical drop as it flows over the dam, resulting in a deep scour pool below. The structure appears to be relatively new and continues to function for the creation of habitat. Structures such as this were observed frequently in the East Branch of the Neversink River and can significantly alter flow dynamics. The presence of this dam is forcing a portion of the flow into a side channel in the left floodplain. This channel continues through the floodplain and converges with the main channel downstream of the confluence of the East and West Branches. (A526) The scour caused by the divergence along the left bank has resulted in the placement of gabion baskets on the left end of the structure. Gabion baskets are very susceptible to failure during high flows, as larger rocks moved by the stream can continuously hit the cage and cause structural weaknesses. The combination of stresses caused by stream flow and sediment movement can cause tearing of the basket and release of the rock inside, resulting in the structure no longer functioning for its intended purpose.

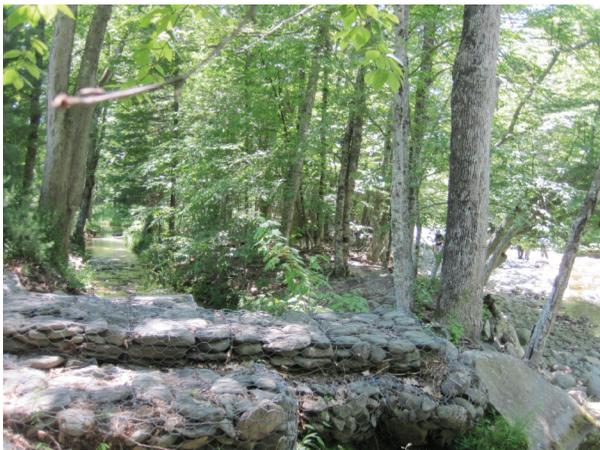
Gabion baskets preventing scour caused by divergence (A526)

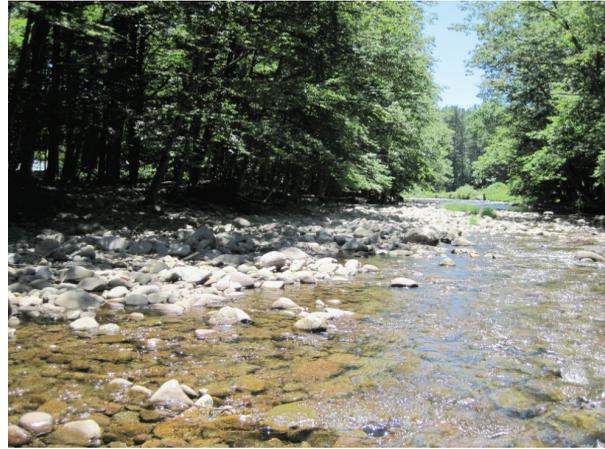
approximately 200-feet in length and is located between Station 750 and Station 550. Very little vegetation exists along this depositional feature. (A527)

Cobble side bar along left bank with little vegetation (A527)

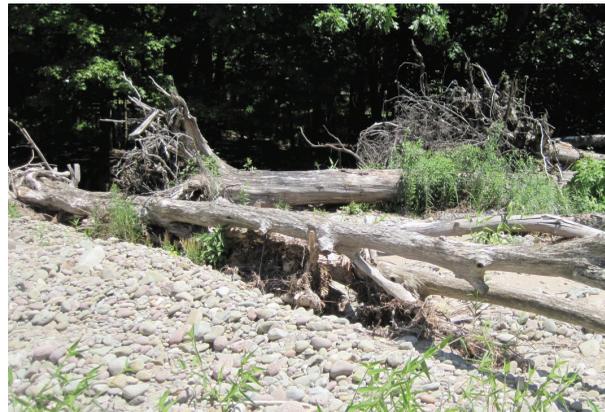
Large woody debris has accumulated along the left side of the stream and is causing obstructions to flow at Station 390 and Station 180. (B429) Japanese barberry, a species that is invasive to the Catskills, was documented at Station 380. This species was first brought to North America by early settlers for its use in making dyes and jams, as well as its popularity as an ornamental plant. It can have a negative effect on ecosystem health because it can compete against native plant species for resources and effectively lower diversity. The leaf litter of the Japanese Barberry can raise the pH levels of the soil and influence nitrogen levels, therefore making the area unsuitable for native plant species.

Large woody debris accumulated on left side of stream (B429)

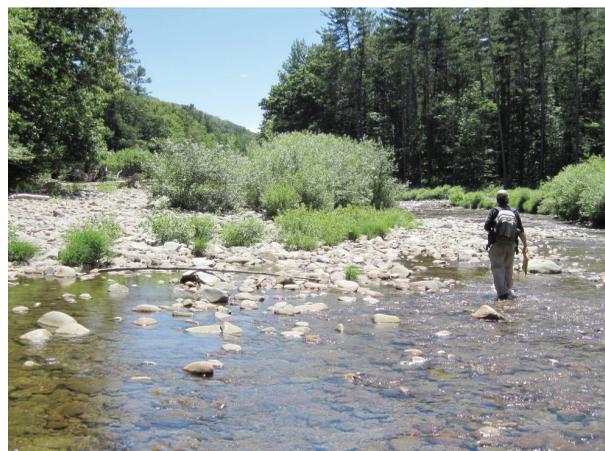
Cobble bar on left side of stream (B425)

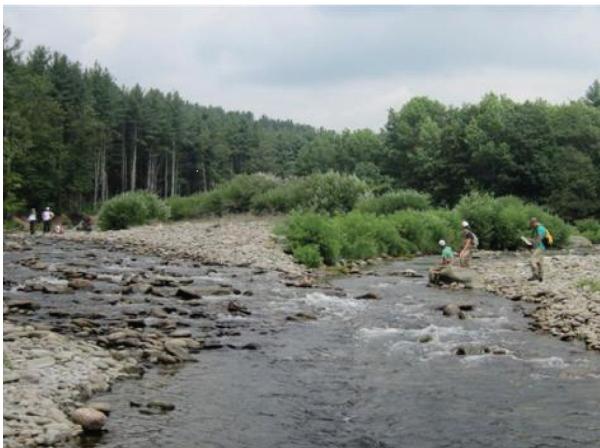
A significant amount of sediment deposition begins on both sides of the channel at Station 300. A bar begins along the left side of the stream at this Station and continues approximately 500-feet before ending downstream of the confluence. This bar primarily consists of cobble sized materials and is heavily vegetated with willows, making it an ideal harvest site for restoration materials. (B425) Extensive willow stands also exist along the right side of the channel on a bar that divides the two branches leading into the confluence. (B387)

Convergence of East and West Branch (B387)

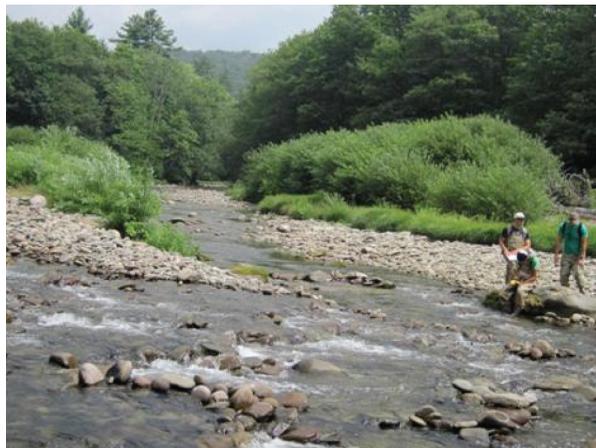
Vertical migration of the channel due to elevation differences at confluence (B383)

An analysis of historical channel alignments at this confluence indicates significant lateral channel migration to the right over the past 50 years. This channel migration can be attributed to a number of natural and human induced changes in the watershed, and can be a reflection of the disturbance history of the channel. Shifts in floodplain land use within the Neversink valley, such as transitions between old growth forest, livestock grazing, and modern development, all contribute to changes seen in channel morphology. Disturbances within the stream channel are also commonplace in the Neversink, and have ranged from the diversion of flow to historical mills and tanneries, to modern day check dams used to create artificial trout habitat. In-channel disturbances such as these have the ability to significantly alter flow regime and sediment transport. In addition to human induced disturbances, this confluence is also naturally susceptible to migration due to the presence of alluvial sediments which are easily eroded and deposited, as well as a lack of any lateral or vertical controls that might prevent migration. These conditions offer little resistance to frequent shifts in the course of flow. At the time of this stream feature inventory, the bed elevation of the West branch was much higher than the East branch at the confluence, resulting in ongoing vertical migration of the channel as water flows over this abrupt elevation drop and scours the bed substrate. (B383)
