Neversink River West Branch

MANAGEMENT UNIT 6

WEST BRANCH MANAGEMENT UNIT 6
BETWEEN STATION 21300 AND STATION 25000

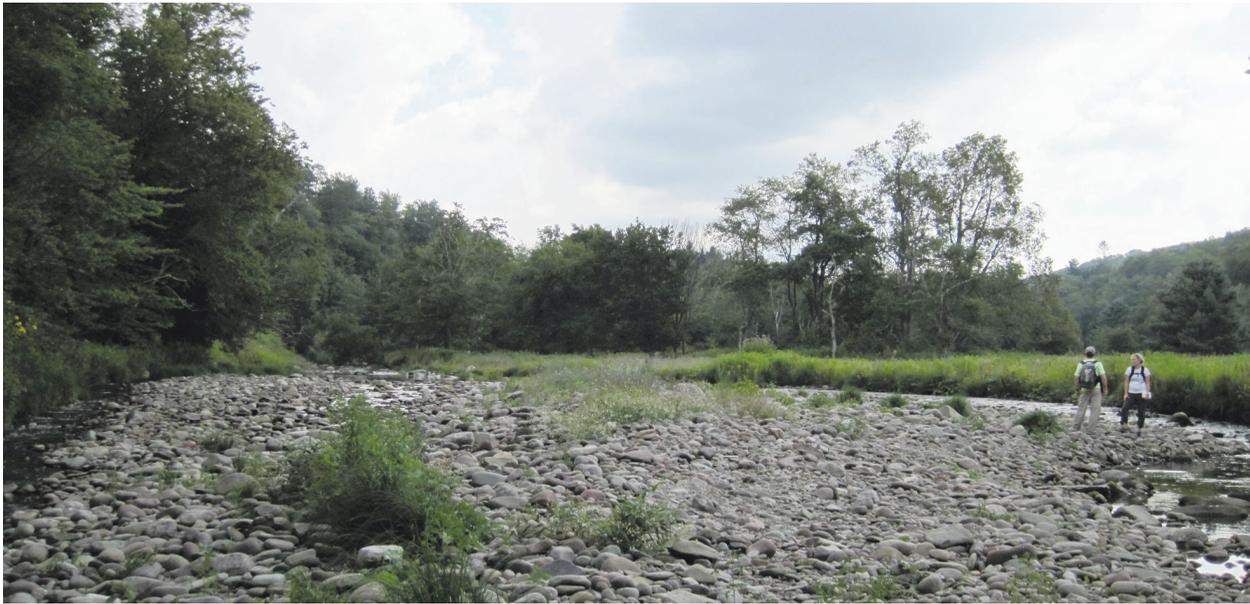
Cobble center bar (A122)

Station 25000 and Station 21330, particularly along the right side of the stream, consist of herbaceous vegetation and potential locations for riparian buffer improvement (*Figure 7*). A cobble center bar with some gravel at the downstream end and little vegetation was observed from Station 24950 to Station 24800. (*A122*)

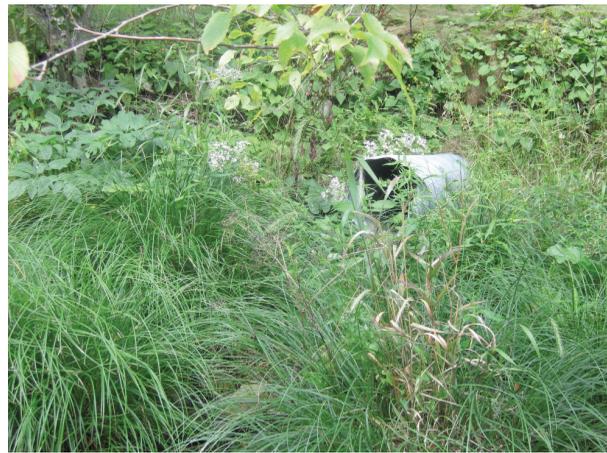
A piped outfall followed by a revetment was observed on the right bank near Station 24020. The piped outfall conveys intermittent flow from the cleared pasture on the right bank via a 15-inch diameter corrugated metal culvert with good outfall protection. It is recommended that the water quality impacts of this outfall be investigated to better understand and possibly mitigate the water quality implications of this conveyance. (*A129*) The 80-foot long revetment appeared to be designed to stabilize the bank and protect Frost Valley Road. The revetment was constructed of rip-rap and documented in good structural and functional condition. (*A131*)

Piped outfall convey flow from cleared pasture (A129)

| Water Quality | Investigation of water quality impacts of piped outfalls at Station 24020, Station 22600 and Station 21500. Maintain household septic systems. |

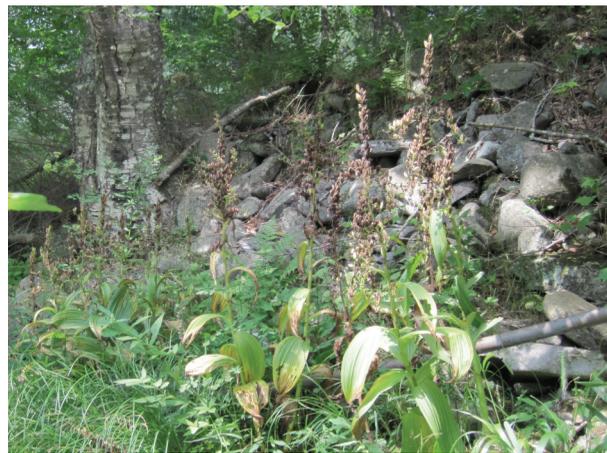
Rip-rap revetment protecting Frost Valley Road (A131)

INFRASTRUCTURE A piped outfall followed by a revetment was observed on the right bank near Station 24020. The piped outfall conveys intermittent flow from the cleared pasture on the right bank via a 15-inch diameter corrugated metal culvert with good outfall protection. The 80-foot long revetment appeared to be designed to stabilize the bank and protect Frost Valley Road. The revetment was constructed of rip-rap and documented in good structural and functional condition.

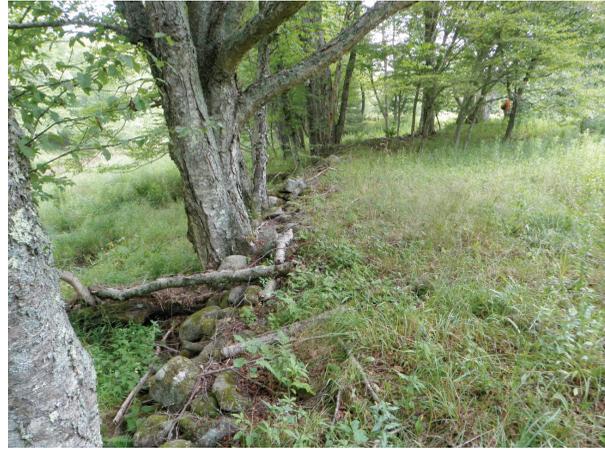
An old stone berm was observed on the left bank extending 90 feet from Station 23810 to Station 23720. The berm was covered with some grass and sedge vegetation and is located slightly upslope of a row of old birch trees. It is possible that this berm was designed to protect an orchard or other forest industry staging area in the left floodplain, although no fruit trees or other evidence of industrial infrastructure were observed. (P7280034)

Stone berm along left bank (P7280034)

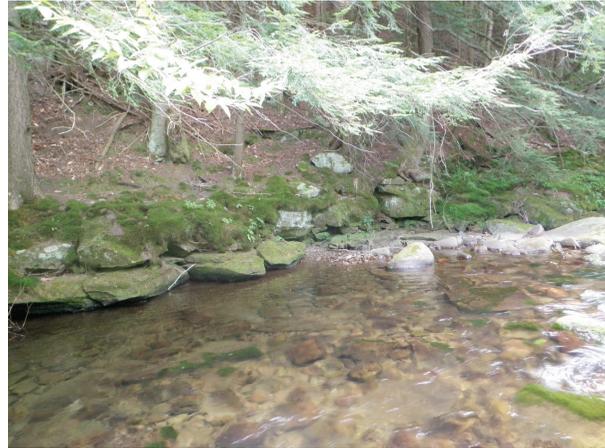
The floodplain on the left bank ends at the convergence of the side channel flowing along the left valley wall near Station 23350. The river enters semi-confined valley conditions downstream of this location as it flows adjacent to the valley wall beginning at Station 23300. This confinement is further evidenced by the exposed bedrock was observed for 150 feet downstream of the convergence forming a bed grade and planform control on the main channel. (P2780041)

Exposed bedrock providing bed and grade control (P2780041)

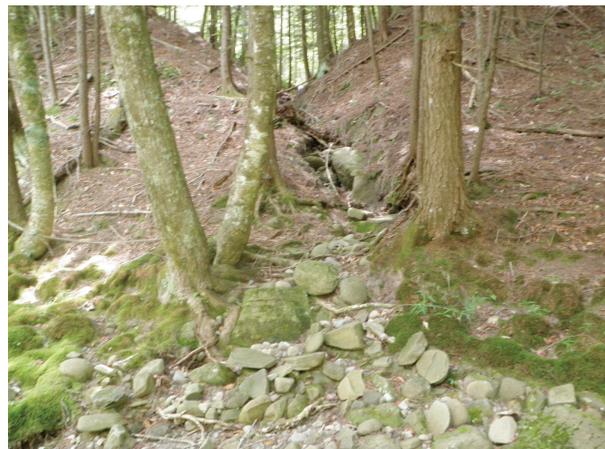
At Station 22400 an intermittent tributary conveying flow from the forested left valley wall joins the main channel, flowing over more exposed bedrock stream bed grade and planform control. (P7280042) Near Station 22100 the exposed bedrock begins to retreat from the stream bank with a forested bankful bench forming on the left bank.

Intermittent tributary conveying flow from left valley wall (P7280042)

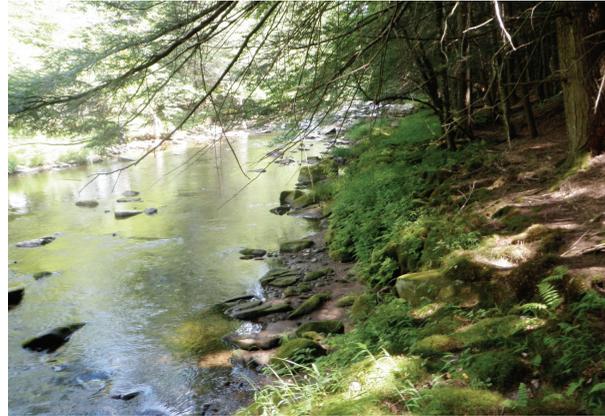
Forested bankfull bench forming on the left (P7280044)
