3.4 Riparian Vegetation Issues in Stream Management

3.4.2 Riparian Vegetation in Broadstreet Hollow

3.4.3. Assessment of the Current Condition of Riparian Vegetation in Broadstreet Hollow

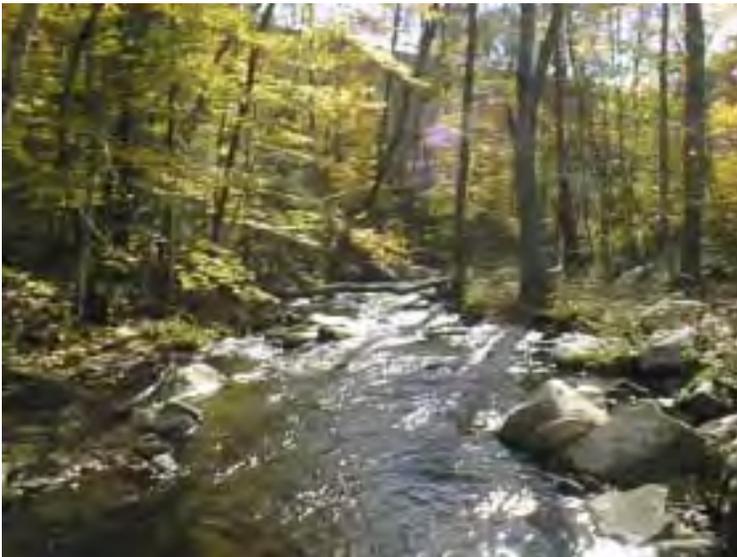
Photo 1. A healthy riparian community is densely vegetated, has a diverse age structure and is composed of plants that can resist disturbance

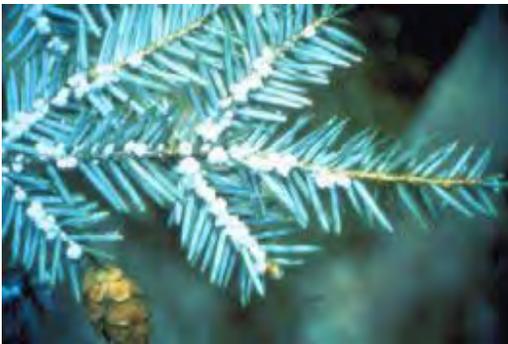
Photo 2. Hemlock woolly adelgid on the underside of a branch.

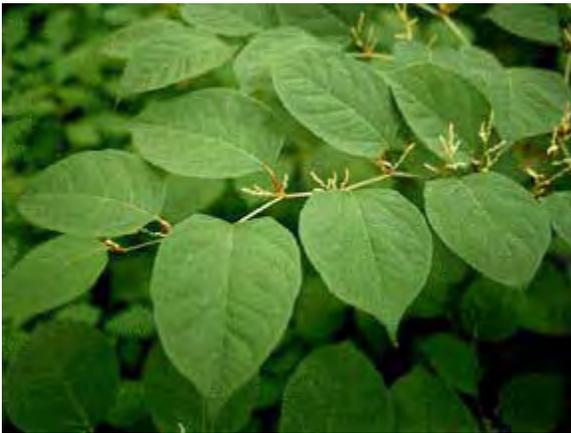
Photo 3. Broad heart shaped leaf pattern of Knotweed

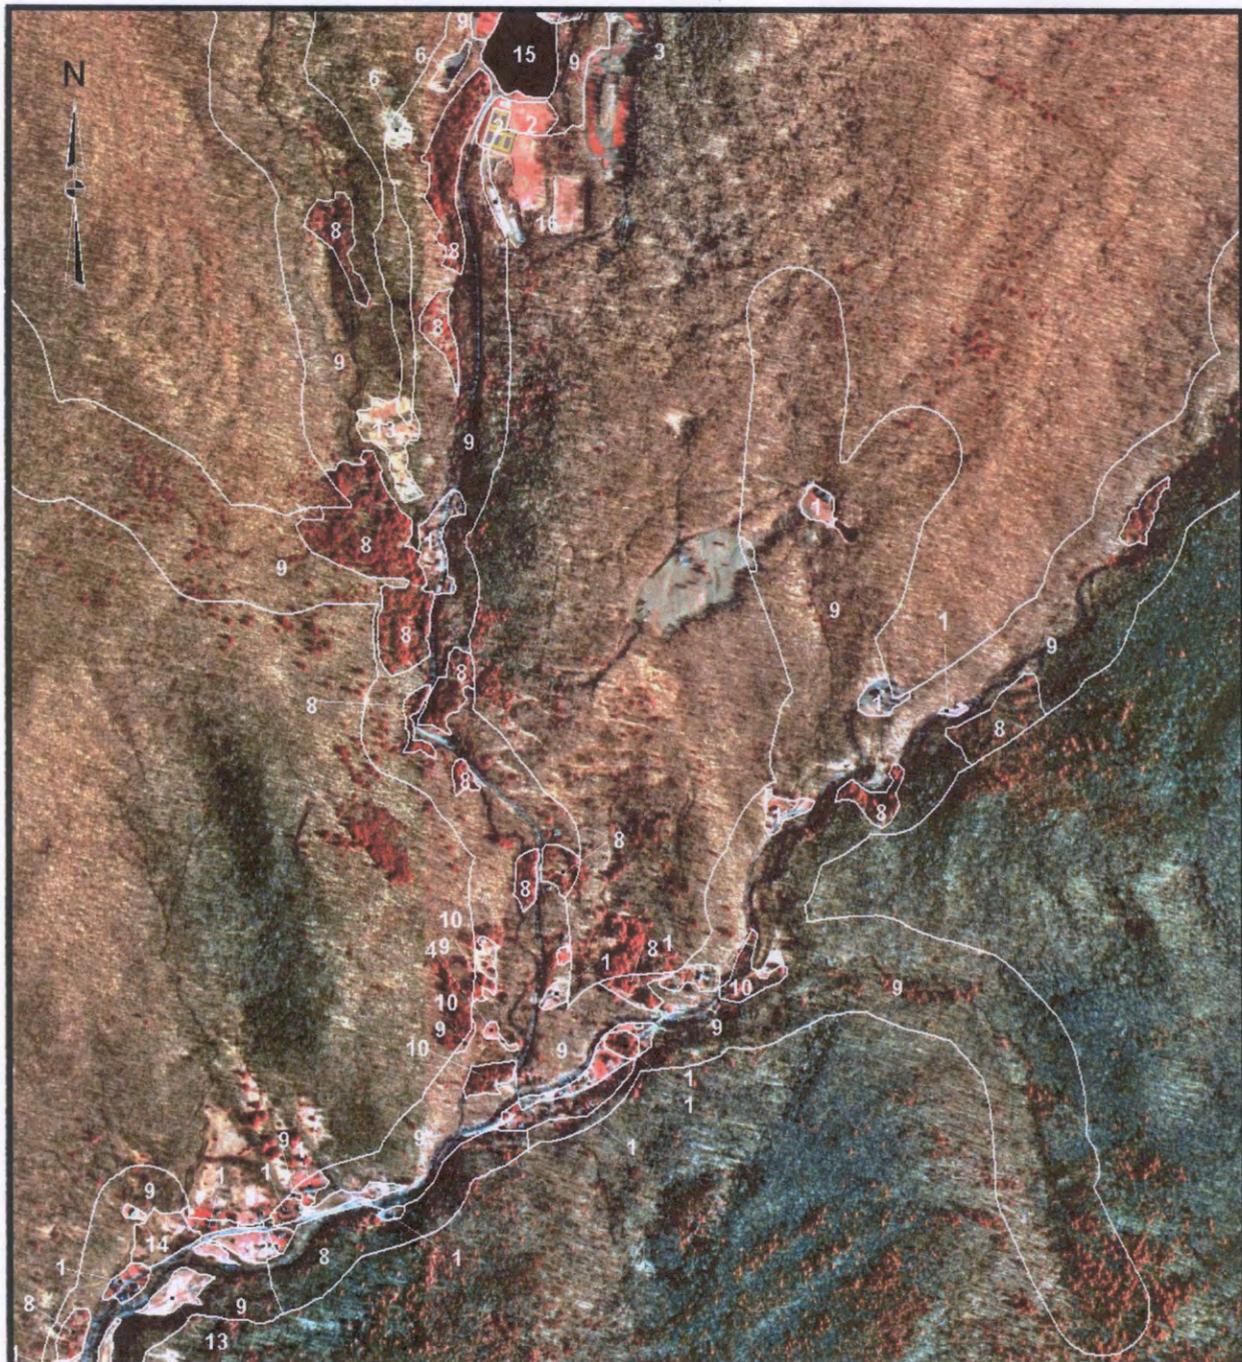
Figure 3. Ecological Communities and Land Use (Upper Watershed)

Delineation of ecological communities from photo interpretation of color infra-red digital orthophotography (1994-99 series) with a 1 meter ground resolution. Verified through a windshield survey and the functional condition assessment Fall 2002.

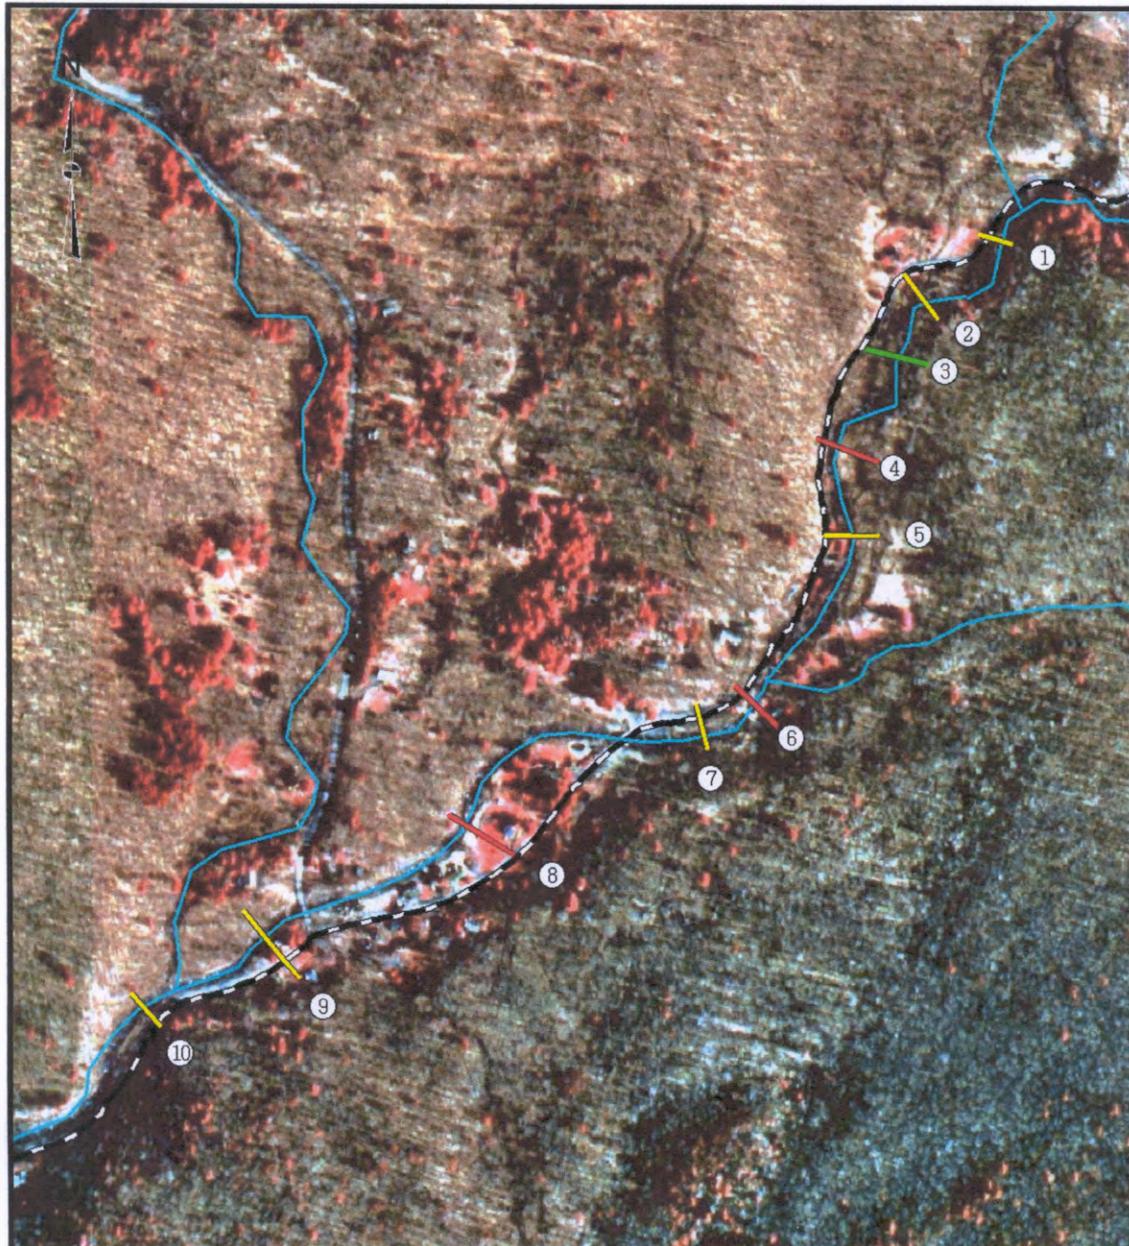
Figure 4. Riparian Vegetation Functional Condition Assessment Cross Section Locations and Ratings

The graphic below (Figure 4) shows the location and functional condition rating for each of the ten cross sections completed in this pilot study. Discussion of the results will be grouped by the various rating classes.

Location of cross-sections are approximate and where mapped to aerial photographs in the field at the time of assessment. Fall 2002.

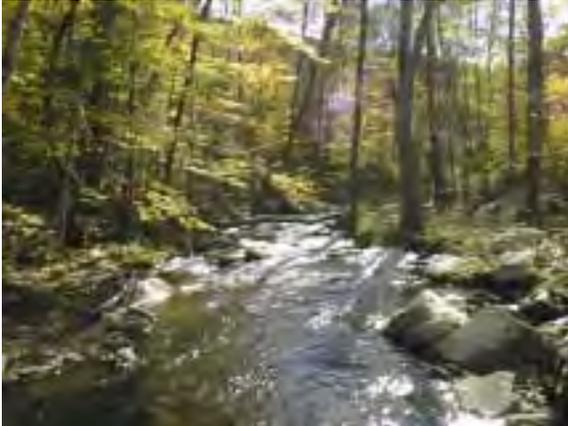
Properly Functioning Condition - Only cross section number 3 achieved this high rating. This site has a wide vegetation buffer (over 50 feet on both sides), an established and unconfined floodplain, and plenty of woody debris to provide additional resistance during high flow conditions. The vegetation is diverse in its composition and structure resulting in a densely rooted soil profile. There is also adequate regeneration on this site to ensure that it will continue to aid in the maintenance of stable stream conditions.

Photo 4. Example of Properly Functioning Condition

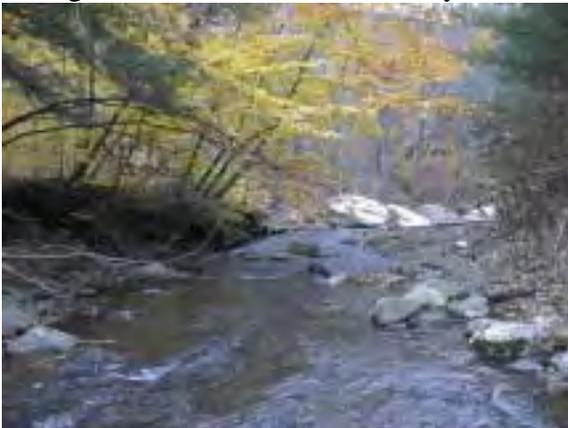
At Risk Condition - Six of the ten cross sections (numbers 1,2,5,7,9 and 10) were rated as functional-at risk. At half of these sites, the proximity of the road, stress on the vegetation associated with road maintenance, and its encroachment on the width of the vegetative buffer has created a condition that has affected the vigor and function of the riparian vegetation buffer. At site 5, the proximity of disturbance associated with an abandoned residence, the invasion of Japanese knotweed (this colony may be the source of many of the downstream knotweed colonies) and the resulting weakened vegetation on the right bank threatens the stability of the stream at this location.

Photo 5. Example of At Risk Condition

At site 1 and 2 the width of the riparian buffer on the right bank is insufficient to provide for the long-term stability of the stream. At each of the “At Risk” sites either an

extension of the buffer or protection of the buffer from road encroachment will reduce the stress and improve the functional condition to a “Properly Functioning Condition” rating.

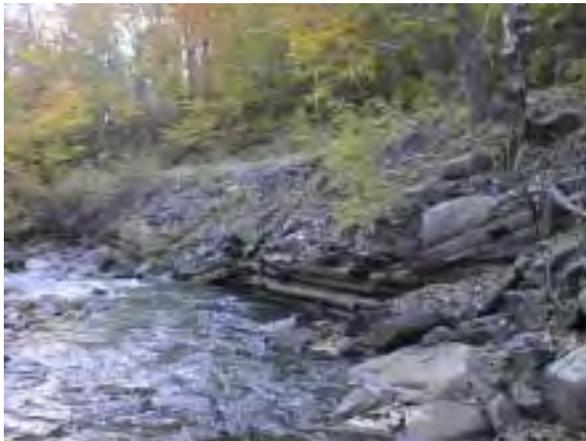
Nonfunctioning Condition- Three cross sections (numbers 4, 6, and 8) were rated as non-functional. At two of these cross-sections (number 4 and 6) the stream was confined by the road and the width of the vegetation buffer was less than five feet. Riprap and log cribbing on the right bank that had been placed to protect the road was in poor condition and was in need of maintenance. Replacement or integration of this revetment with vegetation to protect the bank in place of rock would improve the functional condition to at least the “At Risk” rating. The vegetation on the left bank at cross section 4 was also severely affected by the utility line which parallels the stream. Tree clearing and brush control crews left only a narrow strip of vegetation between the left bank of the stream and the utility line. Cross-section 8 was the stream restoration project site where the woody vegetation has yet to achieve a size and density where it will aid in maintaining stream stability. Areas of this site will need supplemental planting for it to meet the properly functioning condition rating. Plant species diversity at this site was low and the impact of residential dwellings may continue to affect the rating at this reach.

Photo 6. Example of Nonfunctioning Condition
