## 2. Hydrology and Flood History

# Chestnut Creek Stream Management Plan

### 3. Riparian Vegetation Issues in Stream Management

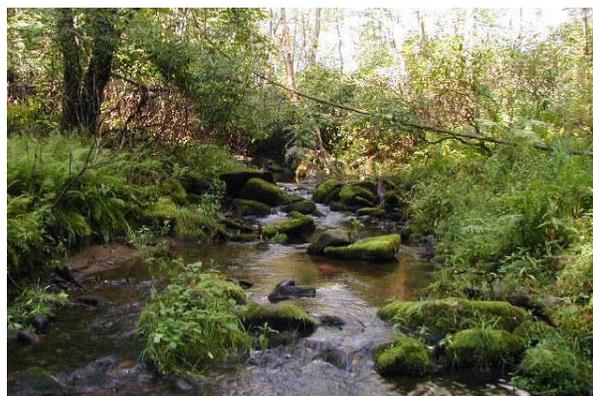
Photo 1. A healthy riparian community is densely vegetated, has a diverse age structure and is composed of plants that can resist disturbance. View upstream from XS-56.

The extent of benefits depends on width of the riparian zone and its species diversity (Photo 1). For example, the only benefit addressed by a 25 foot buffer may be bank stabilization while a buffer over 200 feet includes a whole range of water quality and ecological benefits. In addition, a buffer that contains a variety of species and types (trees, grasses, shrubs, herbs) offers the best protection. An area with diverse species would be more likely to continue to function properly than a simpler community if one species was eliminated (more discussion will follow with the issue of woolly adelgid and Eastern hemlock). Whereas, if only one or a few species covers a streambank and disease or pests attack it, the buffer would quickly disappear. In addition, different types of plants offer a variety of root depth and strength to stabilize stream banks in shallow to deep soils.

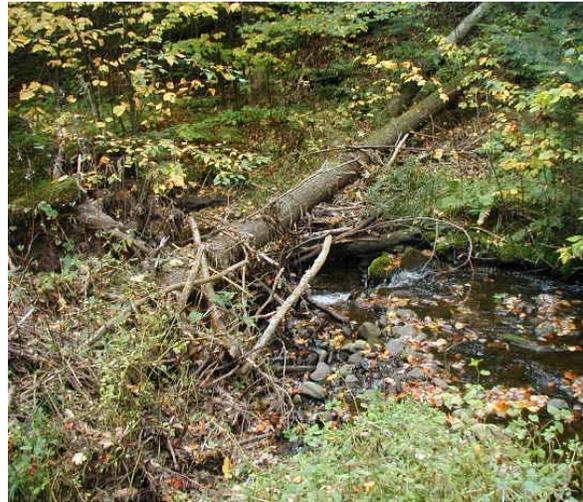
Photo 2. View showing channel wide debris jam.

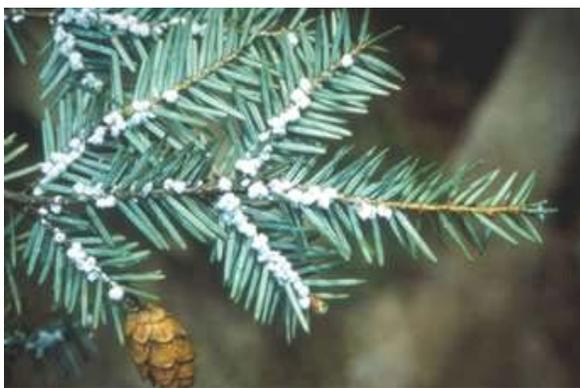
Photo 3. Hemlock woolly adelgid appear as fuzzy white spots on underside of the branch.

Pests and diseases that attack vegetation also impact the riparian area. In the eastern United States, the woolly adelgid (*Adelges tsugae*) attacks eastern hemlock (*Tsuga canadensis*) and Carolina hemlock (*Tsuga carolinianna* Engelman) and can affect entire stands of hemlock, an important riparian species (Photo 3). The stress caused by the adelgid's feeding can kill a tree in as little as 4 years (McClure, 2001). Once a tree is infested, insect density fluctuates with hemlock regrowth. This regrowth is stunted and is later attacked as the adelgid population increases. With each successive attack the reserves of the

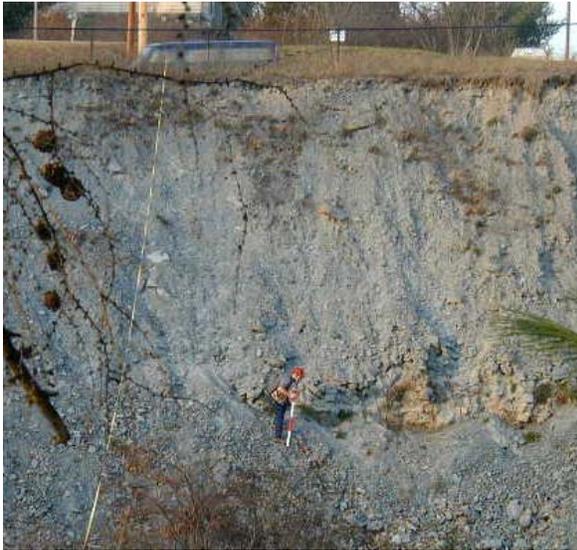
Photo 4. View of eroded left bank on DEP property. Material undercut and slumping.

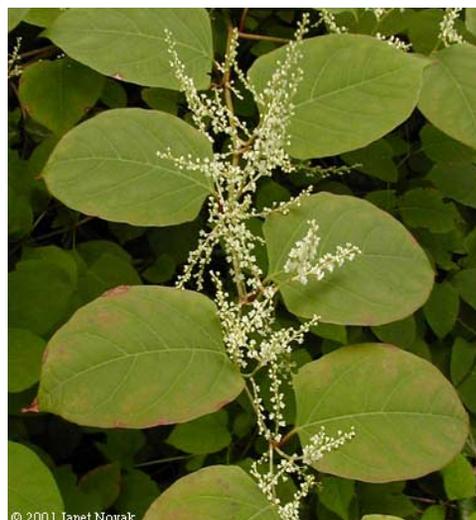
Photo 5. Broad heartshaped leaf pattern of Knotweed (Janet Novak, 2001).

As its common name implies, Japanese knotweed’s origins are in Asia, and it was brought to this county as an ornamental garden plant (Photo 5). This plant grows and spreads rapidly on disturbed sites and prefers moist, open conditions common to developed or cleared stream edges and banks. After establishing itself on a site, Japanese knotweed shades out existing

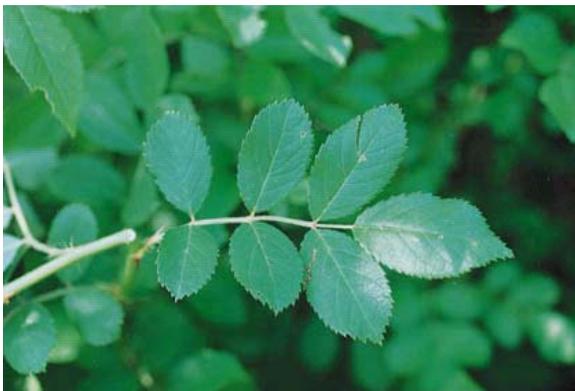
Photo 6. Multiflora rose compound leaf (Samuel Roberts Noble Foundation, Inc. 2003).

Another invasive, Multiflora rose (a thorny perennial shrub with compound leaves) was introduced to the area in the 1930's (Photo 6). This plant was promoted as a 'living fence' to farmers, because its arching stems can take root at the tip, forming dense thickets. The plant's persistent seeds provide an edible resource, and thick stems provide shelter to pheasant, quail, and songbirds. In recent years the rose has been planted along highways to serve as a crash barrier.

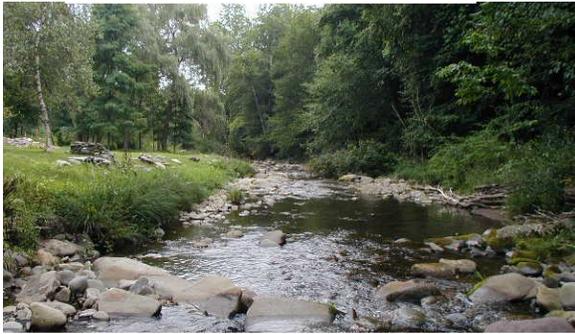
Photo 7. View looking downstream from below XS-124. Mowed lawn is shown on the left, densely vegetated riparian buffer is shown on the right.

The Chestnut Creek riparian area can be characterized as a mix of small wooded buffers with mature trees, shrubs, and herbaceous plants, mowed lawns with scattered trees and shrubs, and reaches along steep hillslopes and terraces with mature forest (Photo 7). In riparian areas
