2.6 Riparian Vegetation Issues in Stream Management

General Concepts of Riparian Vegetation Ecology and Management

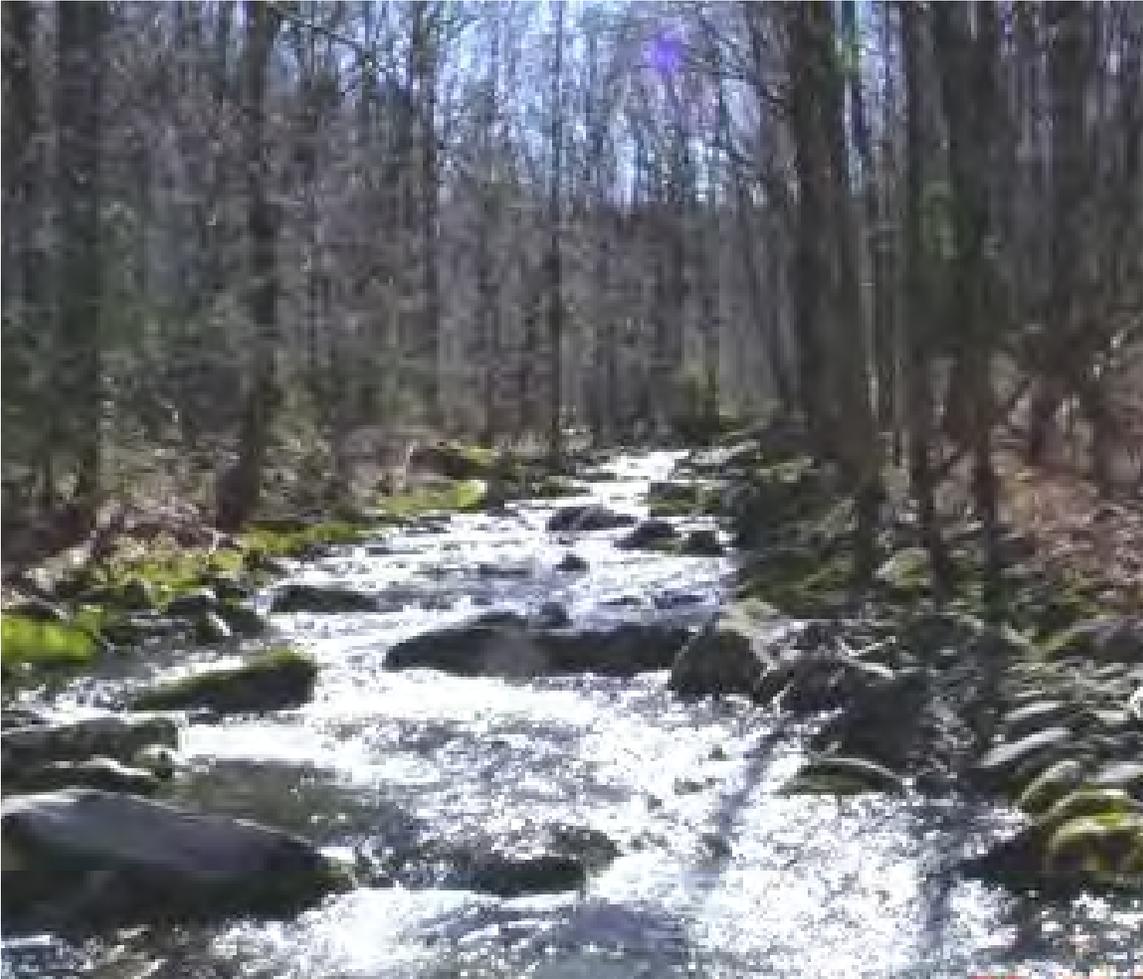
West Kill bounded by a mixed northern hardwood forest – the tree roots and boulders in the bank form a dense matrix capable of withstanding floods and ice floes.

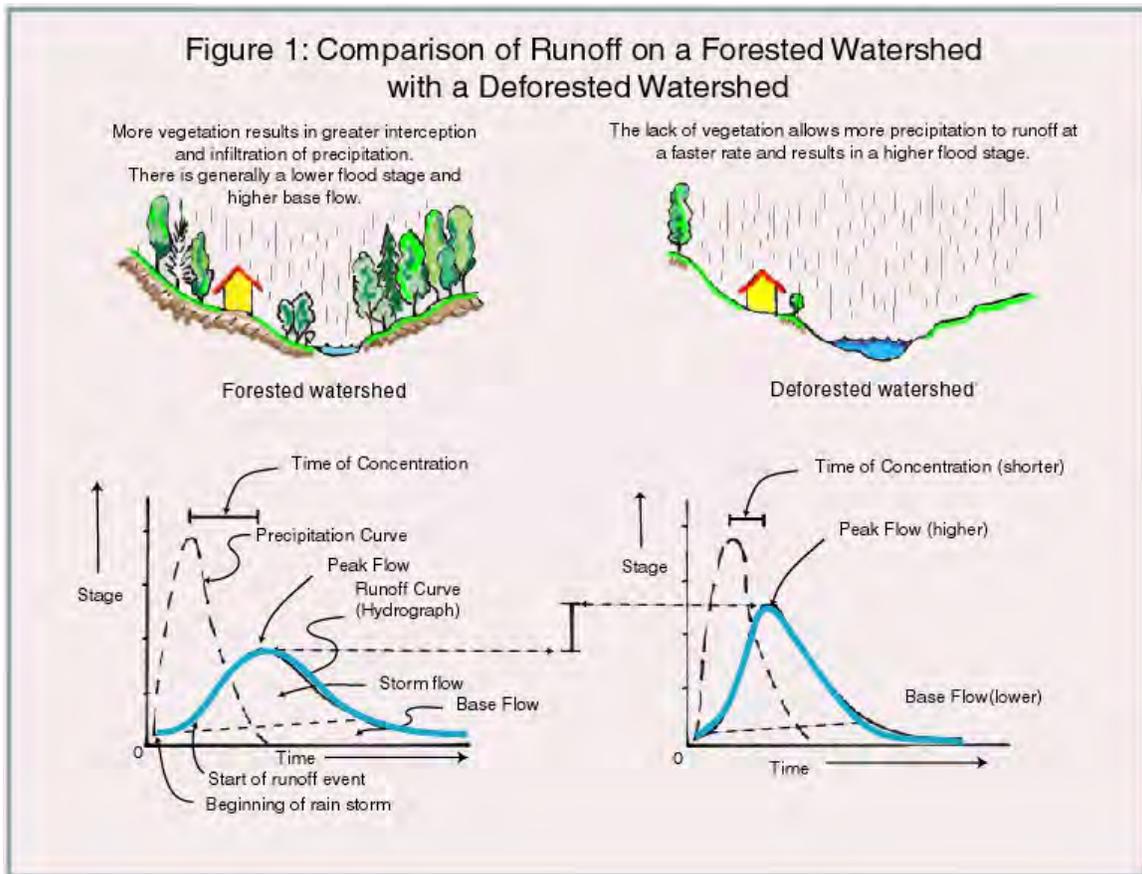
Illustration by P. Eskeli 2002, from *Watershed Hydrology*, P.E. Black, 1991, Prentice Hall, page 202, 214.

Vegetation intercepts rainfall and slows its runoff. This delay increases the amount of precipitation that infiltrates the soil and reduces overland runoff. A reduction and delay

in runoff decreases the occurrence of destructive flash floods, lowers the height of the flood waters, and extends the duration of the runoff event. These benefits are generally most readily observed in forested watersheds like West Kill when compared with similar watersheds where urban development is the chief land use (Figure 1). The reduction in flood stage and duration typically means less disturbance to the streambanks and floodplains.

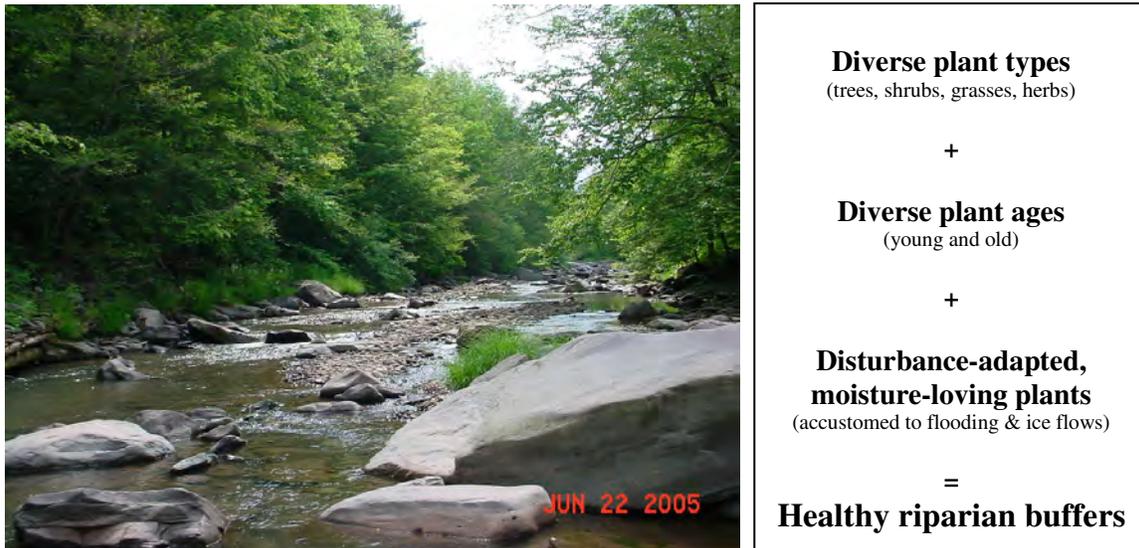
Figure 1 A healthy riparian community is densely vegetated, has a diverse age structure and is composed of plants that can resist disturbance

A healthy riparian plant community should be diverse. It should have a wide variety of plants whether trees, shrubs, grasses or herbs. The age of the plants should be varied and there should be sufficient regeneration of new plants to ensure the future of the community. A diverse community provides a multitude of resources and the ability to resist or recover from disturbance. An important difference between an upland plant community and a riparian community is that the riparian community must be adapted to frequent disturbance from flooding. Consequently, many riparian plants, such as willow, alder, or poplar can regrow from stump sprouts or can reestablish their root system if up ended. Furthermore, the seed of these trees may have a greater ability to germinate and establish in depositional areas, such as gravel bars and lower flood benches.

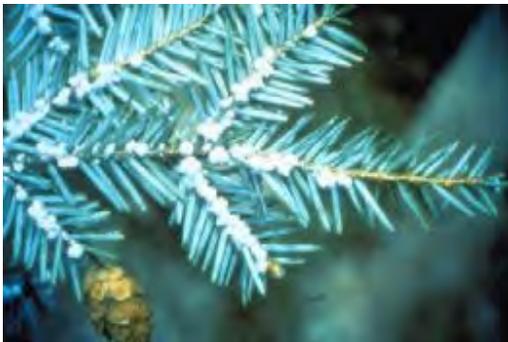
Figure 2 Hemlock woolly adelgid on the underside of a branch.

Pests and diseases that attack vegetation can also affect changes in the ecology of the riparian area and could be considered a disturbance. The hemlock woolly adelgid (*Adelges tsugae*) is an insect, which feeds on the sap of hemlocks (*Tsuga spp.*) at the base of the needles causing them to desiccate and the tree to take on a greyish color. The stress caused by this feeding can kill the tree in as little as 4 years and take up to 10 years where conditions enable the tree to tolerate the attack (McClure, 2001). This native

hemlock regrowth occurring in periods when population densities are lower. This regrowth is stunted and is later attacked as the adelgid population increases. With each successive attack the reserves of the tree become depleted and eventually regrowth does not occur. The native predators of hemlock woolly adelgid have not offered a sufficient biological control, but recent efforts to combat the insect include the experimentation with an Asian lady beetle (*Pseudoscymnus tsugae* Sasaji) which is known to feed on the adelgid. Initial experimental results have been positive, but large-scale control has yet to be attempted. The US Forest Service provides extensive information about this pest at its Morgantown office “forest health protection” webpage:

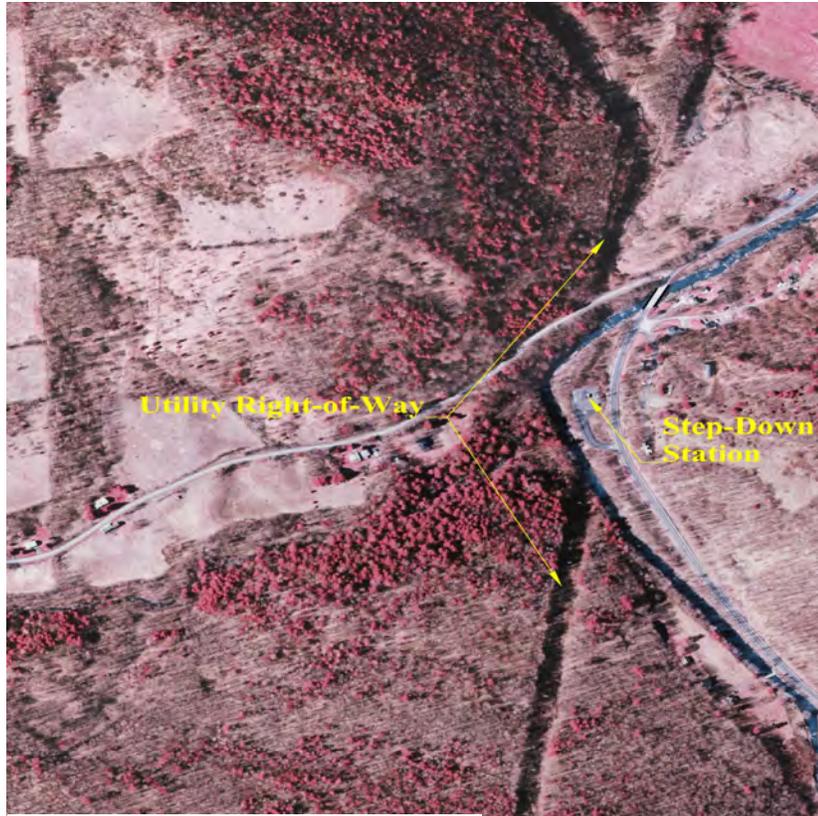
Figure 3 Utility Right-of-Way.

Utility lines parallel the roadway and cross the stream at various points requiring the utility company to cut swaths through the riparian vegetation at each crossing, further

fragmenting essential beltways for animal movement from streamside to upland areas. Although the right of way of the road and utility line sometimes overlap, at several locations along the stream, the right of way crosses through the riparian area separate from the road. This further reduces the vigor of riparian vegetation and prevents the vegetation from achieving the later stages of natural succession, typified by climax species such as sugar maple, beech and hemlock.

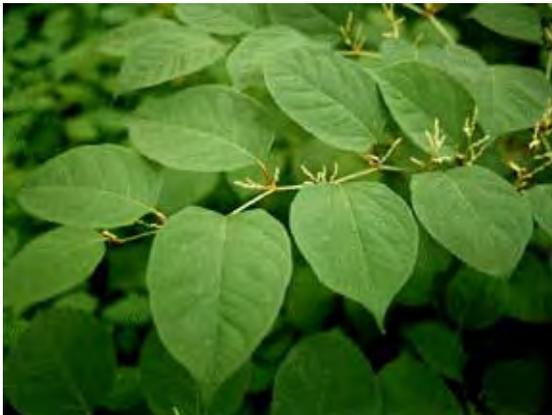
Figure 4 Knotweed’s leaf pattern

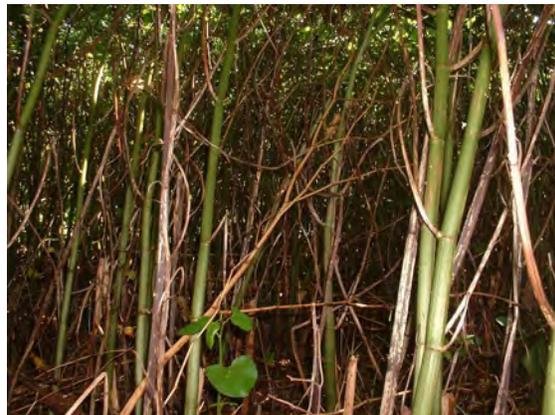
Figure 5 Dense stand of Knotweed

Japanese knotweed spreads primarily by vegetative means. Often, earthmoving contractors, highway department crews or gardeners transfer small portions of the roots in fill or soil that get dumped on a stream bank. These roots then grow into a new plant that soon becomes a colony. Once in the riparian area, high flows scouring the bank may spread portions of the root downstream where it establishes new colonies on disturbed sites or sediment deposits. The aboveground portion dies back each fall and re-grows to a height of 6- 9 feet tall each spring. The canopy of the dense stands of bamboo-like stalks, covered by large heart shaped leaves (Photo 4), blocks out almost all light from reaching the soil (Photo 5), thereby shading out other plants and leaving the soil bare.

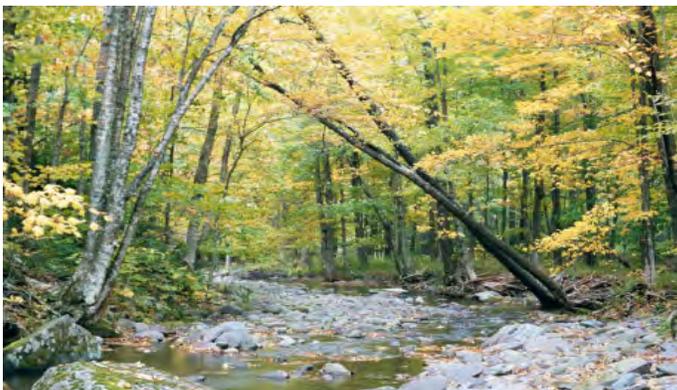
Figure 7 Riparian vegetation (closed deciduous), along the West Kill, protects streambanks and water quality, and provides habitat and food sources for fish and wildlife.
