FAWN HILL WOODLAND VALLEY ROAD STREAM PROJECT- UPDATE 12/14/2010

Project Number: AWSMP_1008T2

December 14, 2010

Warner Creek Stream Management Project

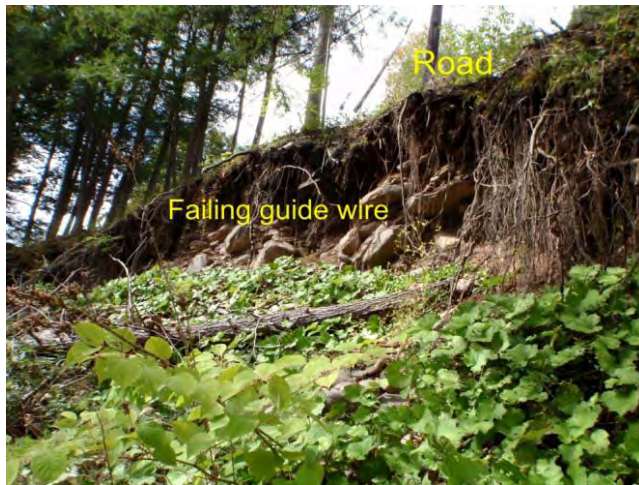
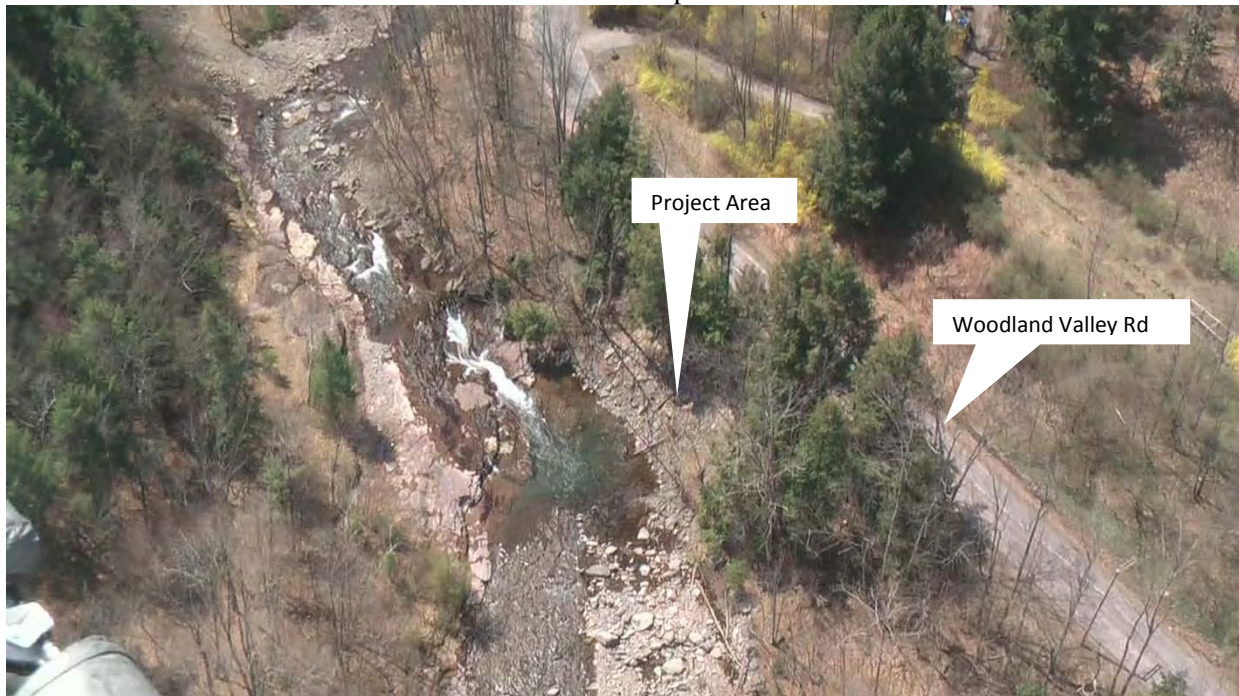
The eroding stream bank is approximately 25ft above stream and 80ft long. The bank is composed of fluvial deposits, glacial till and road fill material. The Woodland Valley Road runs adjacent to the bank and portions of the road are approximately 8ft from the edge of the eroding bank. The stream channel at the base of eroding area is primarily a bedrock controlled pool.

Figure 1 Top photo shows undercut road at the top of the failing bank. Bottom photo is an aerial photo of Woodland Valley Creek, project location and proximity to the road.

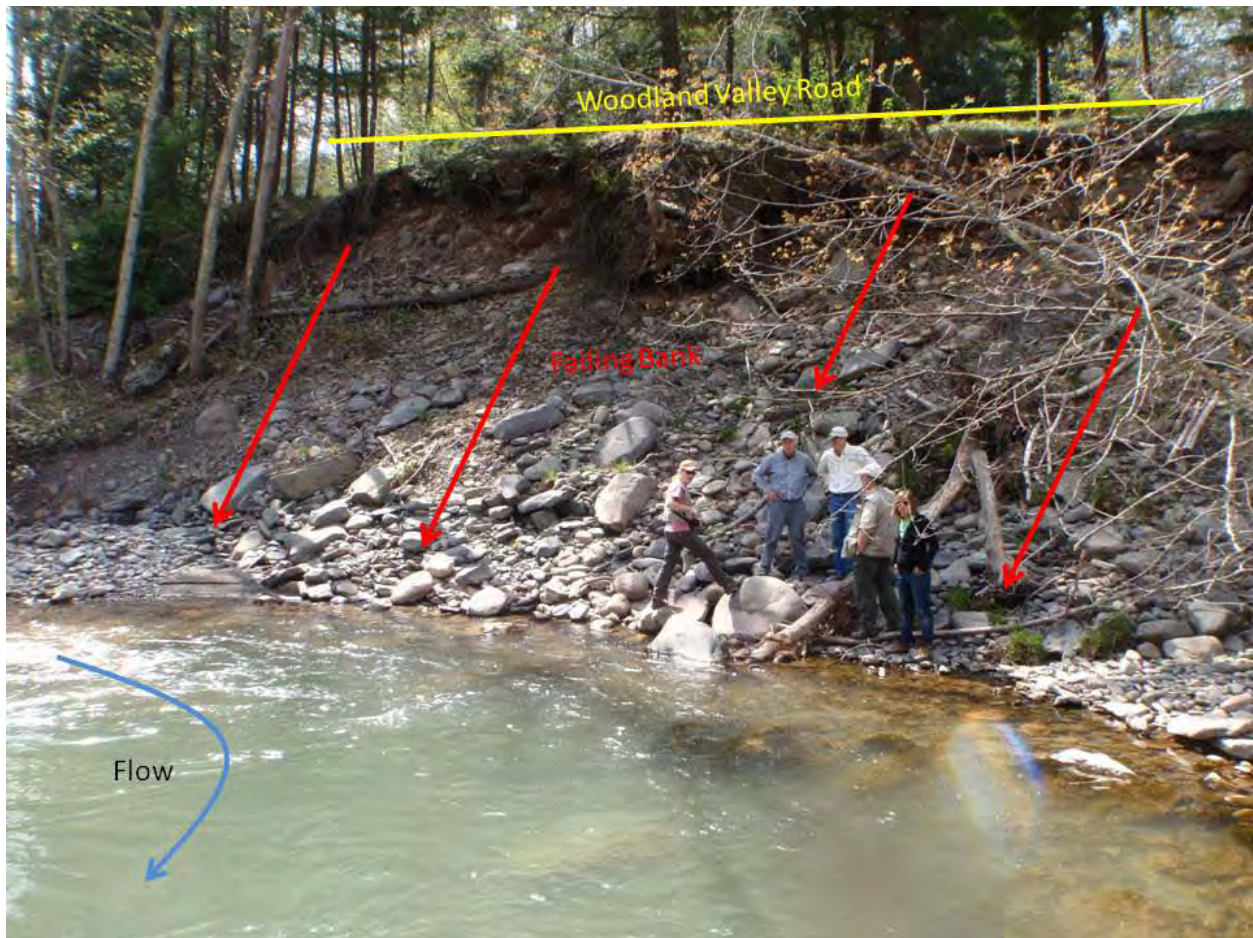
Figure 2 Visual analysis depicting pool, failing bank and location of Woodland Valley Road.

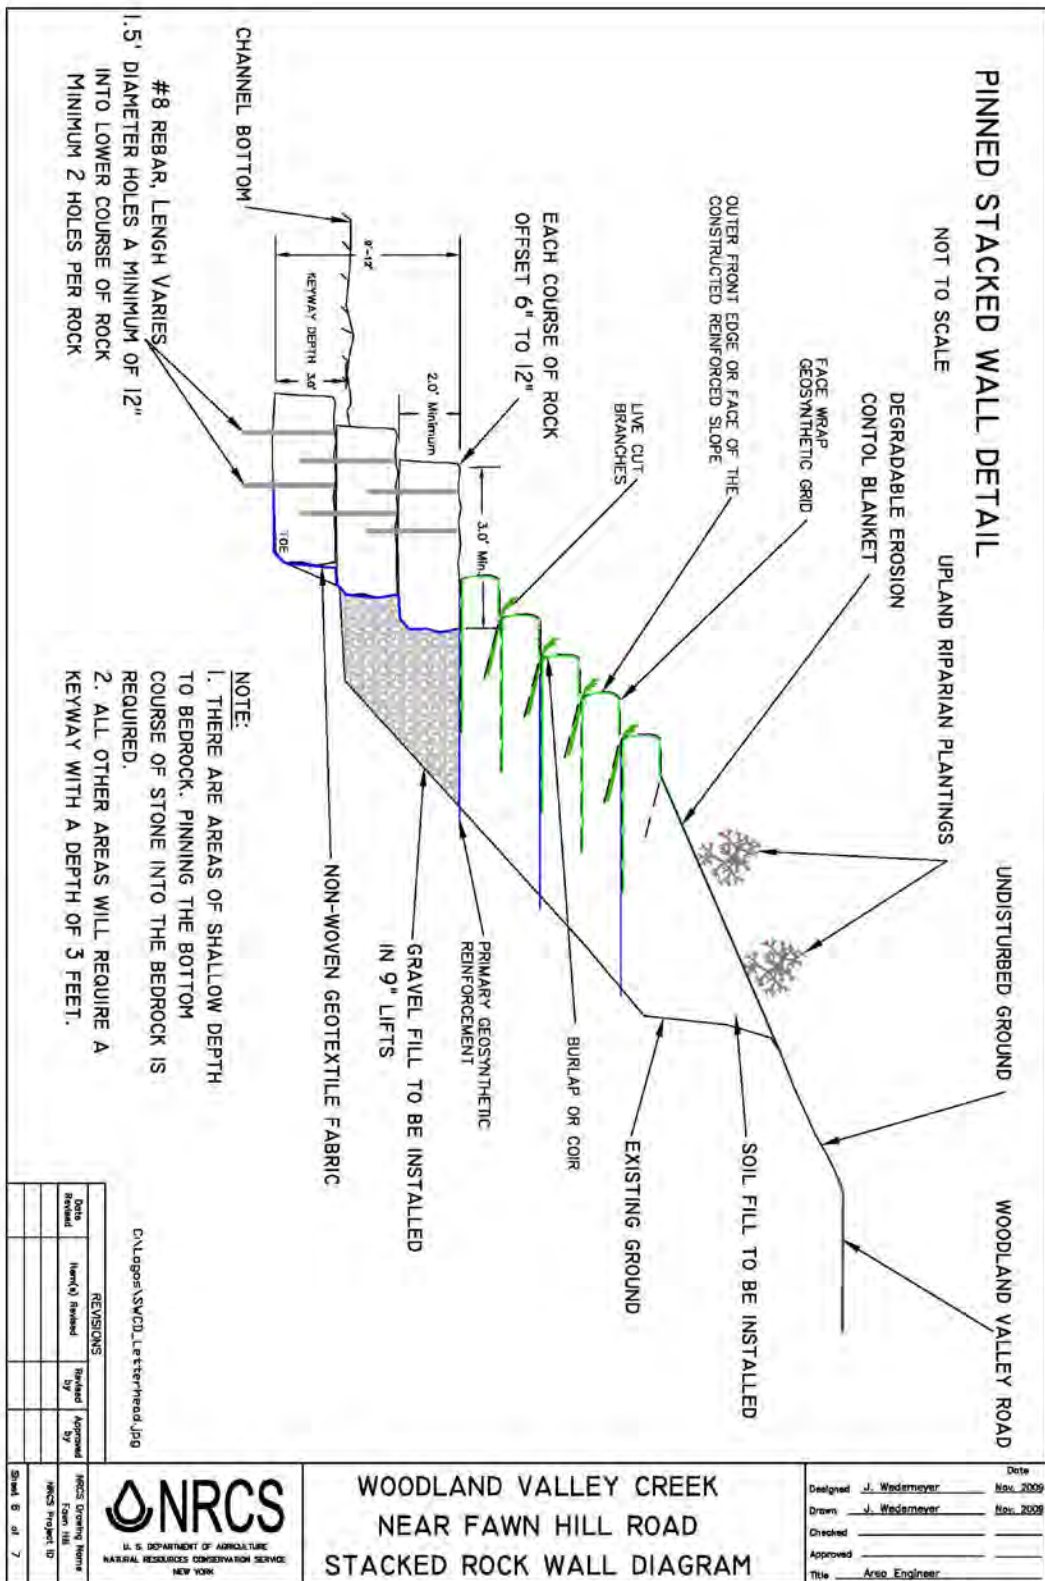
Figure 4 Drawing depicting stacked rock wall and VRSS

- Cost of project covered at 75% level from a FEMA mitigation fund, AWSMP funds 25% level.
- Overall cost of project approximately \$125,000.
- Completed project installation. Installed 150ft of stacked stone wall and bio-engineered vegetated reinforced soil slope (VRSS).
- Final step scheduled for spring 2011 to plant trees and shrubs on upper slope

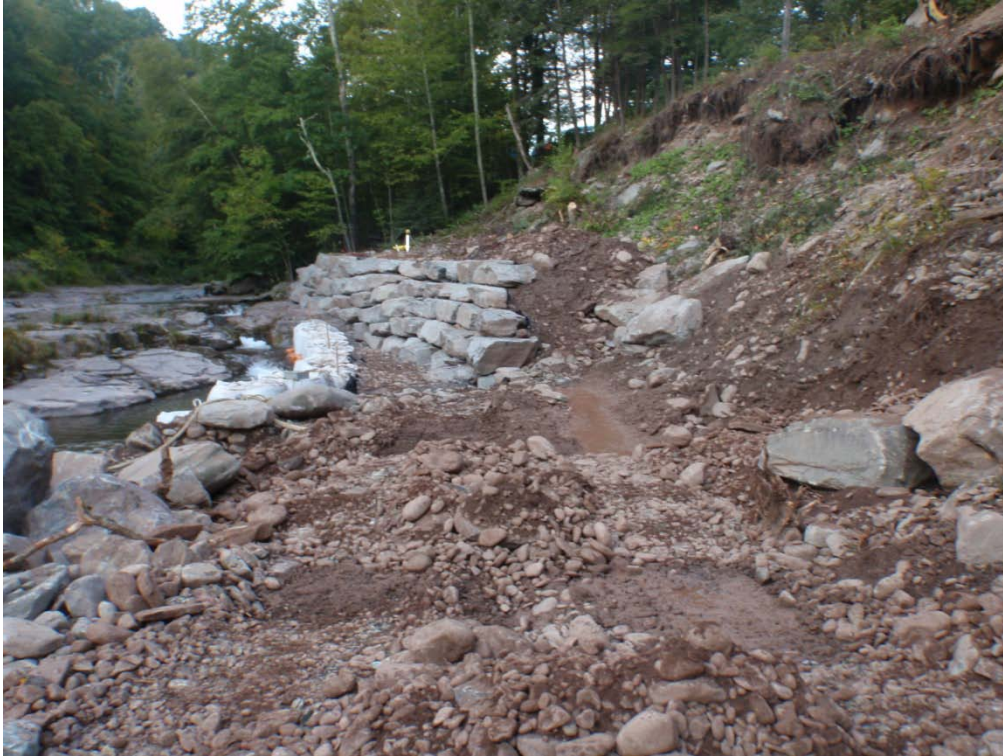
Figure 5 Construction of stacked rock wall.

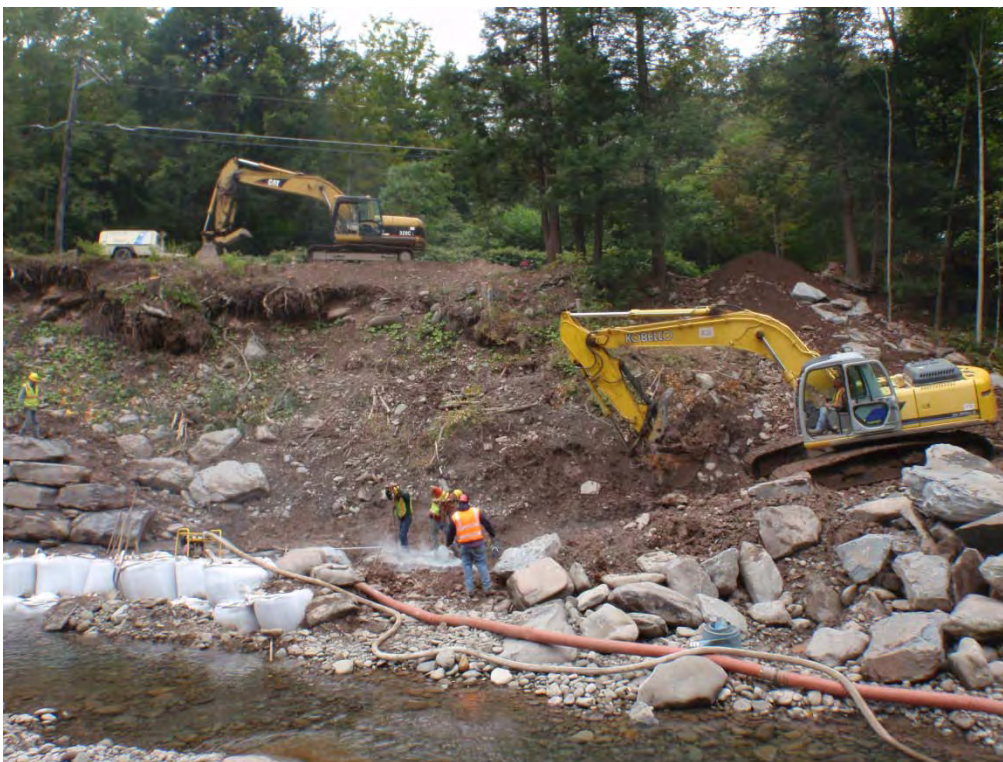
Figure 6 Construction continued 1

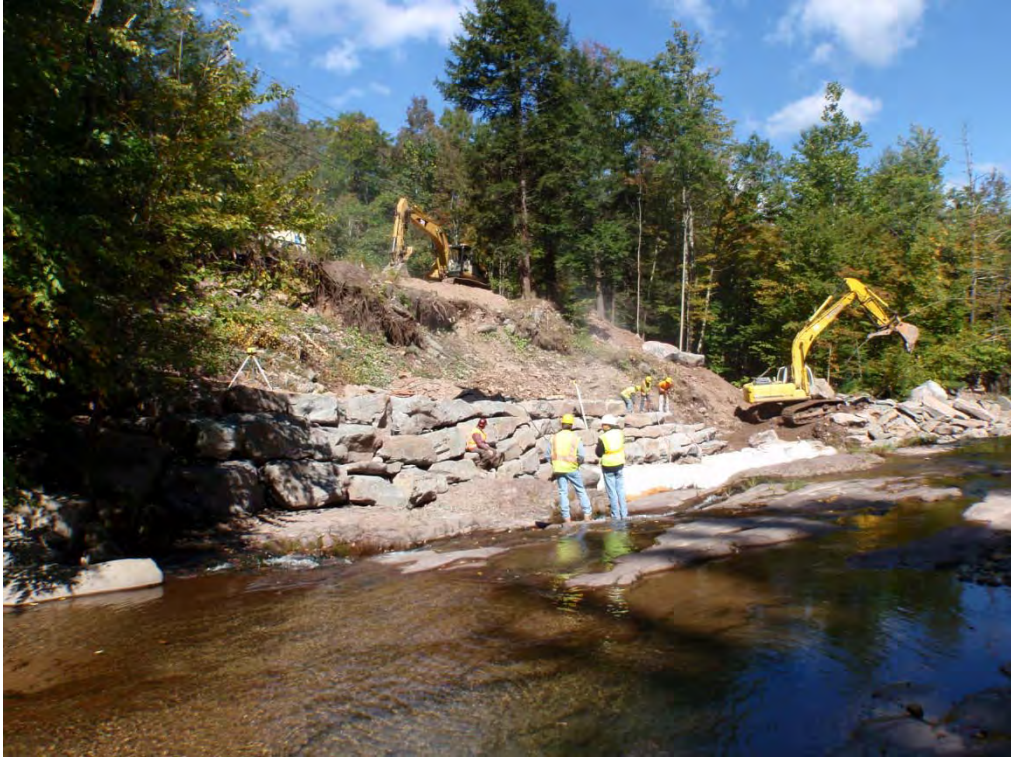
Figure 7 Construction continued 2

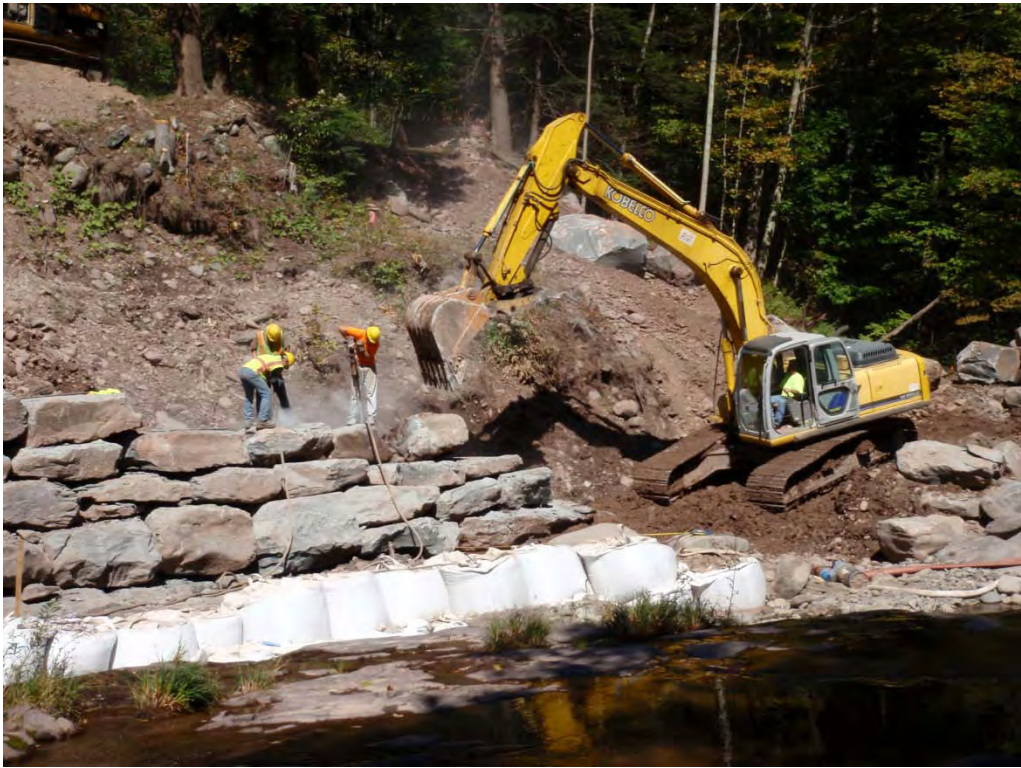
Figure 8 Construction continued 3

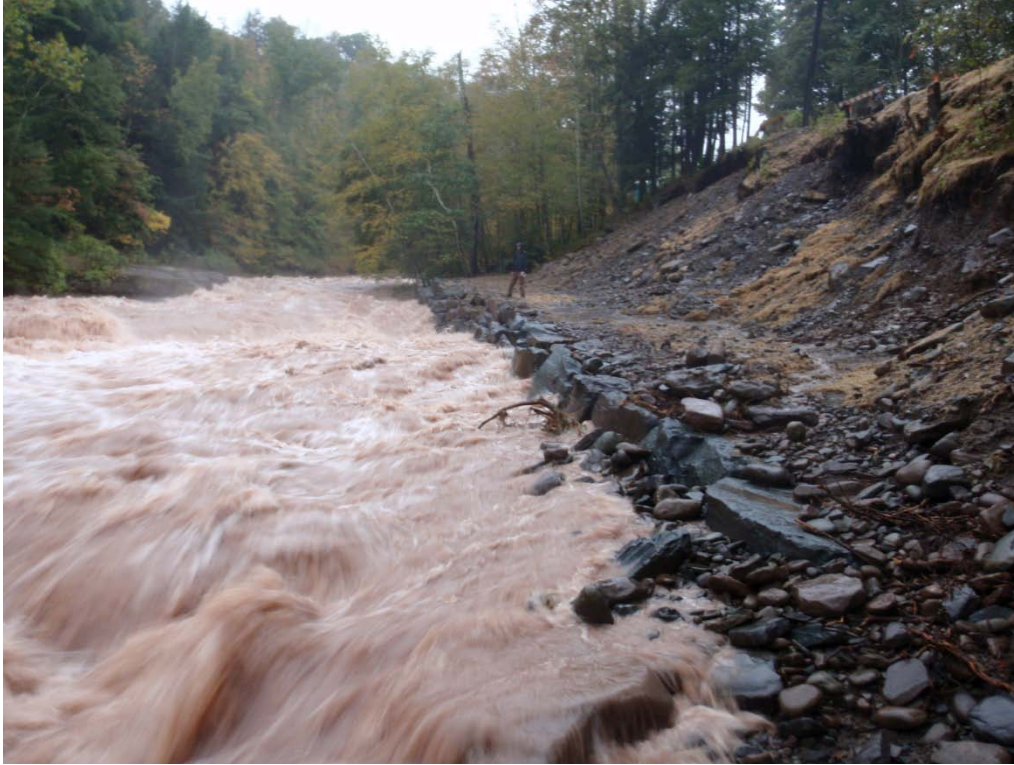
Figure 9 October 1st 2010 flood event approximately one hour after peak stage

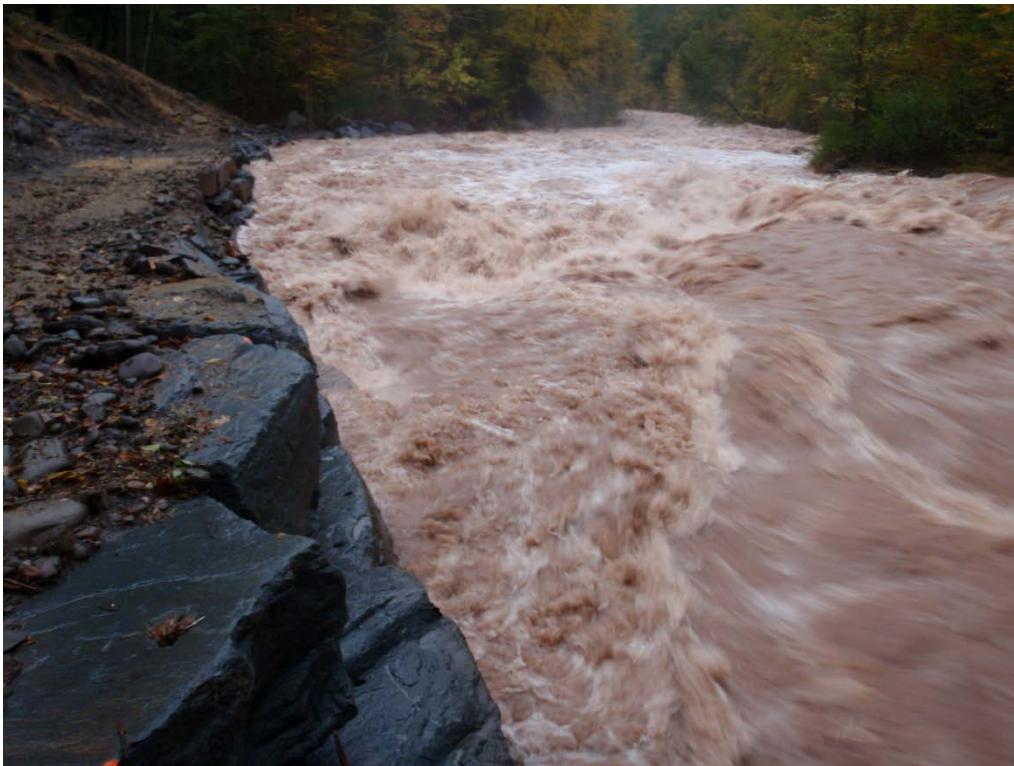
Figure 10 View looking downstream during October 1st 2010 flood event

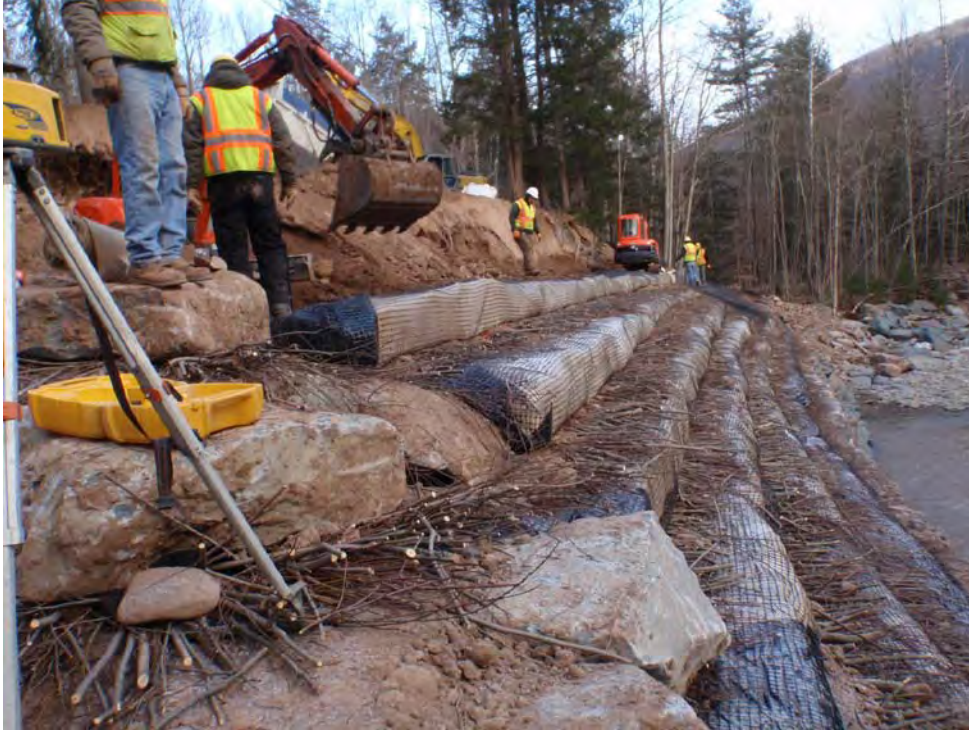
Figure 11 Construction of VRSS 1

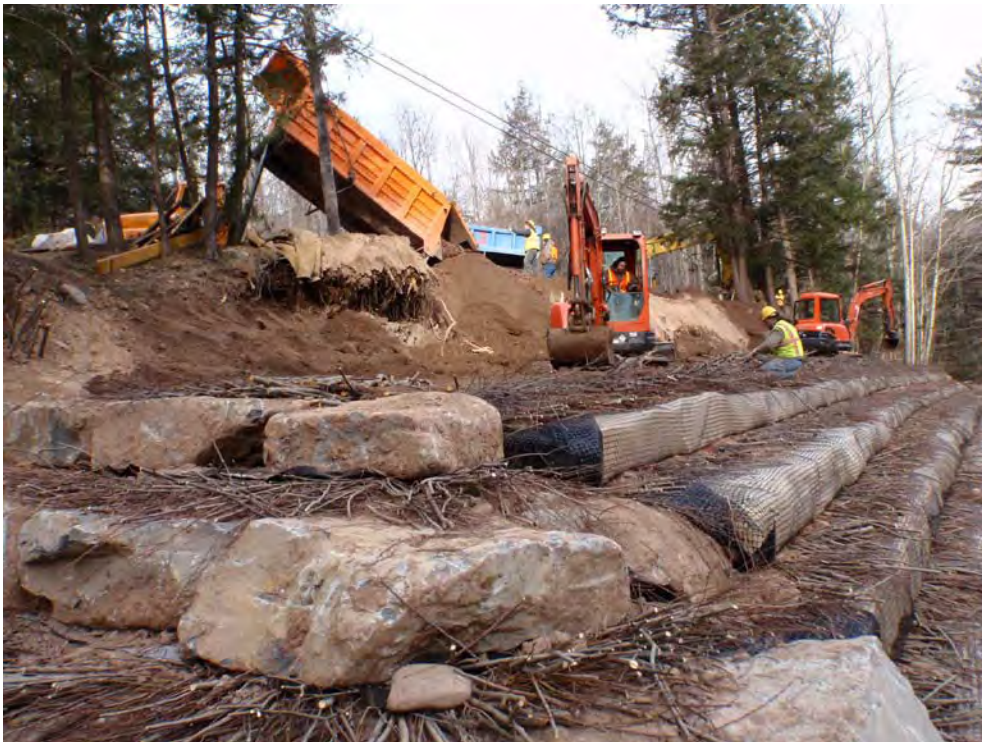
Figure 12 Construction of VRSS 2

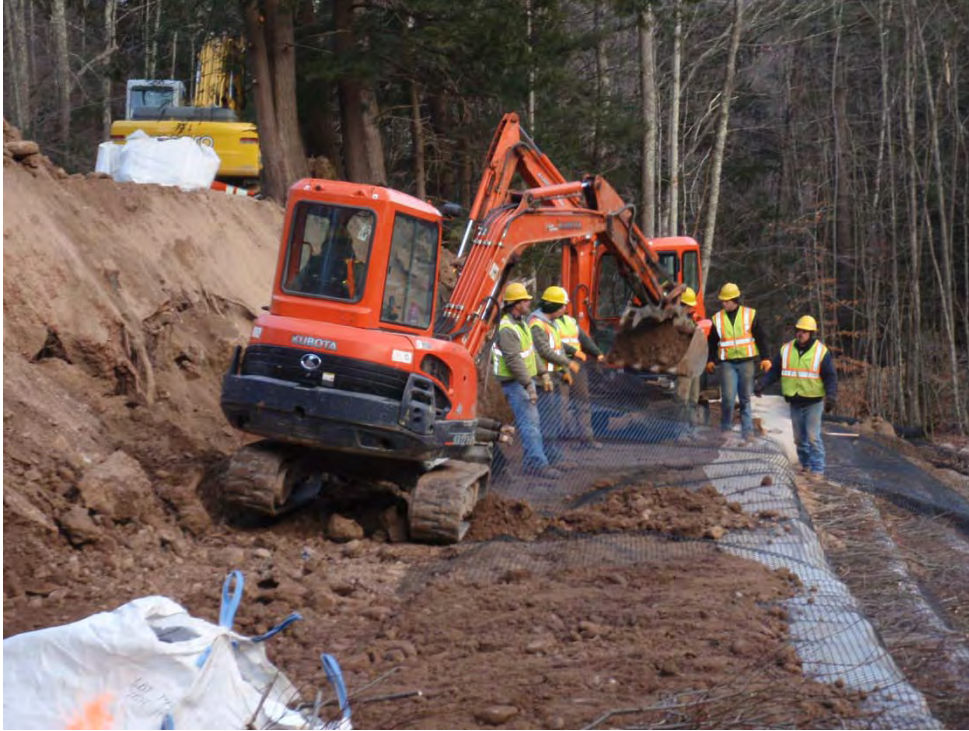
Figure 13 Construction of VRSS 3

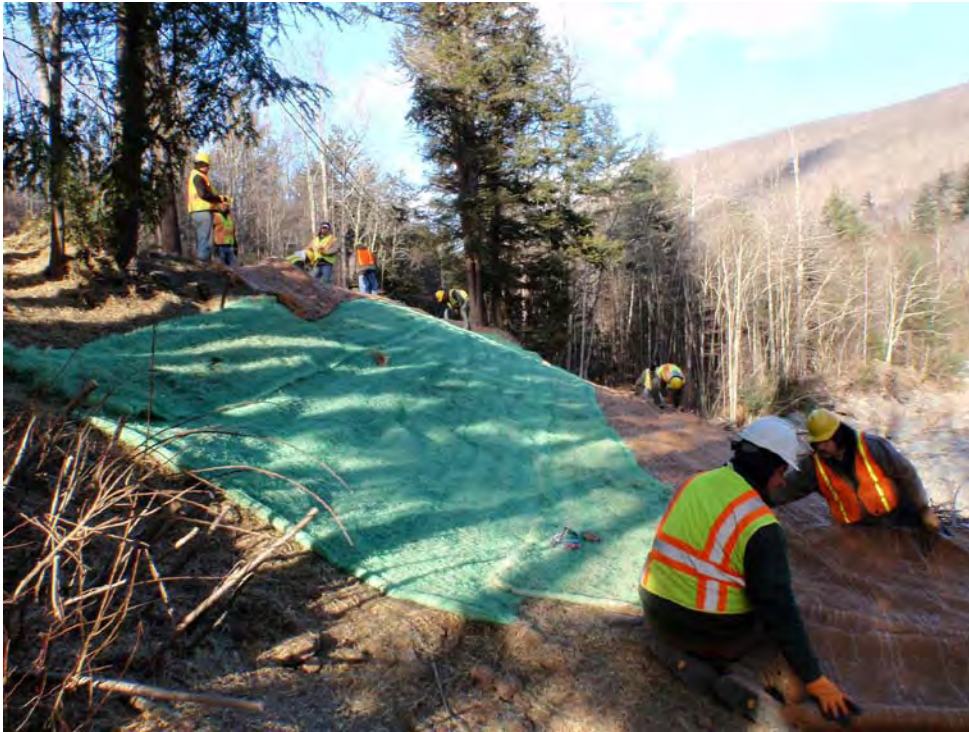
Figure 14 Application of erosion control matting

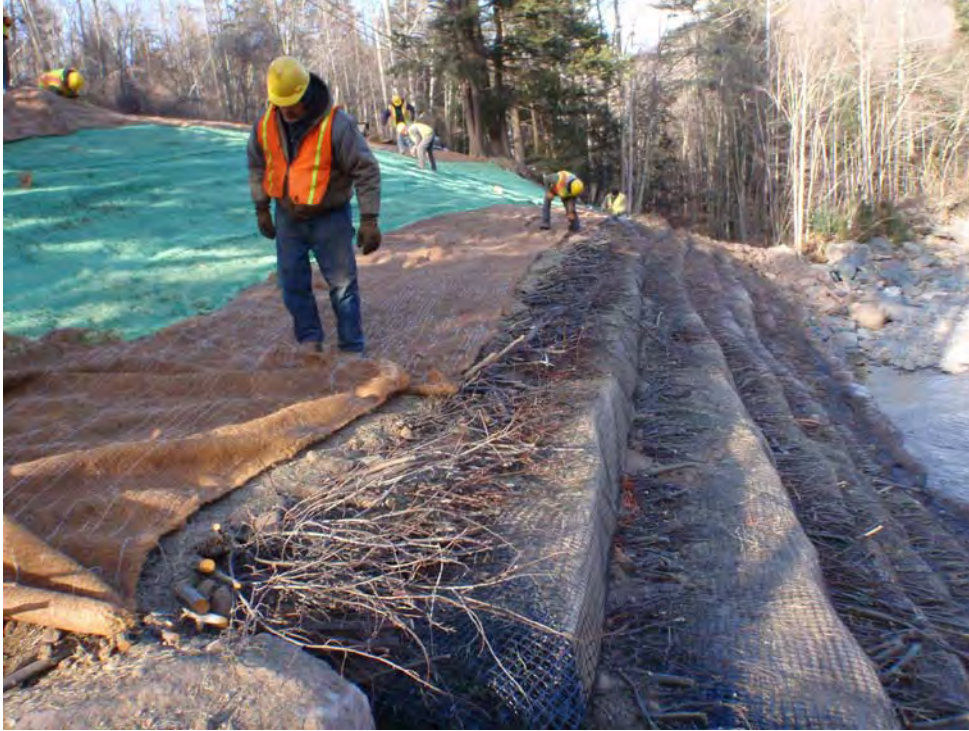
Figure 15 Erosion control matting 2

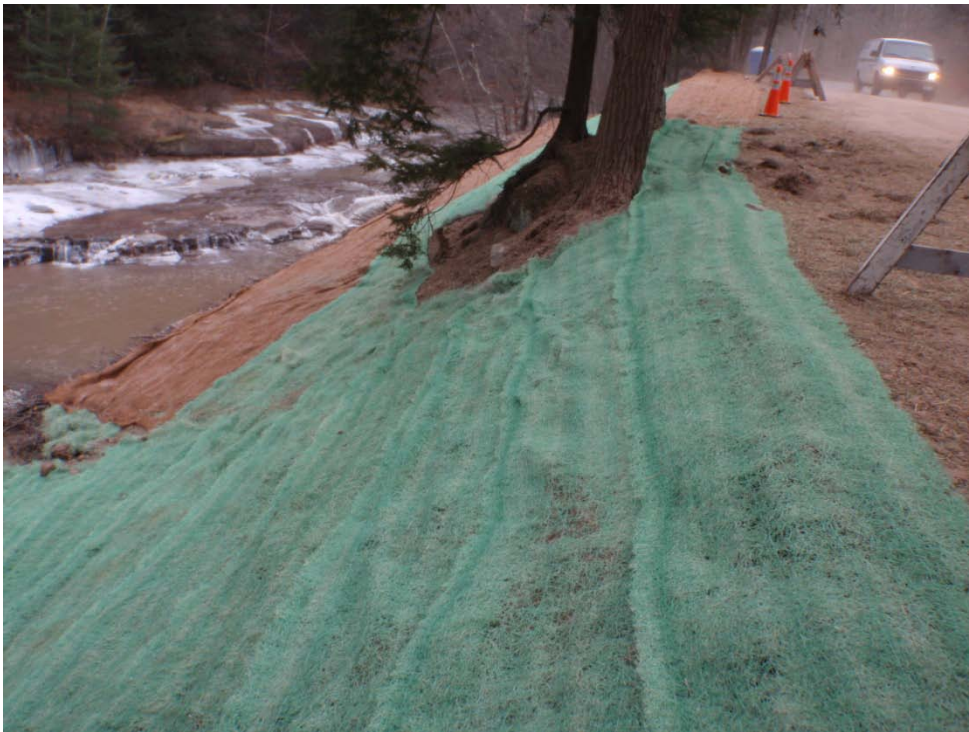
Figure 16 Completed application of erosion control matting

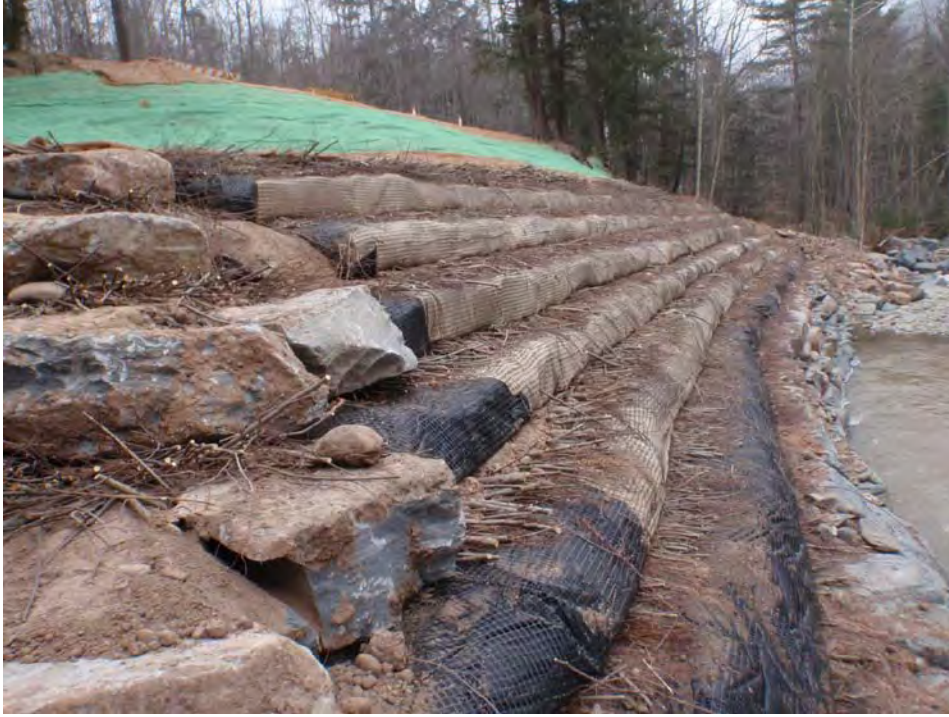
Figure 17 Completed project December 10 2010
