# Ashokan Watershed Stream Management Program

## Esopus Creek at Woodland Valley Restoration Demonstration Project

### Evaluation October 30, 2008 Meeting Summary

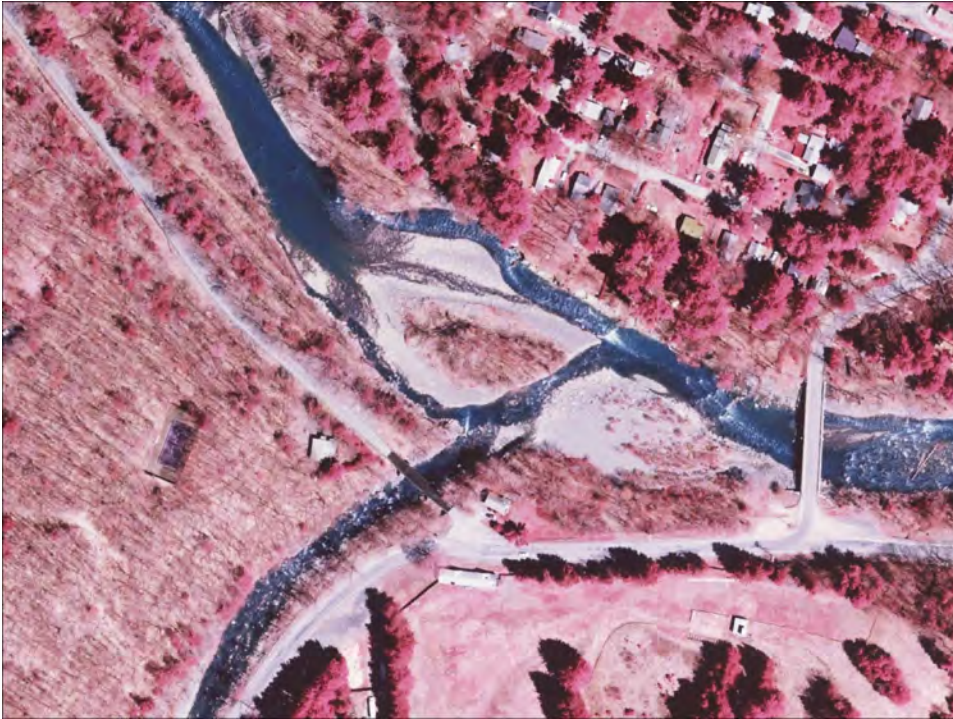
**Figure 1. Aerial photo of the Woodland Creek/Esopus Creek confluence. The project reach extends from the head of the bifurcated reach down to the Woodland bridge (2001, DOQQ)**

- *Project location:* The site is at the confluence of Woodland Creek with Esopus Creek – a setting that is inherently dynamic given the variability in magnitude of water and sediment discharge from the two mountain streams (Figure 1). Anecdotal and aerial photo evidence suggests that the channel and bar formation have undergone dramatic shifts in response to large flood events. The setting’s inherent “instability” is compounded by a double-span bridge located just downstream of the confluence that produces a clear constriction in channel dimensions.
- *The problem requiring a solution:* Following the January 1996 flood, a headcut into underlying glacial lake clay propagated through a secondary channel along the left descending bank and ended up capturing most of the Esopus Creek flow

- (Figure 1). The altered alignment of the channel, the stratified composition of the 32-foot high terrace (from bottom to top: glacial lake clay, glacial till, pre-historic stream deposits) and subsequent floods resulted in a rapidly retreating eroding bank (approximately 3 feet/year). Risks associated with continuing erosion included increasing potential for exhuming several residential septic systems, causing additional property damage, producing a continuing source of turbidity and creating a hazard to recreational users of the stream (Figure 2).

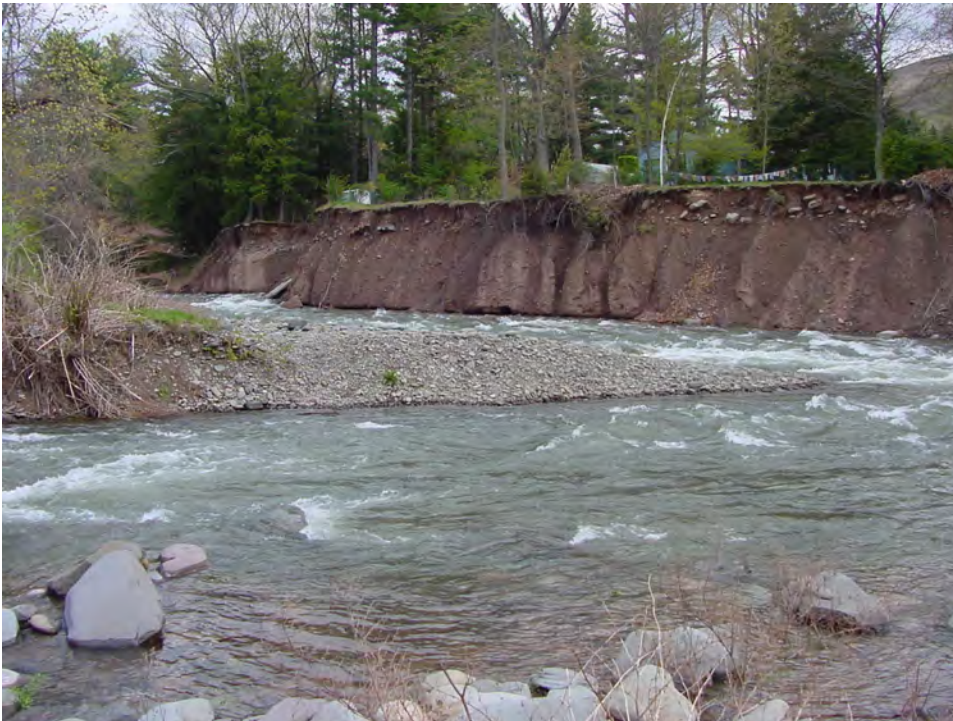
**Figure 2. Eroding stream bank/glacial till terrace (May, 2003)**

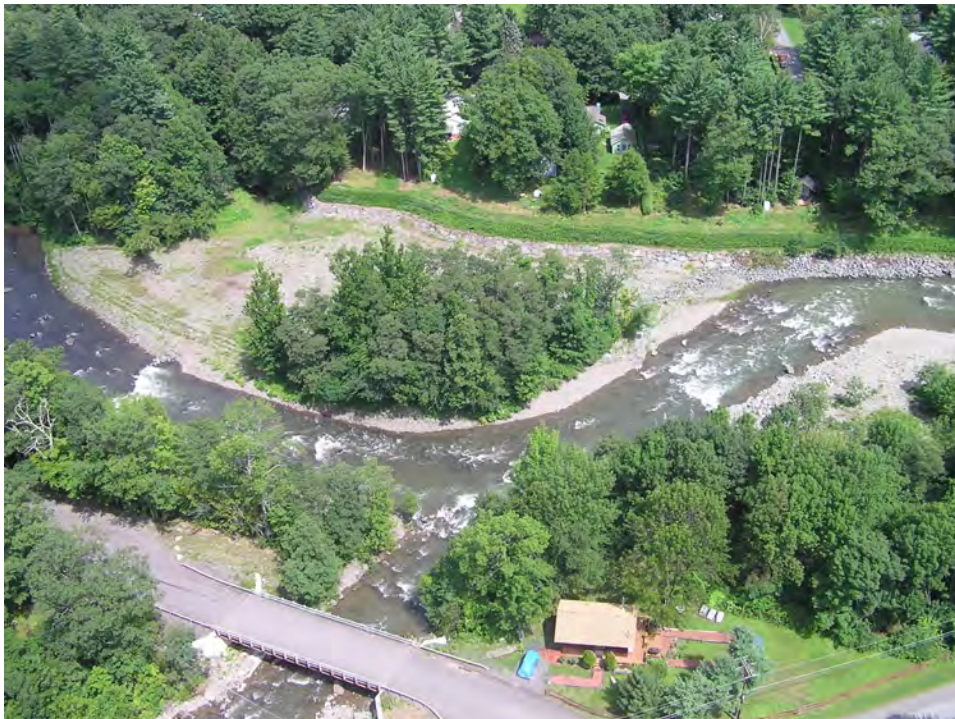
**Figure 4. Esopus Creek Restoration Demonstration Project - one year after completion (august, 2004)**

- *The implemented solution:* The selected alternative conceptual design was completed by FIScH Engineering with NRCS, an NYSDEC Article 15 permit was obtained and the project was constructed in 2003 in two stages: the channel work, bank revetment, and flood plain reconstruction were completed by October 01, 2003 and the vegetation (trees and willow fascines) and bioengineering (VRSS) were completed in early December, 2003. Figure 4 is an aerial view of the site taken approximately one year after construction (August, 2004).

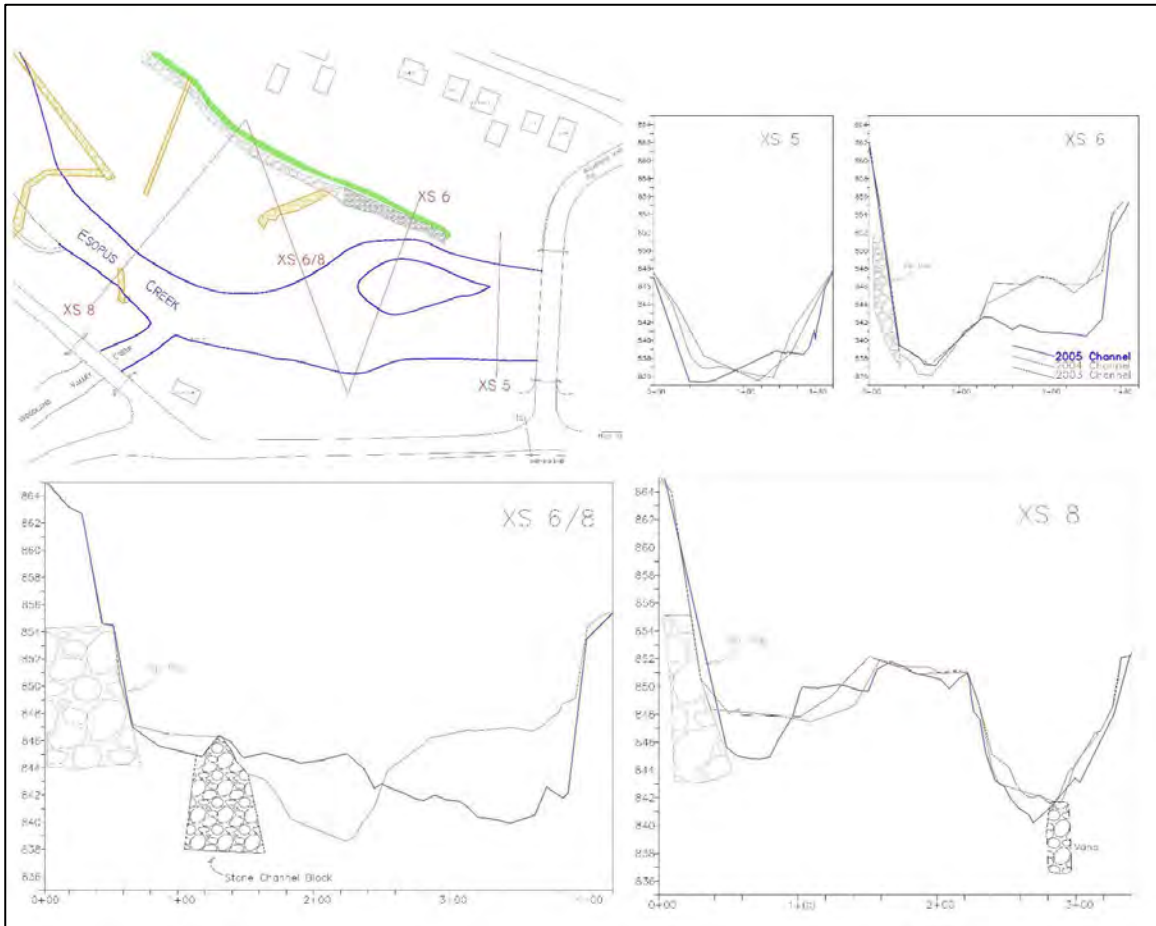
Figure 5. Example of post-flood monitoring by surveying monumented cross-sections.

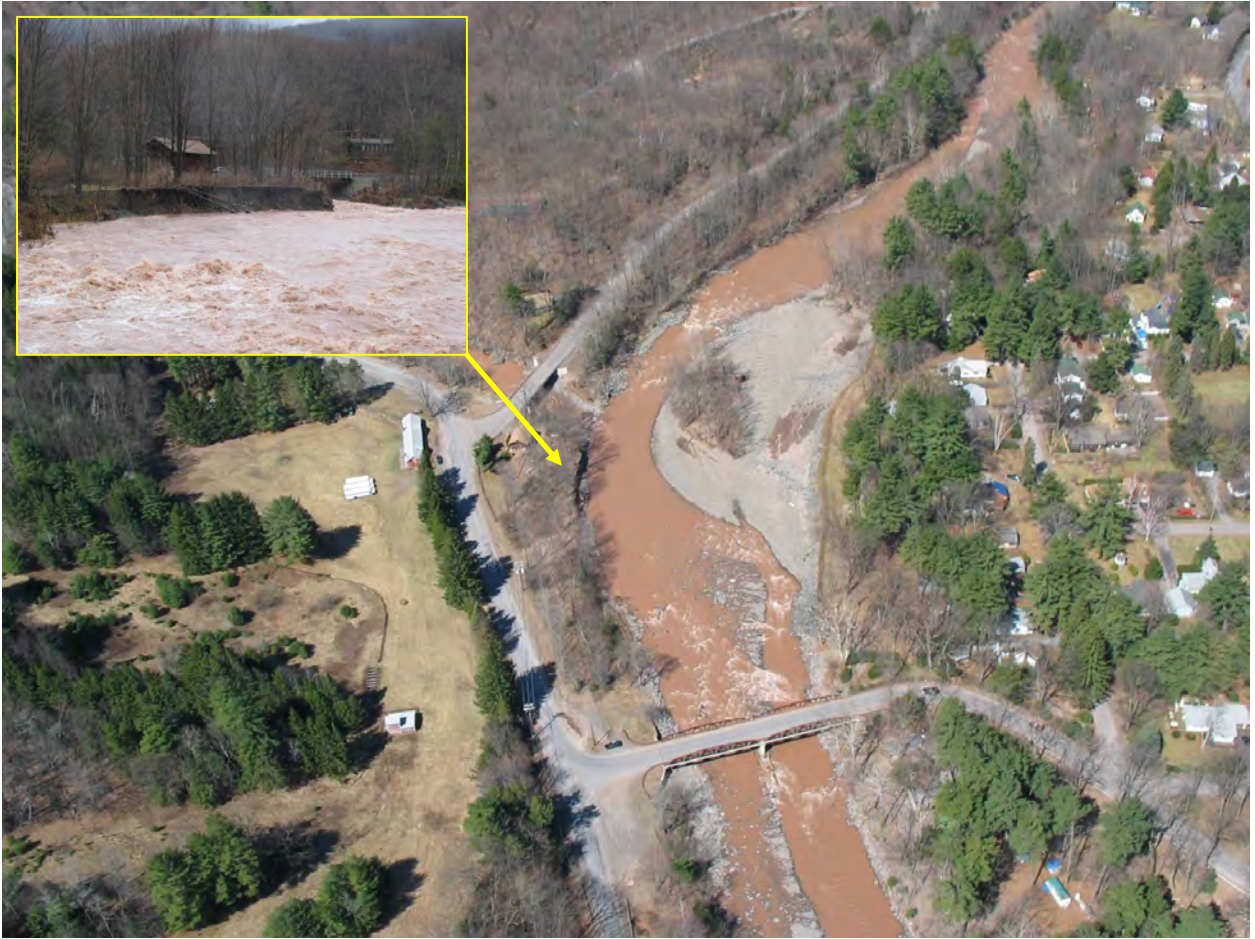
The extreme flood event that occurred on April 2-3, 2005 caused considerable damage throughout the Esopus Creek watershed including the project reach (Figure 6). There has been a perception and/or declaration of project “failure” by some observers based on the changes occurring just downstream of the project reach, most notably:

- the removal of a large partially-vegetated cobble bar on the right bank between Woodland Creek confluence and the bridge crossing Esopus Creek (“WV bridge”);
- erosion of the right descending bank adjacent to the eroded cobble bar and consequent damage of railroad grade;
- the “loss” of at least two of the NCD structures (rock vane and weir) below Woodland Creek; and
- the change in alignment toward the right bank and widening of the channel between Woodland Creek and the WV Bridge.
- Erosion along the left bank below the Woodland Bridge.

**Figure 6. Project site following April 2-3, 2005 flood. Aerial shot is from April 5 and ground shot of eroded bank is from April 3.**

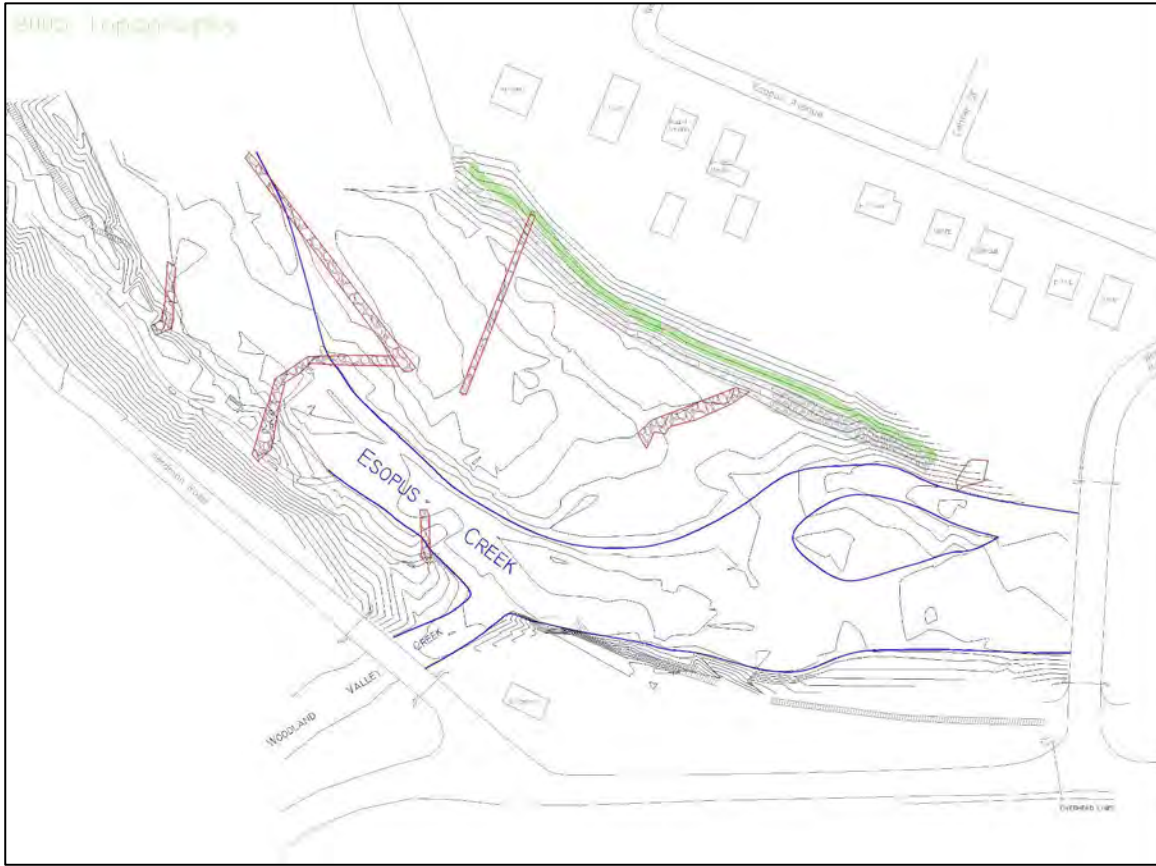
placed at the upstream, “middle” and downstream ends of the filled channel (Figure 3). While the flood plain experienced minimal change from the frequent inundation prior to the April 2005 event it did experience significant change evident following the event (Figure 7). Deposition on the streamward side and scour between the middle and downstream channel blocks caused at least 6 feet of relief in places along the surface. It is noted that Craig Fisichenich anticipated these adjustments (as well as those of the in-channel structures) and informed DEP and UCSWCD on several occasions of the expected changes. The semi-frequent inundation of the left margin of the flood plain from the upstream overflow channel has helped to create a small swale (bound by the channel blocks) that actually appears to function as a riparian wetland. The downstream channel block previously formed the channel boundary but currently an extensive point/lateral bar has prograded the flood plain several meters downstream (Figure 7.) The riprap key trench in the bar below Woodland Valley that keyed the lower weir into the railroad grade embankment was lost during the April flood.

Figure 7. Post April 2005 flood topographic survey with schematics of remaining project features.
