**Chestnut Creek
Town Hall Demonstration Site
Project Report**

Sullivan County Soil & Water
Conservation District
64 Ferndale-Loomis Road
Liberty, NY 12754
November 12, 2003

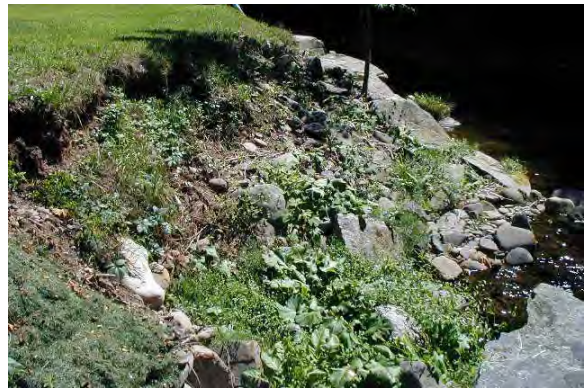
Photo 1. Erosion – left bank behind Town Hall. View looking downstream, dislodged riprap visible in right front corner of photo.

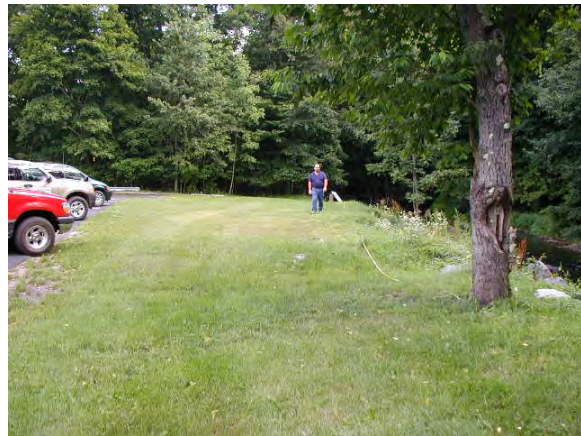
Photo 2. Top of bank before construction. Damaged Black Cherry on right, dry hydrant shown in the distance; both were removed.

The hollow Cottonwood and dying Black Cherry tree were removed from the site in the beginning of September 2003.

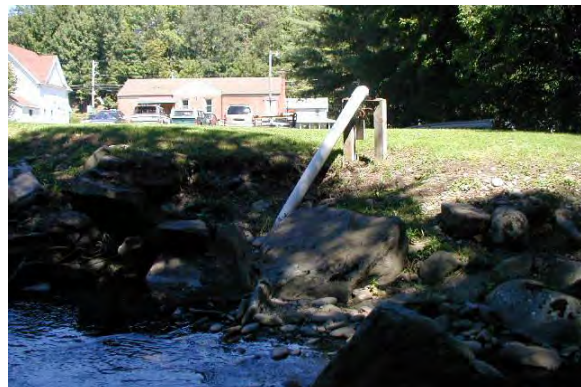
Photo 3. Dry hydrant behind Town Hall parking lot. View looking toward left bank from center of stream.

- 3.) The non-functioning dry hydrant was removed and the bank was graded. An area of about 25' in width was left unplanted for emergency access to the stream at this location.
- 4.) The existing runoff swale from the parking lot was expanded and filled with cobble four feet in depth to improve percolation from parking area runoff (Photos 6&7).

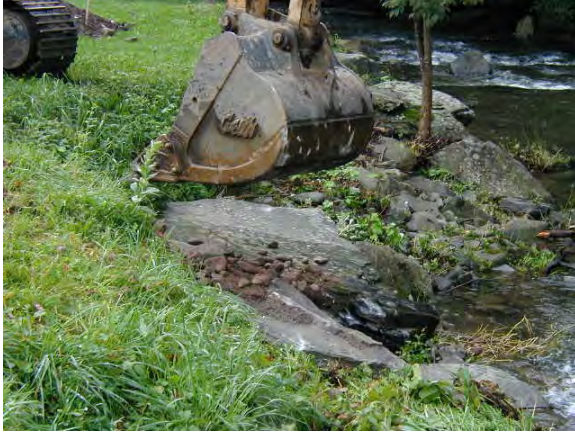
Photo 4. Dislodged riprap removed from the creek and keyed into the eroded bank to create a bankfull bench on September 26, 2003.

- 1.) A stacked rock wall was constructed of medium sized flat native stones as support under the dislodged rip rap that was relocated.
- 2.) The dislodged riprap was removed from the creek and keyed into the stream bank horizontally over the stacked

rock wall (Photo 4&5). Soil was placed to build a bankfull bench modeled on the upstream bench at reference monitoring cross-section XS 03-01.

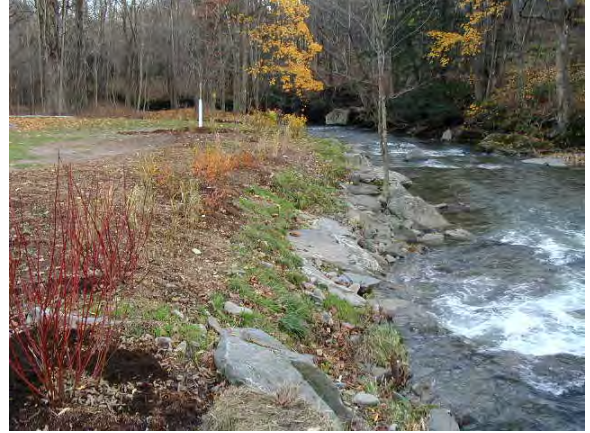
Photo 5. View looking downstream from swale towards stacked rock bankfull bench with new shrubs and native plants.

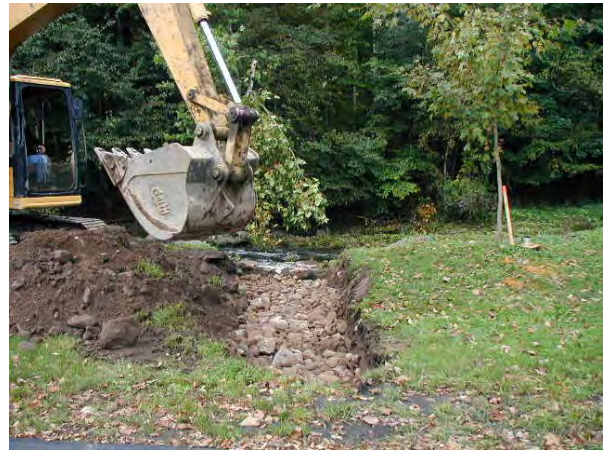
Photo 6. Swale expanded and filled with cobble; September 26, 2003.

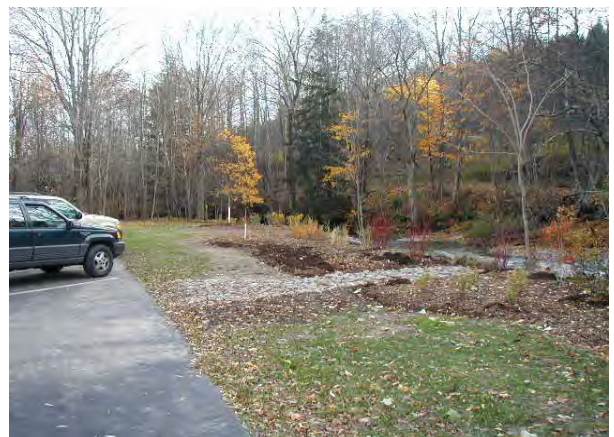
Photo 7. View looking downstream from parking lot. Shows completed swale and planted buffer.

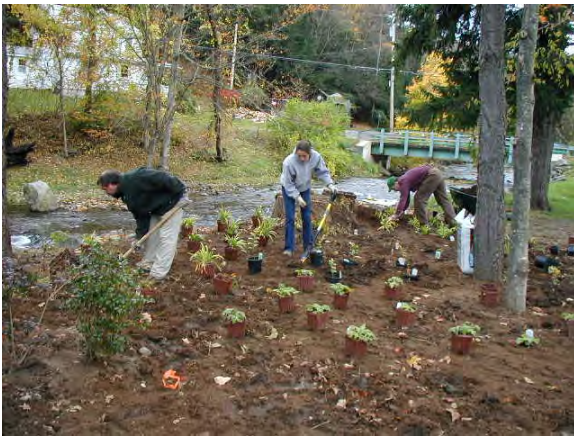
Photo 9. October 16, SCSWCD and DEP volunteers planting at Town Hall Demonstration

Restaino. Native trees, shrubs and herbaceous materials were planted on the left bank, adjacent to the Town Hall parking lot, over approximately a 300' x 10' to 15' area, as a riparian buffer (Photo 9). Many volunteers helped prepare this project including AmeriCorps, Natural Resource Conservation Service, Watershed Agricultural Council, SCSWCD, Neversink residents, Catskill Watershed Association, Cornell Cooperative Extension.

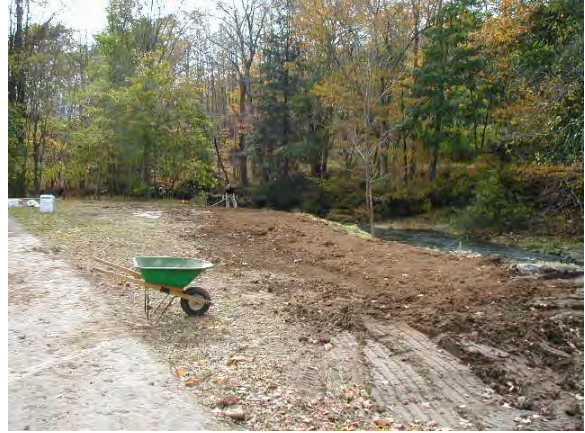
Photo 8. Topsoil/compost distributed at site. View looking downstream from parking lot; October 15, 2003.

- 5.) The sod layer along top of bank where the riparian buffer would be planted was removed with the excavator.
- 6.) On October 14 & 15, 2003 top soil and peat moss was imported to the site as a soil test revealed organic matter at the site was only 1 percent. The remaining vegetation was weeded from the

bed and the topsoil/compost was spread and graded (Photo 8).

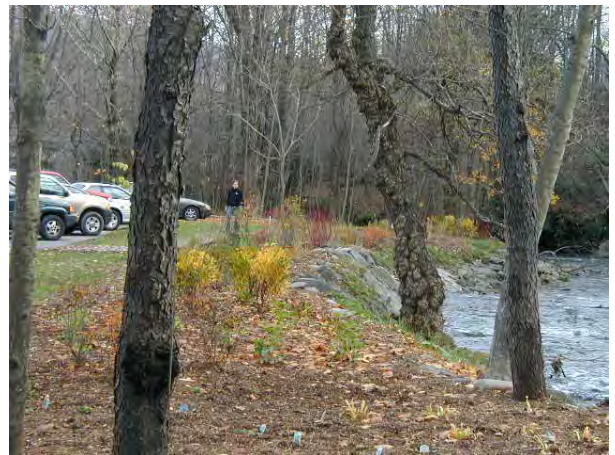
Photo 10. Looking downstream at extent of completed riparian buffer, from just above willow tree. Project ends at tree line property boundary in background.

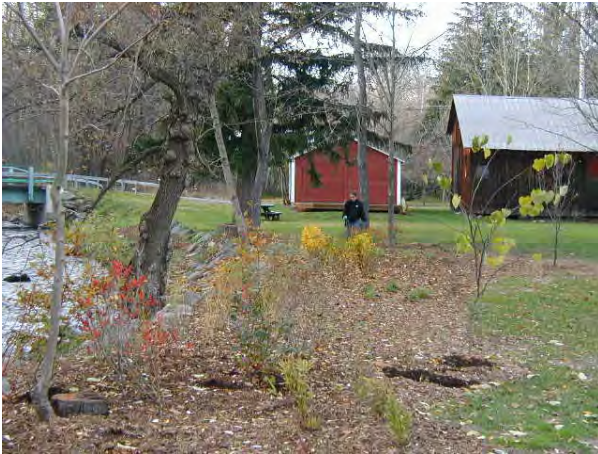
Photo 11. Looking upstream towards River Road Bridge at extend of completed riparian buffer, from just below willow tree. Project ends by Norway Spruce before picnic table in background.
