Ashland Connector Stream Restoration Project

Project Implementation Report

Town of Ashland, Greene County, New York

December 2006

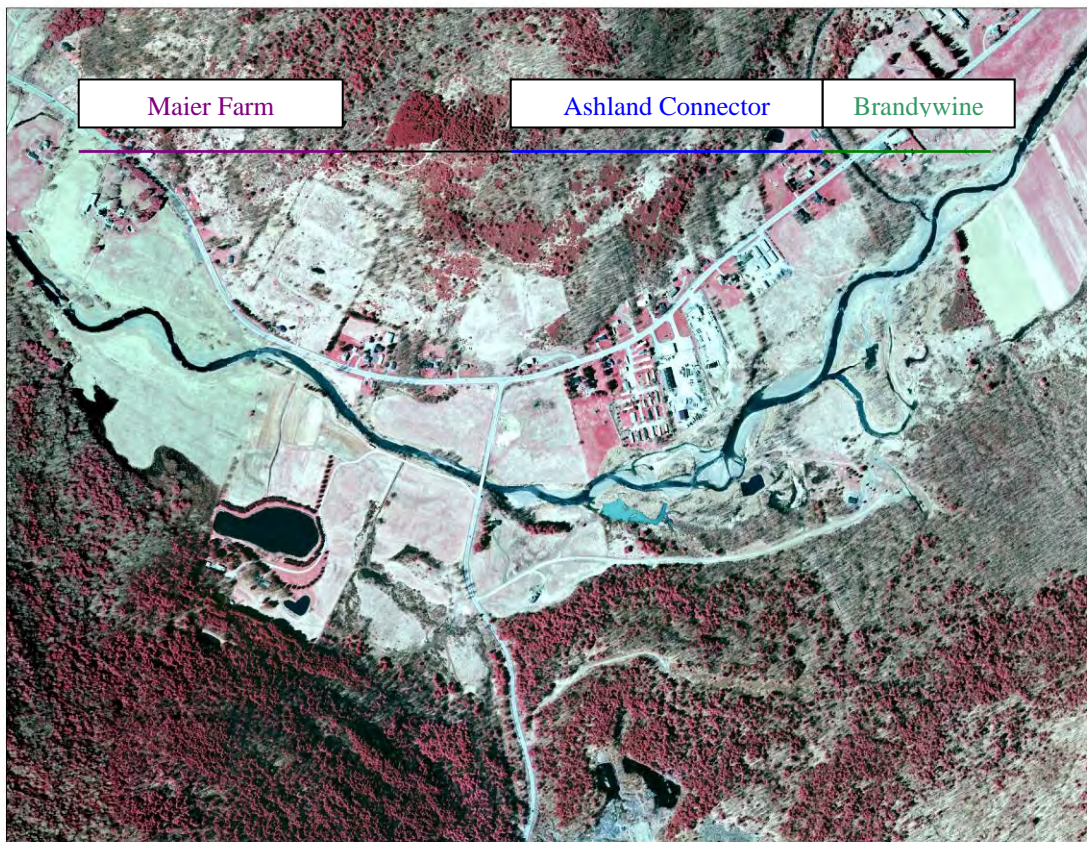
2001 Digital Ortho Quarter Quad imagery displaying Maier Farm on the left, Brandywine on the right and the pre-restoration condition in the Ashland Connector project reach

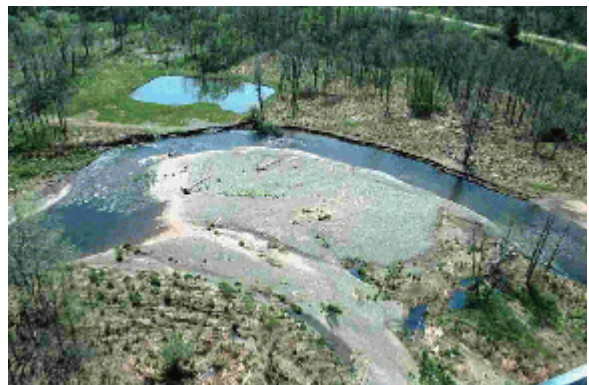
Active channel migration has historically threatened this floodplain pond. Knotweed is a significant limiting factor to the likelihood of the reach regaining natural stability.

Numerous wetlands and a man-made pond are located on the south floodplain. The wetlands are contiguous with extensive wetland conditions in the reach, and in most cases were the result of channel adjustments that abandoned meander scrolls. The wetlands and pond contribute to the diverse habitat potential of the reach. The wetlands within the reach were considered a priority for protection or mitigation due to the scarcity of established riparian wetlands within the Batavia Kill watershed. The historic channel shifts had frequently impacted these wetlands by removing much of the wetland soils and vegetation. Insufficient sediment conveyance through the reach had also resulted in deposition (filling) in many low wetland areas in the reach.

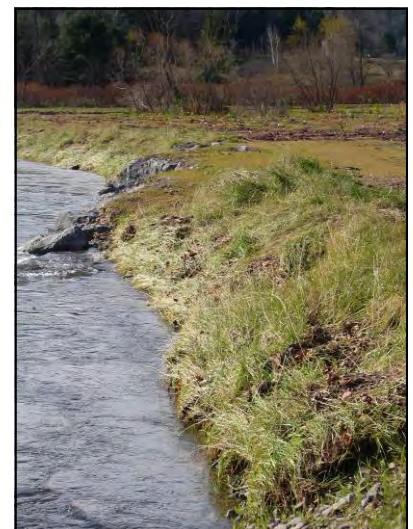
Pre-vegetated Sod Mats

Upon completion of the project channel and floodplain grading, the pre-vegetated sod mats were cut from the ground using a custom fabricated loader bucket. The mats were then transported to the streamside, and placed in areas expected to be particularly vulnerable to erosion. Several of the mats were placed on the face of the stream bank on the outside of meander bends where erosive forces are greatest. The mats provide a dense root network that serve to stabilize the stream bank. The root network of the pre-vegetated mat is far more developed than what could be achieved by simply seeding the bank following construction. The aesthetic quality of the banks treated with the mats is also far superior to that of the untreated banks.

NCD projects are at their weakest immediately following construction due to the nature of disturbance necessary to install the restoration design. Restoration of vegetation, critical to stream stability, is a priority from a soil stabilization standpoint. In order to establish mature stream bank vegetation immediately following construction GCSWCD prepared seed beds on top of erosion control blankets and planted them with a specially design riparian grass seed mix early in the 2006 growing season. These seed beds were created on lands owned by NYCDEP adjacent to the project area.

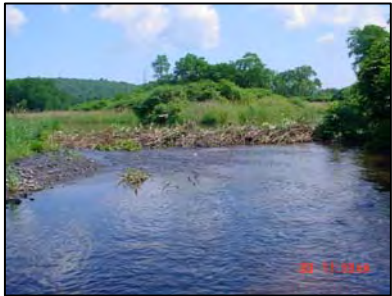
A beaver dam near the upstream extent of the project obstructed the bankfull channel at the time of the photo to the left. Sediment and flow conveyance was restored to the reach through the installation of a geomorphically appropriate channel design.

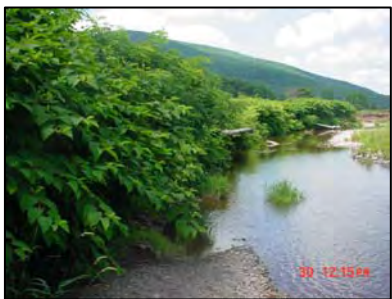
Knotweed was the dominant vegetation along much of the project reach. Knotweed was removed from several areas while floodplains were created in other areas. Buffers have been planted in those areas that will help protect the stream from the impacts of the invasive species.

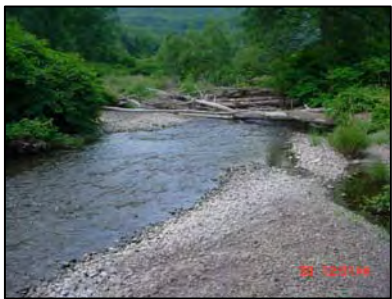
Excessive debris deposits obstructed the flow path and disrupted sediment transport through the reach. Structure and habitat mimicking that provided by natural debris was restored to the reach in the form of rock vanes and riffle/pool bed features.

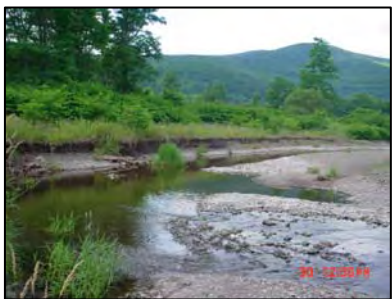
Accelerated sediment deposition resulted in aggradation, transverse bars, and bank cutting. Channel dimensions were installed to restore appropriate sediment transport and rock structures protect against bank erosion while vegetation becomes established.

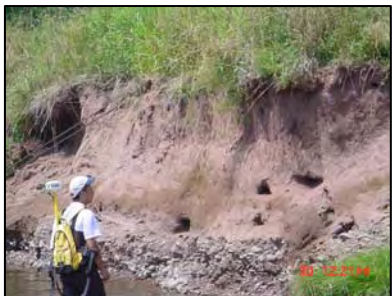
Bankfull benches were installed in place of high cut banks. The benches provide a place for bank stabilizing vegetation to become established with access to groundwater. The lower bank height allows roots to bind soils at the toes of the stream banks.
