Riparian Corridor Management Plan East Kill

Bardfield Property – Jewett, NY

February 2, 2011

**Catskill Streams Buffer Initiative Coordinator
Greene County Soil and Water Conservation District
Cairo, NY**

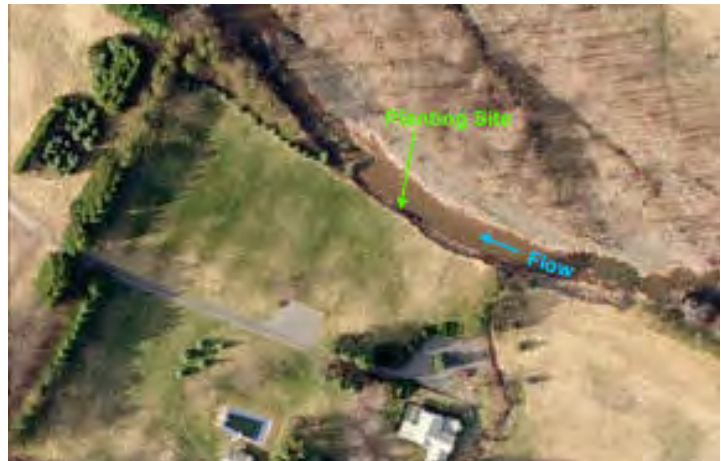
The Bardfield property is located on Shadow Mountain Road off of Route 23C in East Jewett, NY. The northern property boundary is the East Kill, which is a C (TS) stream suitable for trout spawning.¹ During a site visit conducted by GCSWCD staff in November of 2010, erosion was evident in the form of 500 feet of undercut bank along the left bank (looking downstream). Although the stream had migrated through a 20 year old pine and spruce buffer, there were no immediate threats to structures on the property. Other than a few mature trees present at the top of the bank, deep-rooted vegetation was sparse along the property line. The low elevation, flood prone left terrace is currently a field of mowed herbaceous vegetation, and was identified as such in the East Kill Stream Management Plan which was conducted in 2007 by the GCSWCD.

Riparian planting site as shown in 2007 SMP

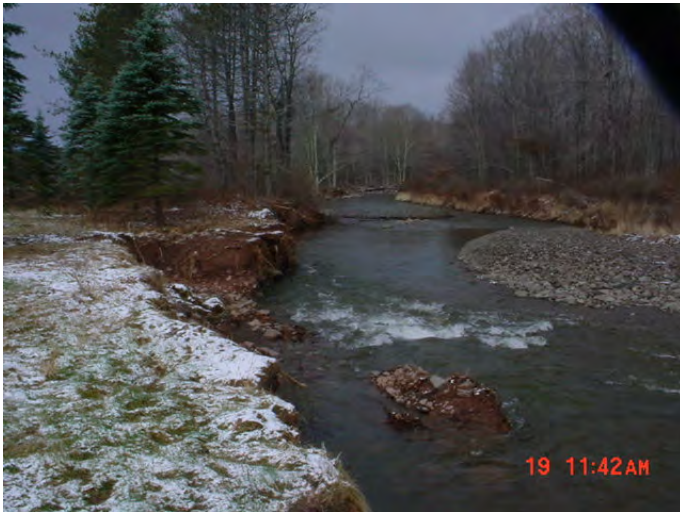
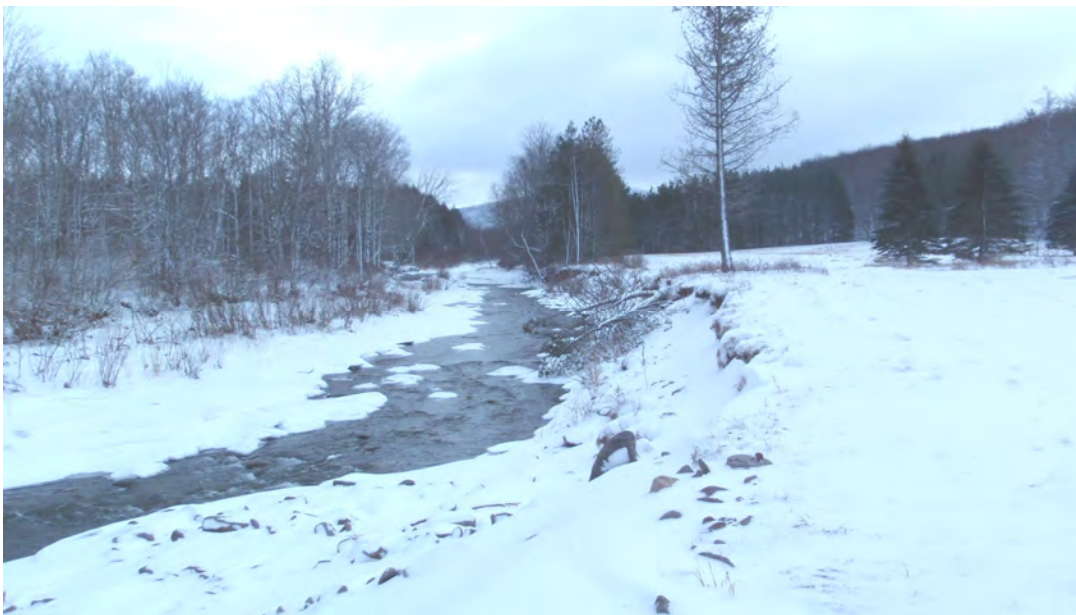
After the November site visit, Mr. Bardfield applied for a stream bank disturbance permit to reinforce the banks with rip-rap, and completed much of this work prior to the CSBI site visit in December. He has indicated that plans for the spring of 2011 include a continuation of rip-rap placement near the upstream end of his property. Although the banks were covered with snow at the time of the site visit in December 2010, much of the existing rock armoring was visible and appeared to be in fairly good functional condition. The photo below taken in November 2010 shows the view looking downstream from Stephen's property prior to rip-rap installation, and highlights the severity of historic bank erosion at this site.

Eroding streambank looking upstream at Joshua Bardfield's parcel 12/22/10

5) Interplant native shrub and sedge species through the rip-rap. This planting will help to strengthen the revetment, while enhancing aquatic habitat.

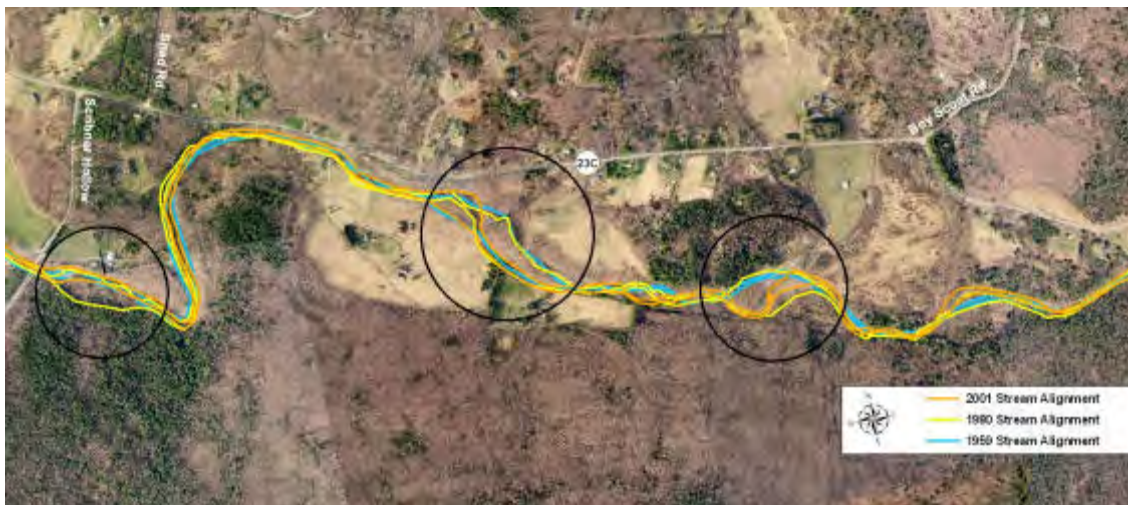
As seen from the historical stream channel alignments (below), the planform of the channel alignment has changed significantly over the years along this management unit. In each of the three locations, the channel has experienced lateral migration, the movement of a channel across its floodplain over time. Channel migration can occur through natural processes of erosion and deposition over time, but is often expedited by human induced changes to the stream. Historically, through the section of stream that runs through the Bardfield parcels, there has been a split channel, the locations and lengths of the secondary channel has changed over time as the outside banks of the meandering channel moved laterally across the valley floor and down the valley. Currently, the flow along this property is confined to a single channel. However, channel alignment is subject to relatively frequent change due to various factors.

Historic stream channel alignments with 2006 aerial photograph

The East Kill Stream Management Plan recommends that management efforts in this unit should focus on establishing a riparian buffer in appropriate locations by planting native trees and shrubs along the streambank and the upland area. Buffer width should be increased by the greatest amount agreeable to

the landowners. Increasing the buffer width to at least 100 feet will increase the buffer's functionality and protect the stream from nearby land uses.
