Riparian Corridor Management Plan

Mad Brook

Brunsdon Property – Windham, NY

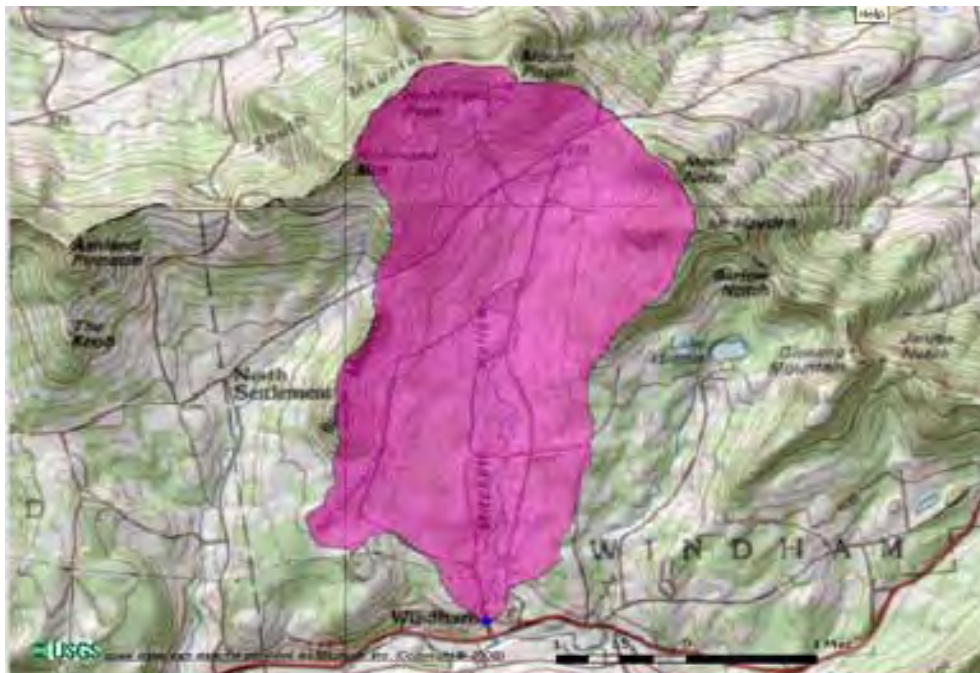
The drainage area for this location is 8.71 mi² including runoff from portions of Mount Pisgah, Mount Nebo, Mount Hayden, Richmond Mountain, and Bump Mountain. Approximately 88% of the drainage area is covered by forest. In the area where erosion is occurring on Brunsten's property, the roots are exposed on a mature evergreen adjacent to the stream. The ground cover is primarily herbaceous in the project area as the site is the landowner's backyard. The opposite side of the stream has a vegetated buffer.

USGS StreamStats map showing Drainage Area for Brunsten property

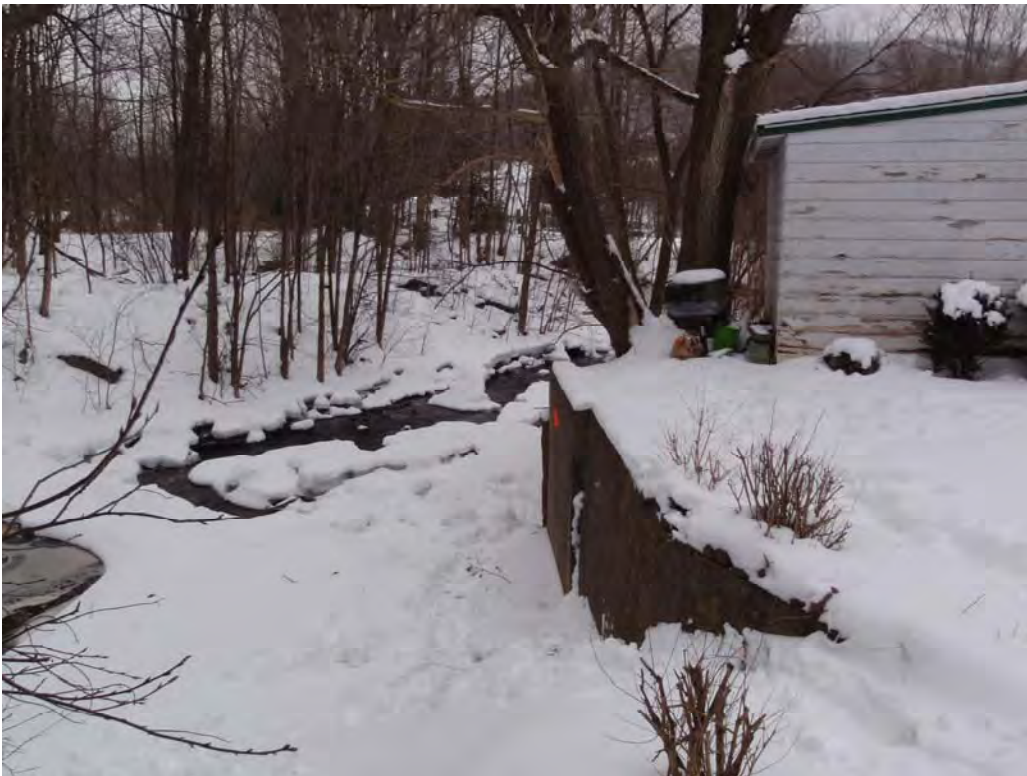
The cracked retaining wall which extends on Brunsdens' property has been studied by Delaware Engineering. Although the Town of Windham received a grant from the Catskill Watershed Corporation for the Mad Brook retaining wall project, design and construction of repair work has been delayed due to lack of sufficient funding to complete the project.

Downstream view showing cracked retaining wall, 2010

- 5) **Continue to monitor reach stability through normal observations.** Take photographs from the same location each year to photo document erosion.
- 6) **Consider cutting mature tree (at risk of falling) on severely undercut banks above beginning of root ball.** To minimize soil loss and further erosion of undercut banks, leave root ball in place in bank.

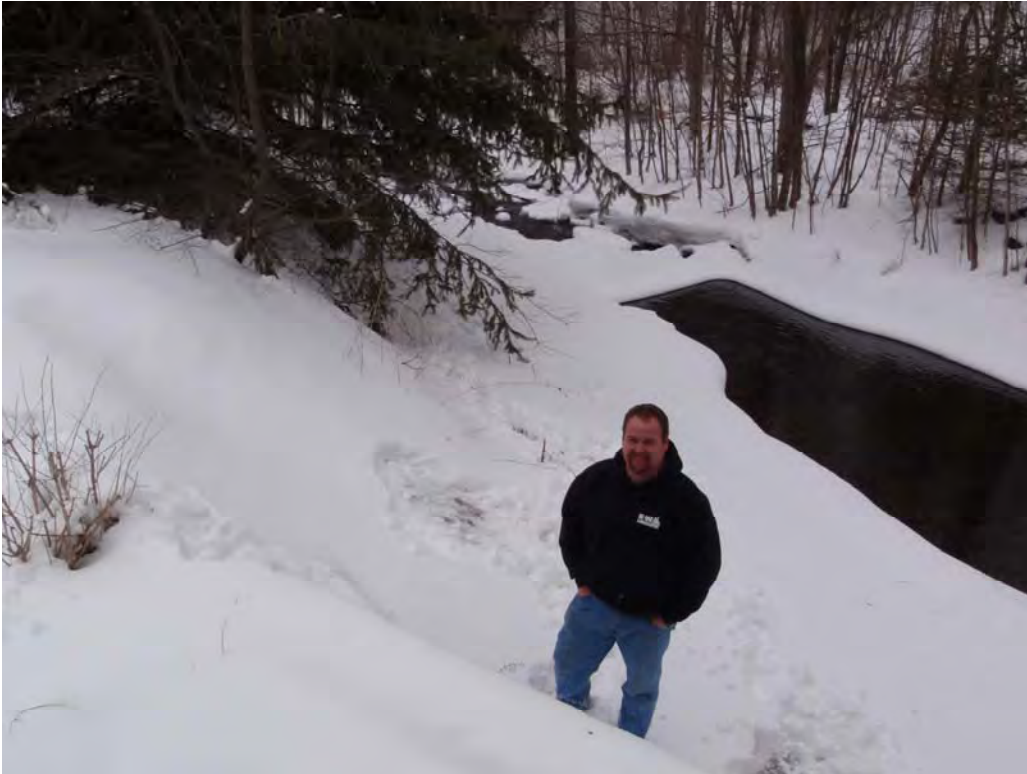
Upstream view of planting area, 2010

- 1) **Apply** to CSBI for funding support to install one or more of the practices below.
- 2) **Establish a riparian buffer** as deep rooted woody vegetation is critical to maintaining bank stability. This site could benefit from enhanced buffer width and establishment of more woody vegetation. Planting and maintaining a healthy buffer of native trees and shrubs along streambanks and floodplains is one of the most cost effective and self-sustaining methods for landowners to protect streamside property. Planting native species such as willow can help restore the riparian buffer to stabilize the streambanks. Native species are recommended due to their adaptation to our regional climate and soil conditions and because they typically require less maintenance than exotic species following planting and establishment.
