**Riparian Corridor Management Plan
East Kill
Dodson / McCloskey Property – Jewett, NY**

March 18, 2010

**Laura Weyeneth
Catskill Streams Buffer Initiative Coordinator
Greene County Soil and Water Conservation District
Cairo, NY**

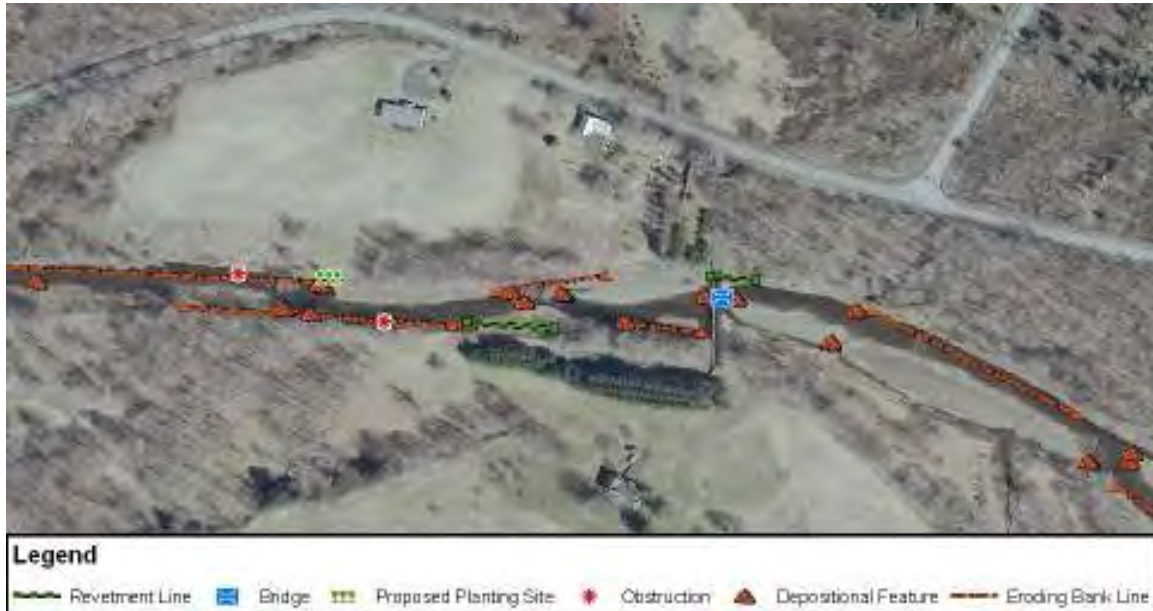
Greene County Soil and Water Conservation District (GCSWCD) completed the East Kill Stream Management Plan in 2007. The Dodson/McCloskey parcel that GCSWCD visited in February 2010 is located in Management Unit 5. Although historical stream channel alignments show the planform of the channel alignment has not changed significantly over the years along this management unit and the channel has remained fairly stable, bank erosion was noted along the Dodson/McCloskey parcel during the stream feature inventory as seen in the map below. (Red lines indicate locations of bank erosion.)

East Kill Management Unit 5 Stream Feature Inventory with 2009 aerial photograph

Sediment deposition can be seen on aerial photos directly downstream of the private bridge located just upstream of the Dodson/McCloskey property. Excessive sediment deposition upstream and downstream of a bridge commonly occur when an inadequately sized bridge opening causes water to back up upstream of the bridge and reduces stream velocity. As stream velocity slows, sediment drops out causing aggradation of the channel bed. The height and width of this bridge opening posed a constriction to flow. In high stage, floodwater can seek conveyance through alternative paths, forming new channels around the bridge constriction, as appeared to have happened at this site.

The Stream Management Plan recommends that management efforts in this unit should focus on preservation of existing wetlands and forested areas and improvements to the riparian buffer by planting *herbaceous* areas and revegetated stream banks with native trees and shrubs.

Recommendations for this management unit also include establishing a riparian buffer in appropriate locations by planting native trees and shrubs along the streambanks and upland area. Buffer width should be increased by the greatest amount agreeable to the landowners. Increasing the buffer width to at least 100 feet will increase the buffer's functionality and protect the stream from nearby land uses.

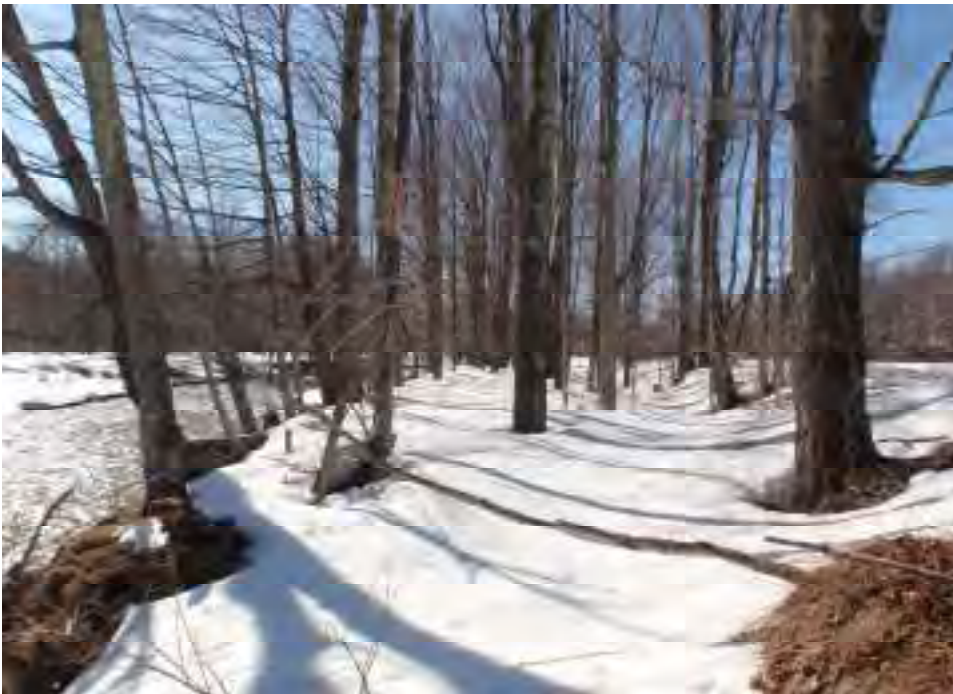
The landowners have expressed concerns about erosion occurring on the East Kill segment that runs along the back of their property. Heavy rains and two to three high water events each year have led to increased erosion. Localized erosion was noted at the site visit on the right streambank. The ground cover is primarily herbaceous although the ground was covered in snow at the time of the site visit. Planting additional native species such as willow and alder can help restore the riparian buffer to stabilize the streambanks.

There is a small patch of Japanese knotweed that is not too large to eradicate. It would be beneficial to remove the knotweed before it spreads and replant the disturbed area with native species.

Downstream view, March 2010

- 1) **Apply** to CSBI for funding support to install one or more of the practices below.
- 2) **Establish a riparian buffer** of deep rooted woody vegetation to maintain bank stability. Planting and maintaining a healthy buffer of native trees and shrubs along streambanks and floodplains is one of the most cost effective and self-sustaining methods for landowners to protect streamside property. Native species are recommended due to their adaptation to our regional climate and soil conditions and because they typically require less maintenance than exotic species following planting and establishment.

- 3) **Use vegetative treatments such as dormant posts and stakes to address minor localized erosion.** Bioengineering, the use of live vegetation to stabilize soils associated with streambanks, can be used at this location. Dormant cuttings from appropriate species, such as willows and dogwoods, quickly establish vegetation on the banks. Live posts and stakes are cut from living willow shrubs when the shrub is dormant (usually during the fall). The stakes, ranging from one to several feet long, are hammered or pushed into the stream bank where they will grow quickly and provide necessary bank stabilization where it is needed most. A dormant post detail drawing is attached.

- 4) **Use live fascines.** Live fascines are a standard bio-engineering technique which involves the bundling and planting of dormant plant cuttings. The plant bundles sprout and develop a root mass that will hold the soil in place and protect the streambank from erosion. A live fascine detail drawing is attached.

- 6) **Remove Japanese knotweed.** Invasive, non-native species can threaten the ecology of a native plant community. This impact may extend to an alteration of landscape or bank stabilization. Japanese Knotweed is an exotic, invasive species and in recent years has been a serious issue in the Schoharie Basin. As the name implies it comes from Asia and was originally brought here as an ornamental plant. In an attempt to beautify their homes, residents unknowingly introduced a threatening element to the environment. Knotweed out-competes native plants by growing much faster than its native counterparts. Knotweed can tower over native plants, cut off their light supply and eventually, take over the entire length of a stream. This is especially dangerous, because knotweed does not hold stream banks together as well as native species. Furthermore, it is a very resilient plant. Simply cutting it down without proper disposal can potentially make the problem worse. See the link below (in the Resources list) to learn how to identify and control Japanese Knotweed.
