# FARBER FARM STREAM RESTORATION PROJECT - EAST KILL -

## IMPLEMENTATION & MONITORING REPORT

FARBER FARM PROJECT - JEWETT, GREENE COUNTY, NY

UPDATED  
MAY 2006

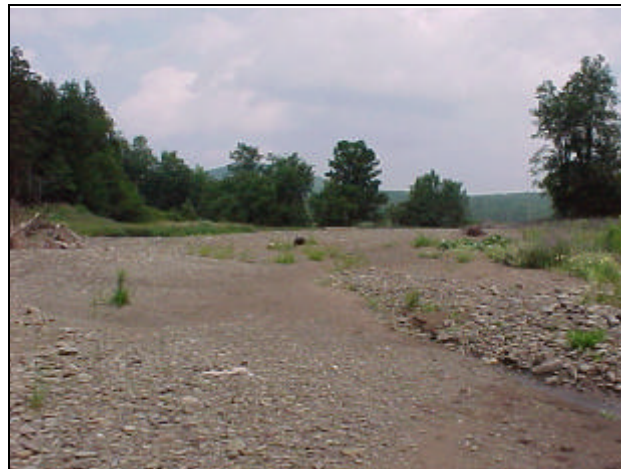
Image of subsurface stream flow condition during summer base flow.

Inventories during low flow conditions documented subsurface flows during the summer thus limiting aquatic habitat. The existing channel did not exhibit the bed diversity that is typical of a natural riffle/pool sequenced stream channel.

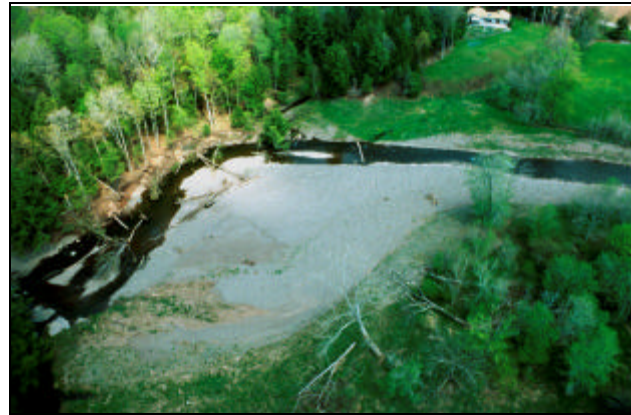
Image of excessive deposition and bar formation at the bottom of project reach.

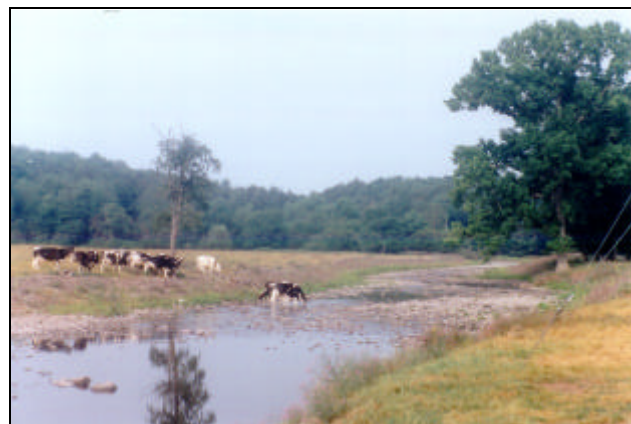
Image of livestock in channel and grazing on streambank vegetation.

Riparian buffers are crucial in maintaining stream stability within this stream type and valley setting. The riparian area through the Farber Farm reach was primarily maintained as pasture land. Livestock historically grazed on the riparian vegetation, leaving the banks more exposed to erosive forces, and had direct access to the stream channel, which may have impacted water quality.

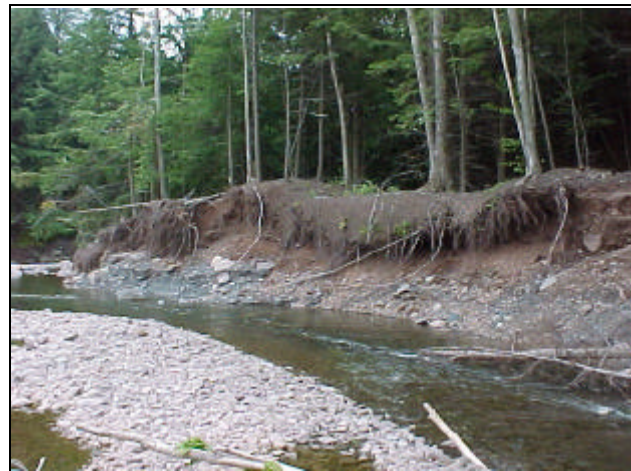
Image of stream bank erosion near bottom of project reach.
